Quality Issue #002: CDOM drift

Issue number: 2			
Contact details: chiara.monforte@voiceoftheocean.org; callum.rollo@voiceoftheocean.org			
Version	Date	Comments	Authors
1	2023-07-07	Creation of document	Chiara Monforte and Callum Rollo
2	2023-07-28	Added info on new missions: SEA069_M15; SEA077_M24 and SEA078_M14	Chiara Monforte
3	2023-08-21	Correction of a typo of flag value in the legend table	Chiara Monforte
4	2023-09-21	Added info on new mission: SEA056_M64; SEA079_M14 and SEA076_M19	Chiara Monforte
5	2023-10-06	Added info on new mission: SEA077_M25 and SEA078_M15	Chiara Monforte
6	2023-11-13	Added info on new mission: SEA079_M16	Chiara Monforte

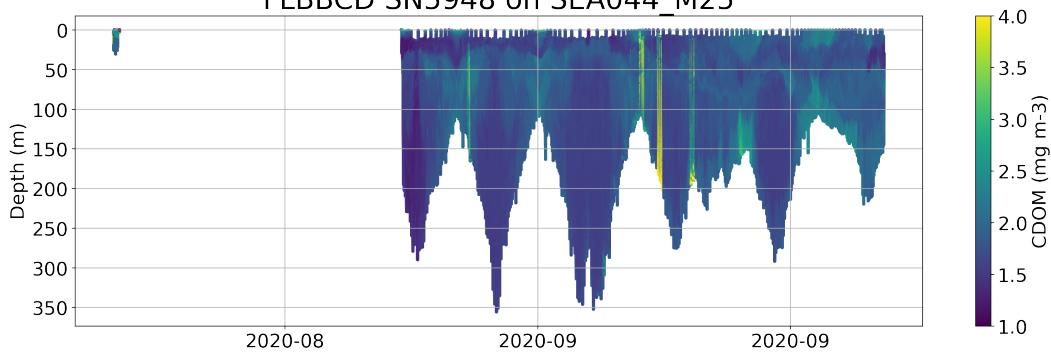
Glider	Plots
SEA044	<p style="text-align: center;">FLBBCD SN5948 on SEA044_M25</p>

<p>Comment: This mission in summer 2020 in Skagerrak showed no temporal drift. The protective copper plate was present.</p>
SEA055	<p style="text-align: center;">FLBBCD SN5925 on SEA055_M16</p>

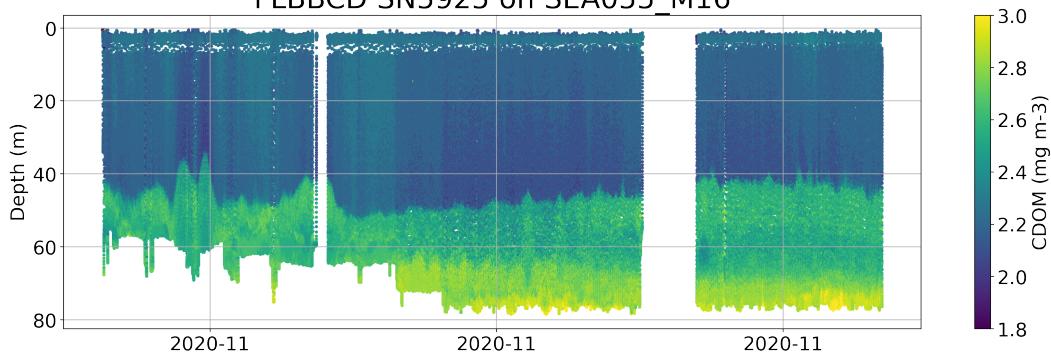
<p>Comment: This mission in late 2020 in Bornholm, where the glider surveys anoxic water, showed no temporal drift. The protective copper plate was present.</p>
