Quality Issue #001: RINKO-AROD-FT optodes

Issue number: 1			
Contact details: chiara.monforte@voiceoftheocean.org; callum.rollo@voiceoftheocean.org			
Version	Date	Comments	Authors
1	2023-07-07	Creation of document	Chiara Monforte and Callum Rollo
2	2023-07-10	Added info on new missions: SEA044_M83 and SEA063_M62	Chiara Monforte
3	2023-07-27	Added info on new missions: SEA067_M46; SEA069_M15; SEA077_M24 and SEA078_M14	Chiara Monforte
4	2023-08-04	Added info on new mission: SEA044_M84	Chiara Monforte
5	2023-08-14	Added info on new mission: SEA063_M63	Chiara Monforte
6	2023-09-21	Added info on new mission: SEA056_M64; SEA079_M14; SEA044_M85; SEA044_M86 and SEA076_M19	Chiara Monforte
7	2023-09-27	Added info on new mission: SEA063_M65	Chiara Monforte
8	2023-10-06	Added info on new mission: SEA077_M25 and SEA078_M15	Chiara Monforte

1 Introduction

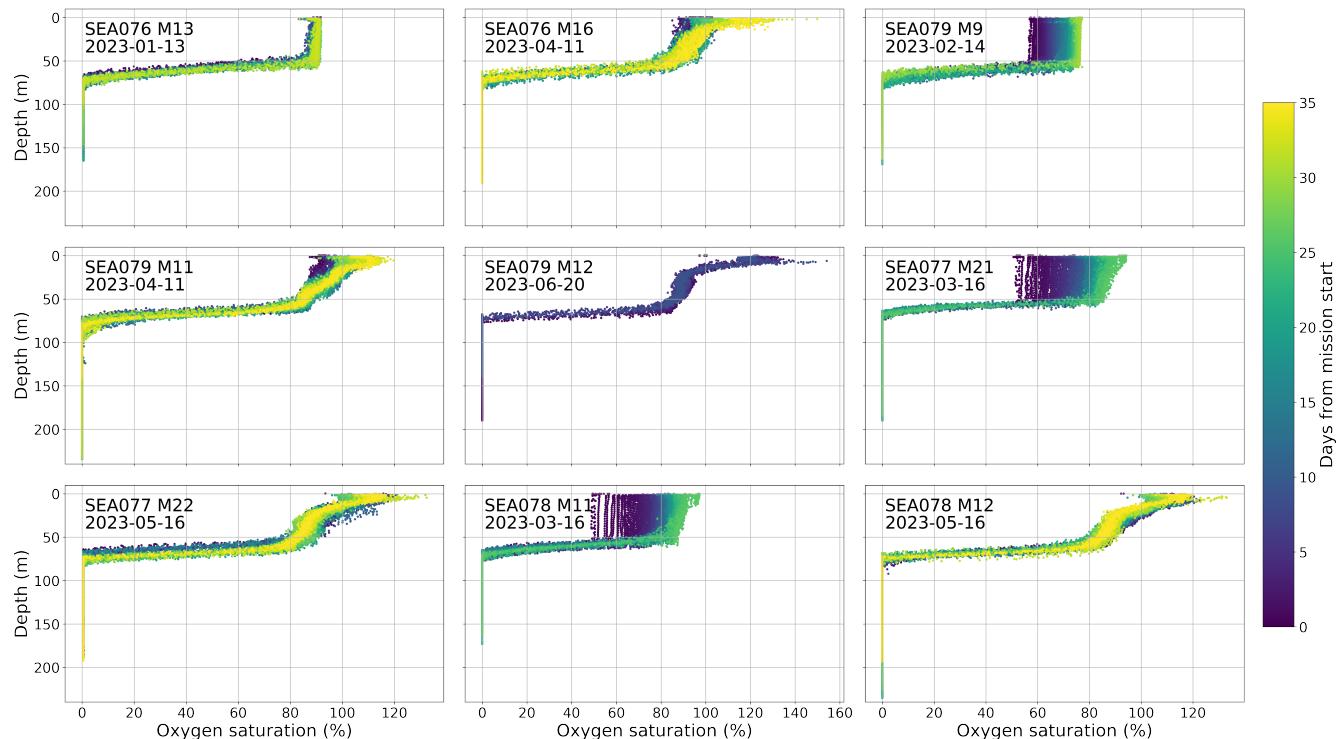
Few example missions from the Gotland Basin are shown below (Figure 1). Oxygen saturation over depth is presented and data is colored by time (in days since deployment). Some missions exhibit an evident temporal drift (SEA079_M9; SEA077_M21; SEA078_M11) with saturation values increasing from around 50% to just below 100% in about 25 days.

Figure 1: Oxygen saturation plotted over depth and colored by time (in days since deployment) for 9 missions in the Gotland Basin. Glider serial and mission number as well as the deployment date are noted on the top left of each subplot.
