Quality Issue #002: CDOM drift

An ongoing issue affects CDOM in glider with the FLBBCD sensor deployed from 2022-09-01. In the affected datasets, CDOM values show a temporal decrease. From 2022-12-01, the protective copper plate covering the sensor was removed on all the gliders deployed in Bornholm and Gotland. This resolved the temporal decrease, but some sensors displayed a temporal increase. Investigation is ongoing and data quality remains uncertain. All affected datasets have been flagged. Check the variable `cdom_qc`. The table below (Table 1) shows an updated list of all the mission deployed with a FLBBCD sensor, color-coded by severity. Flag column corresponds to data quality: suspect (3), fail (4), and good (1).

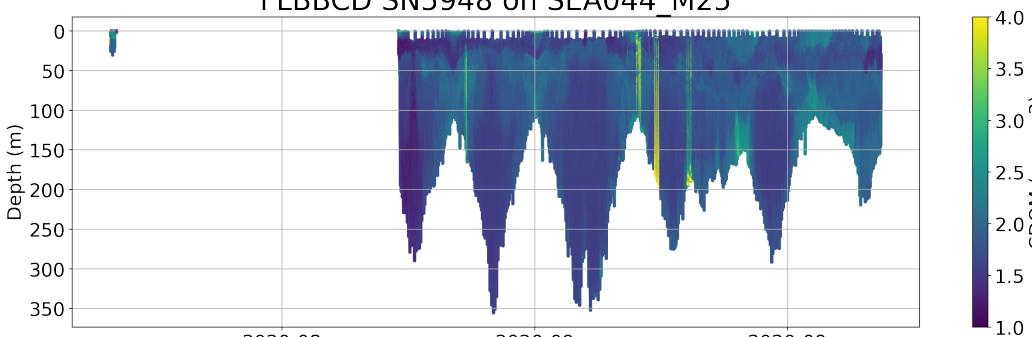
<p>Comment: This mission in summer 2020 in Skagerrak showed no temporal drift. The protective copper plate was present.</p>
SEA055	<p style="text-align: center;">FLBBCD SN5925 on SEA055_M16</p>

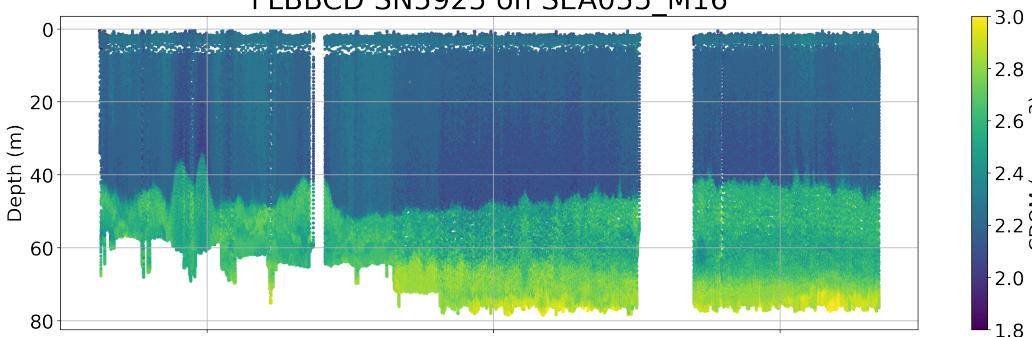
<p>Comment: This mission in late 2020 in Bornholm, where the glider surveys anoxic water, showed no temporal drift. The protective copper plate was present.</p>
SEA068	<p style="text-align: center;">FLBBCD SN7564 on SEA068_M27</p>

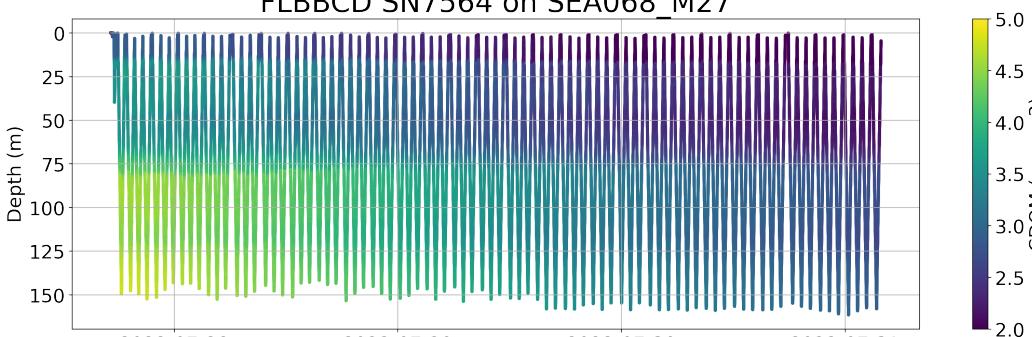
<p>Comment: The short mission in Gotland shows an evident and rather strong temporal drift. Values decrease from 5 to 2 mg m^-3. The protective copper plate was present.</p>

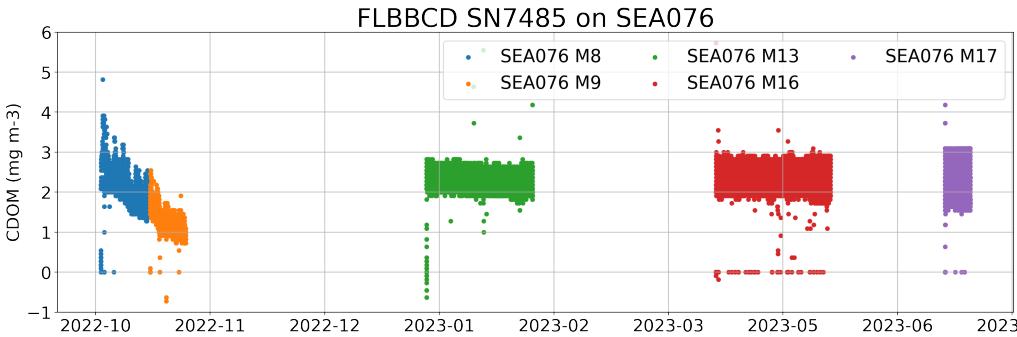
SEA076	FLBBCD SN7485 on SEA076

Comment: The first 2 missions in Bornholm (M8-9) show an evident temporal decrease in CDOM concentration. The protective copper plate was removed (M13-16-17 in Gotland) and data shows no temporal drift. All those missions surveyed anoxic areas.	
SEA077	FLBBCD SN7522 on SEA077

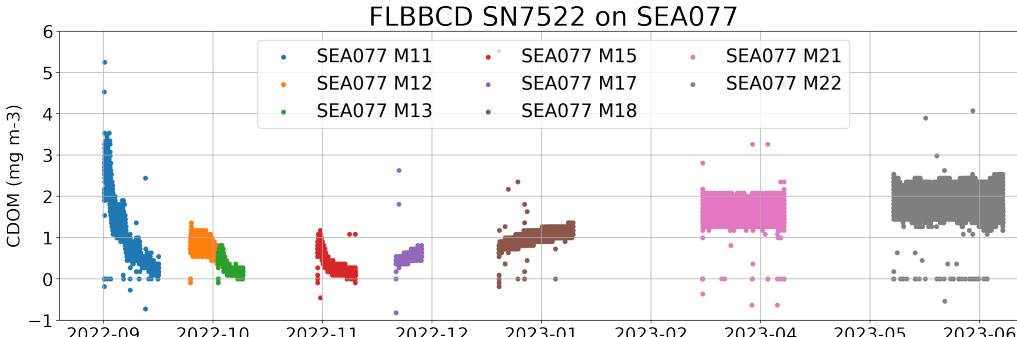
Comment: The first 4 missions (M11-12-13-15) show an evident temporal decrease in CDOM concentration. The protective copper plate on the sensor was removed before the start of mission 17 (in purple in Figure 1). The first two missions after the copper plate is removed (mission 17-18) show a temporal increase instead. Finally, the last two missions (21-22) show no temporal drift. All those missions surveyed anoxic areas.	
SEA078	FLBBCD SN7563 on SEA078

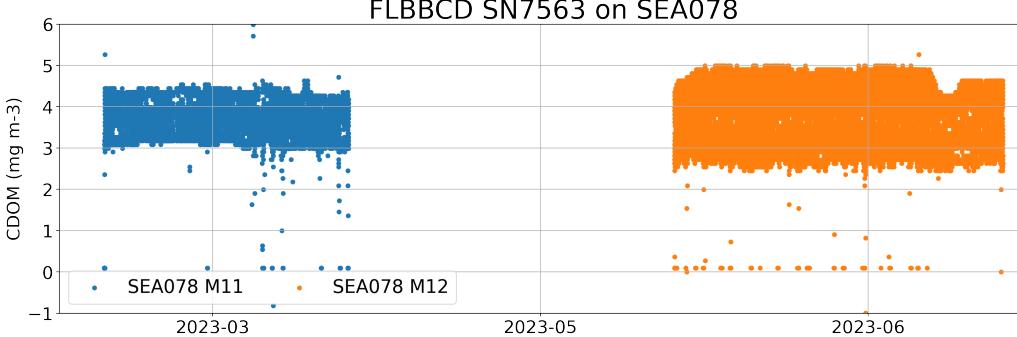
Comment: The protective copper plate was removed before the first deployment. Data never showed a temporal drift. All those missions surveyed anoxic areas.
