Quality Issue #001: RINKO-AROD-FT optodes

Issue number: 1			
Contact details: chiara.monforte@voiceoftheocean.org; callum.rollo@voiceoftheocean.org			
Version	Date	Comments	Authors
1	2023-07-07	Creation of document	Chiara Monforte and Callum Rollo
2	2023-07-10	Added info on new missions: SEA044_M82 and SEA063_M62	Chiara Monforte and Callum Rollo

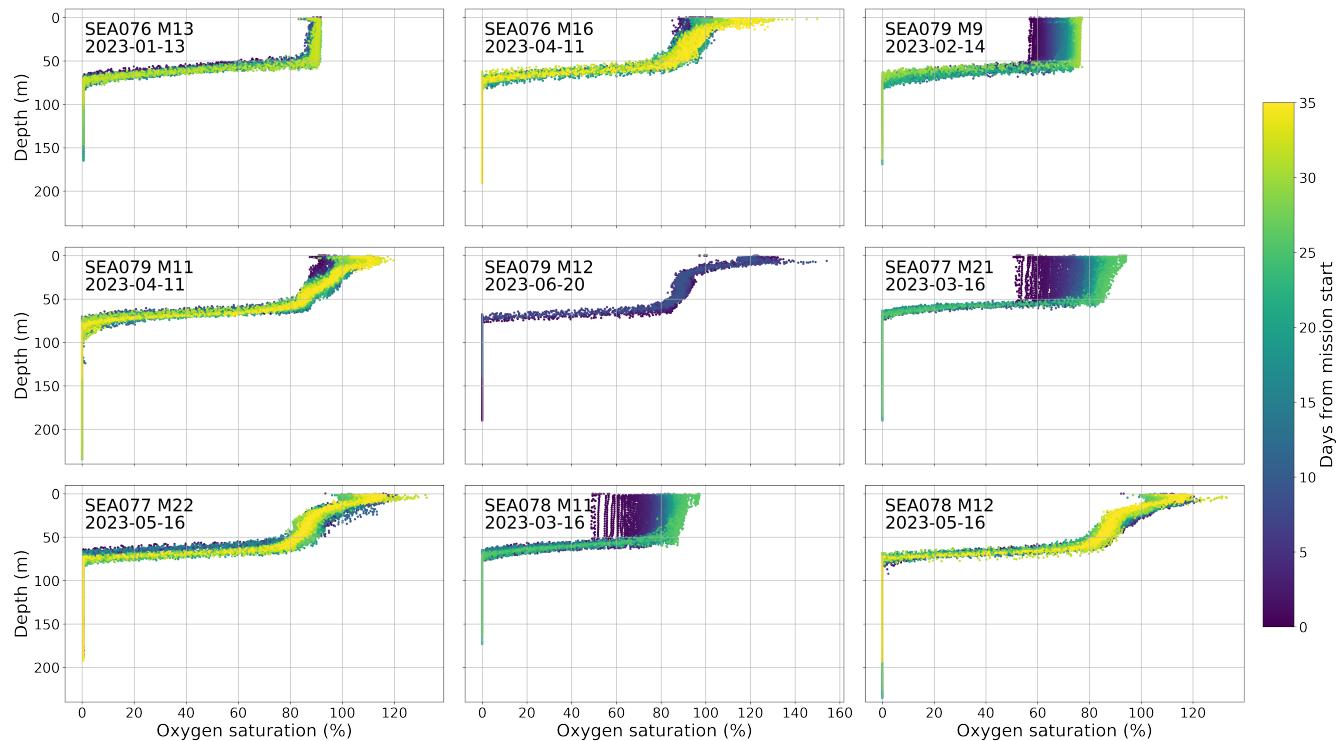
Few example missions from the Gotland Basin are shown below (Figure 1). Oxygen saturation over depth is presented and data is colored by time (in days since deployment). Some missions exhibit an evident temporal drift (SEA079_M9; SEA077_M21; SEA078_M11) with saturation values increasing from around 50% to just below 100% in about 25 days.

Figure 1: Oxygen saturation plotted over depth and colored by time (in days since deployment) for 9 missions in the Gotland Basin. Glider serial and mission number as well as the deployment date are noted on the top left of each subplot.
