Quality Issue #002: CDOM drift

1 Introduction

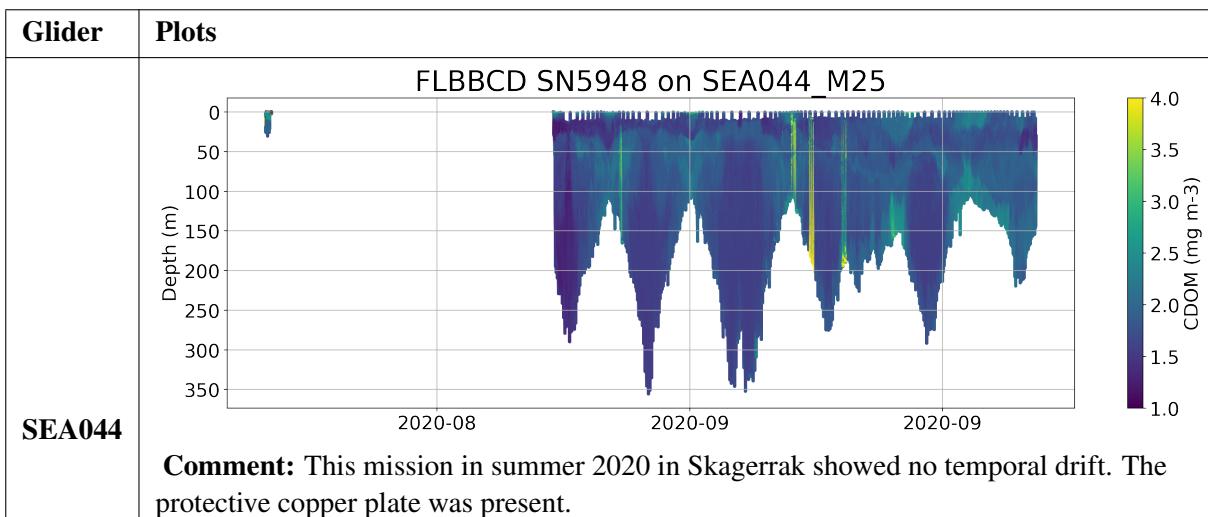
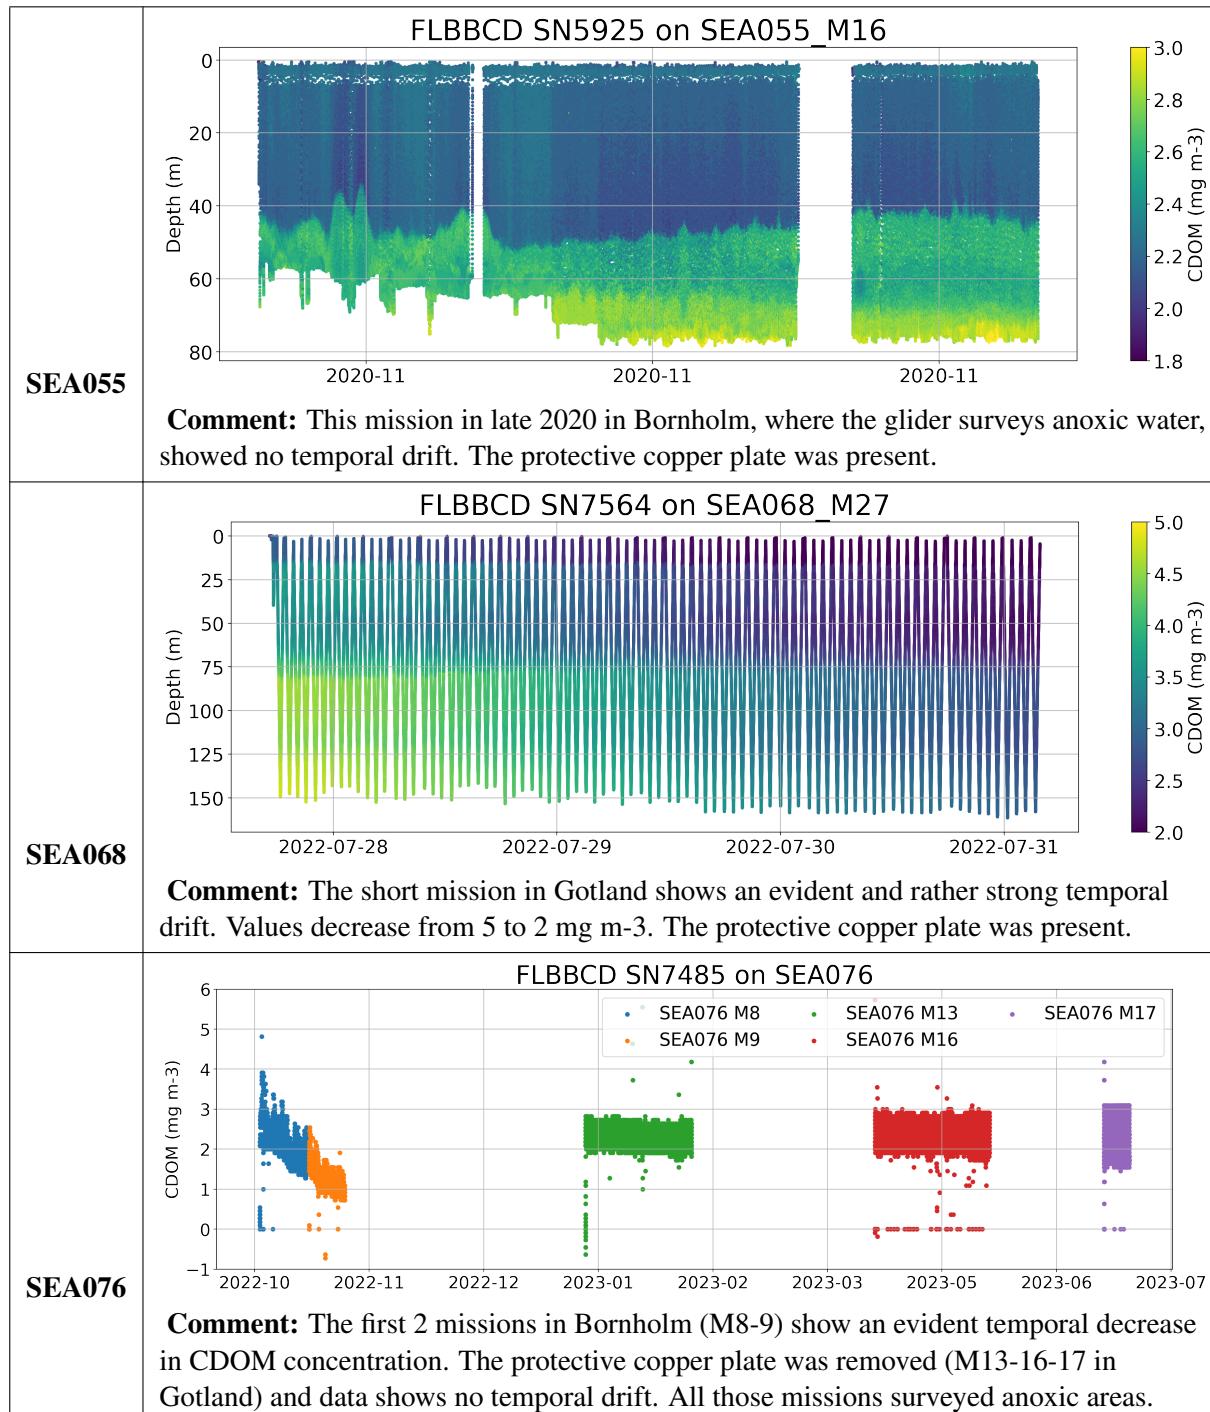
Table 2: CDOM data for each glider to highlight the evolution of the observed issue.

An ongoing issue affects CDOM in glider with the FLBBCD sensor deployed from 2022-09-01. In the affected datasets, CDOM values show a temporal decrease. From 2022-12-01, the protective copper plate covering the sensor was removed on all the gliders deployed in Bornholm and Gotland. This resolved the temporal decrease, but some sensors displayed a temporal increase. Investigation is ongoing and data quality remains uncertain. All affected datasets have been flagged. Check the variable `cdom_qc`. The table below (Table 1) shows an updated list of all the mission deployed with a FLBBCD sensor, color-coded by severity. Flag column corresponds to data quality: suspect (3), fail (4), and good (1).

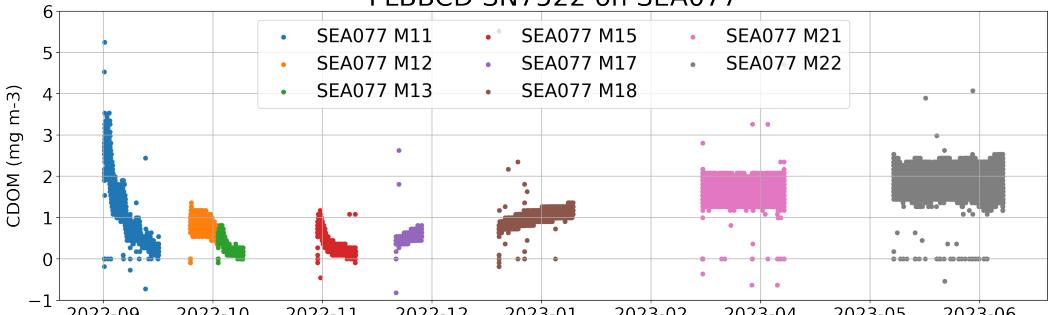
<p style="text-align: center;">FLBBCD SN7522 on SEA077</p>

SEA077	<p>Comment: The first 4 missions (M11-12-13-15) show an evident temporal decrease in CDOM concentration. The protective copper plate on the sensor was removed before the start of mission 17 (in purple in Figure 1). The first two missions after the copper plate is removed (mission 17-18) show a temporal increase instead. Finally, the last two missions (21-22) show no temporal drift. All those missions surveyed anoxic areas.</p>
SEA078	<p style="text-align: center;">FLBBCD SN7563 on SEA078</p>

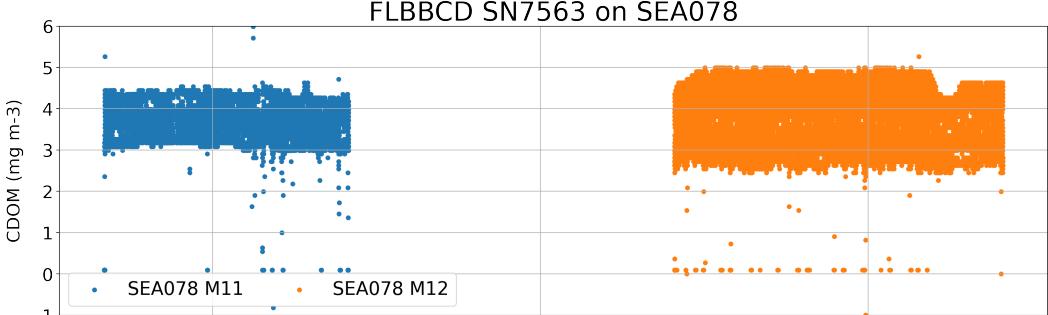
SEA078	<p>Comment: The protective copper plate was removed before the first deployment. Data never showed a temporal drift. All those missions surveyed anoxic areas.</p>
SEA079	<p style="text-align: center;">FLBBCD SN7619 on SEA079</p>

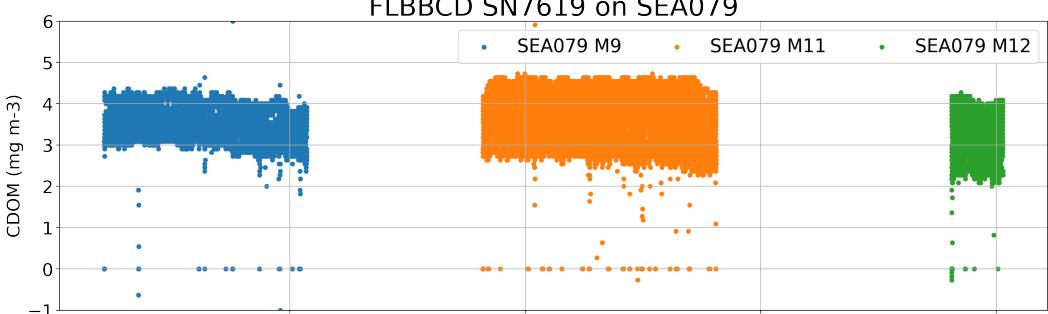
SEA079	<p>Comment: The copper plate protecting the sensor was removed before the first deployment of the glider. Data has never showed a temporal drift. All those missions surveyed anoxic areas.</p>
