# Quality Issue #002: CDOM drift

Issue number: 2			
Contact details: chiara.monforte@voiceoftheocean.org; callum.rollo@voiceoftheocean.org			
Version	Date	Comments	Authors
1	2023-07-07	Creation of document	Chiara Monforte and Callum Rollo
2	2023-07-28	Added info on new missions: SEA069_M15; SEA077_M24 and SEA078_M14	Chiara Monforte and Callum Rollo
3	2023-08-21	Correction of a typo of flag value in the legend table	Chiara Monforte

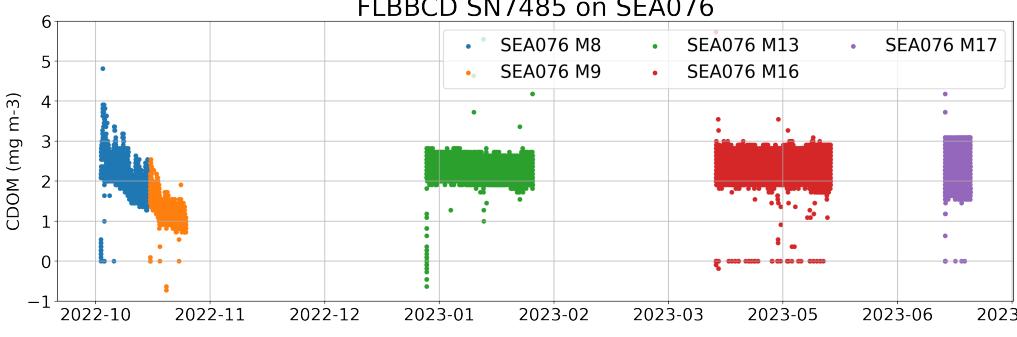
SEA076	<b>FLBBCD SN7485 on SEA076</b>

<b>Comment:</b> The first 2 missions in Bornholm (M8-9) show an evident temporal decrease in CDOM concentration. The protective copper plate was removed (M13-16-17 in Gotland) and data shows no temporal drift. All those missions surveyed anoxic areas.	
SEA077	<b>FLBBCD SN7522 on SEA077</b>

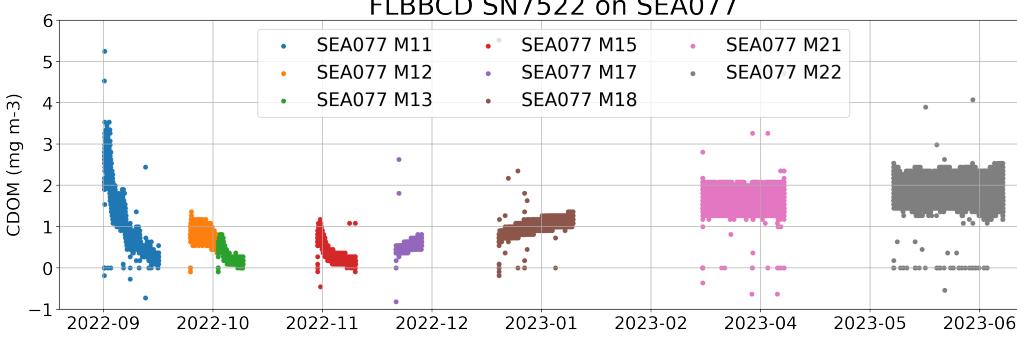
<b>Comment:</b> The first 4 missions (M11-12-13-15) show an evident temporal decrease in CDOM concentration. The protective copper plate on the sensor was removed before the start of mission 17 (in purple in Figure 1). The first two missions after the copper plate is removed (mission 17-18) show a temporal increase instead. Finally, the last two missions (21-22) show no temporal drift. All those missions surveyed anoxic areas.	
SEA078	<b>FLBBCD SN7563 on SEA078</b>

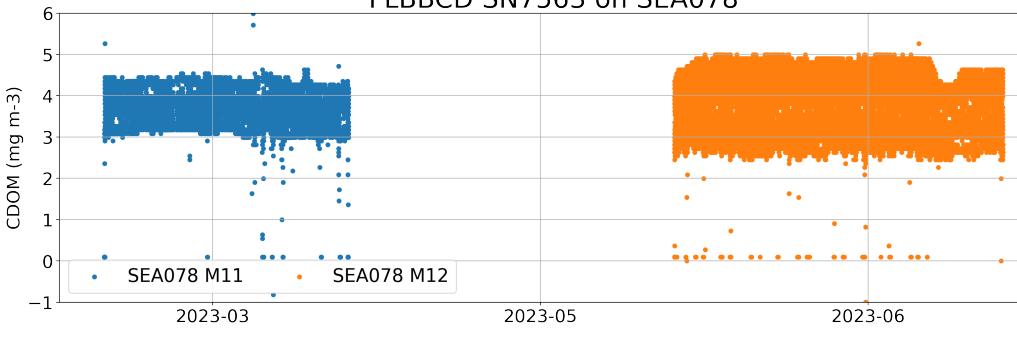
<b>Comment:</b> The protective copper plate was removed before the first deployment. Data never showed a temporal drift. All those missions surveyed anoxic areas.
