Quality Issue #002: CDOM drift

| Issue number: 2 | | | |

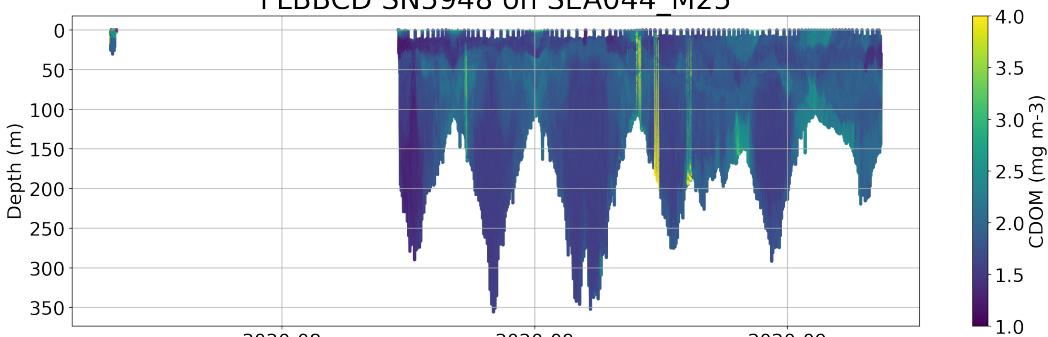
| Glider | Plots |
|---|--|
| SEA044 | <p style="text-align: center;">FLBBCD SN5948 on SEA044_M25</p> <p>Comment: This mission in summer 2020 in Skagerrak showed no temporal drift. The protective copper plate was present.</p> |

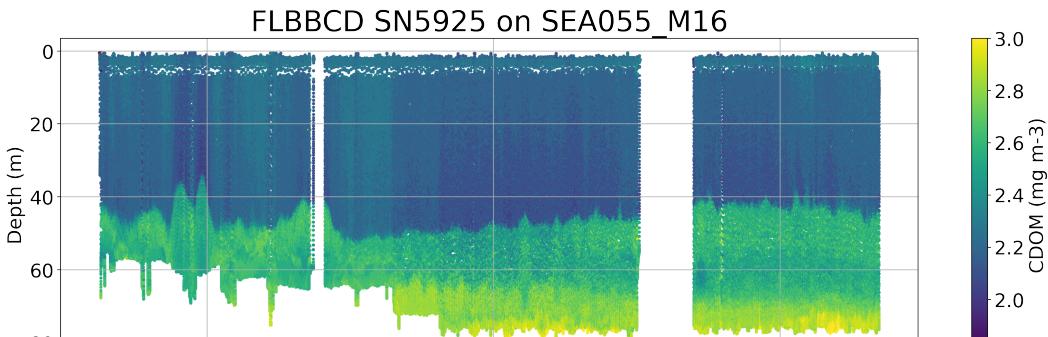
| Glider | Plots |
|---|--|
| SEA055 | <p style="text-align: center;">FLBBCD SN5925 on SEA055_M16</p> <p>Comment: This mission in late 2020 in Bornholm, where the glider surveys anoxic water, showed no temporal drift. The protective copper plate was present.</p> |

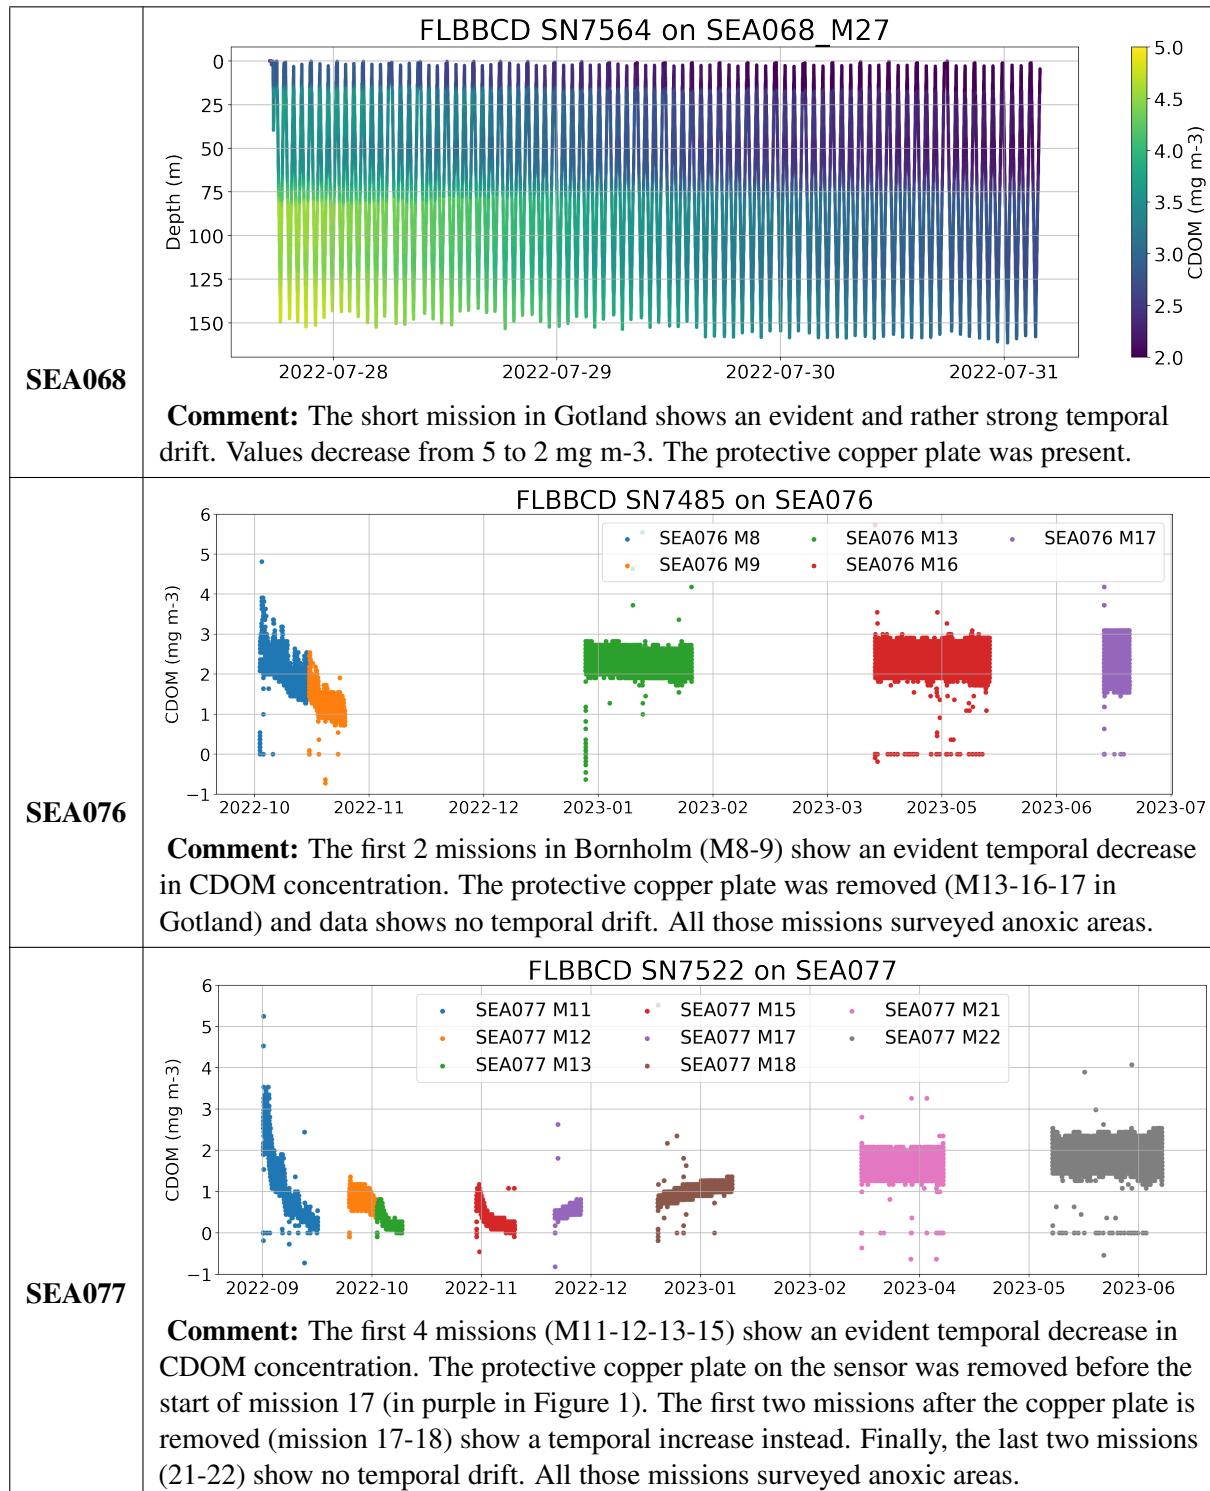
Table 2: CDOM data for each glider to highlight the evolution of the observed issue. (Continued)

An ongoing issue affects CDOM in glider with the FLBBCD sensor deployed from 2022-09-01. In the affected datasets, CDOM values show a temporal decrease. From 2022-12-01, the protective copper plate covering the sensor was removed on all the gliders deployed in Bornholm and Gotland. This resolved the temporal decrease, but some sensors displayed a temporal increase. Investigation is ongoing and data quality remains uncertain. All affected datasets have been flagged. Check the variable `cdom_qc`. The table below (Table 1) shows an updated list of all the mission deployed with a FLBBCD sensor, color-coded by severity. Flag column corresponds to data quality: suspect (3), fail (4), and good (1).

| Legend | | Flag |
|---|---|---|
| B | Apparent temporal decrease in the intensity of the CDOM signal. Cause unknown. | 4 |
| C | Apparent temporal increase in the intensity of the CDOM signal. Cause unknown. In this mission, the protective copper plate over the CDOM sensor was removed. | 4 |
| D | Previous deployments with this sensor showed a temporal decrease in CDOM. The copper plate protecting the optics sensor was removed and this issue appears to be resolved in this mission. The issue with the sensor has not yet been identified, further controls are recommended. | 3 |
