Quality Issue #002: CDOM drift

Issue number: 2
 Report version: 11
 Revised on February 8, 2024

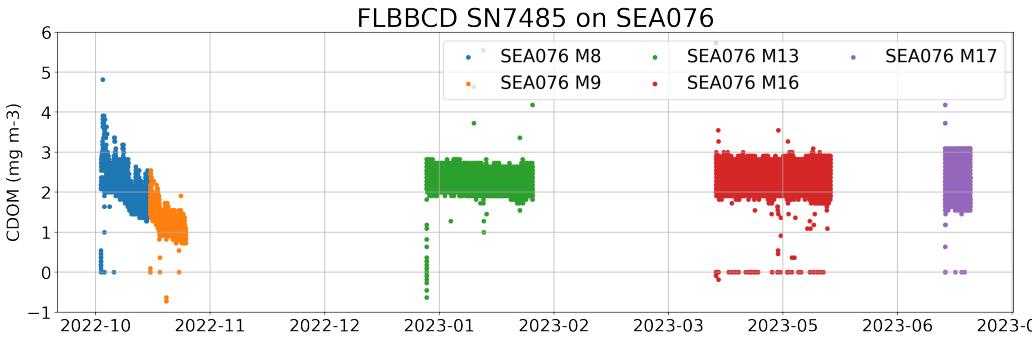
SEA076	FLBBCD SN7485 on SEA076

Comment: The first 2 missions in Bornholm (M8-9) show an evident temporal decrease in CDOM concentration. The protective copper plate was removed (M13-16-17 in Gotland) and data shows no temporal drift. All those missions surveyed anoxic areas.	
SEA077	FLBBCD SN7522 on SEA077

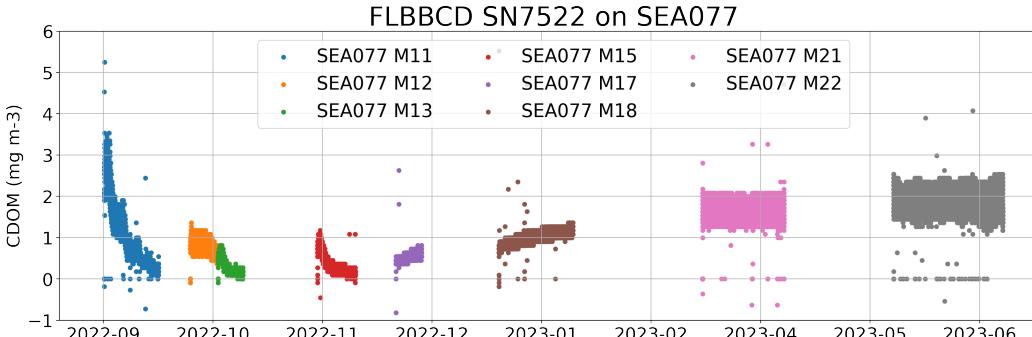
Comment: The first 4 missions (M11-12-13-15) show an evident temporal decrease in CDOM concentration. The protective copper plate on the sensor was removed before the start of mission 17 (in purple in Figure 1). The first two missions after the copper plate is removed (mission 17-18) show a temporal increase instead. Finally, the last two missions (21-22) show no temporal drift. All those missions surveyed anoxic areas.	
SEA078	FLBBCD SN7563 on SEA078

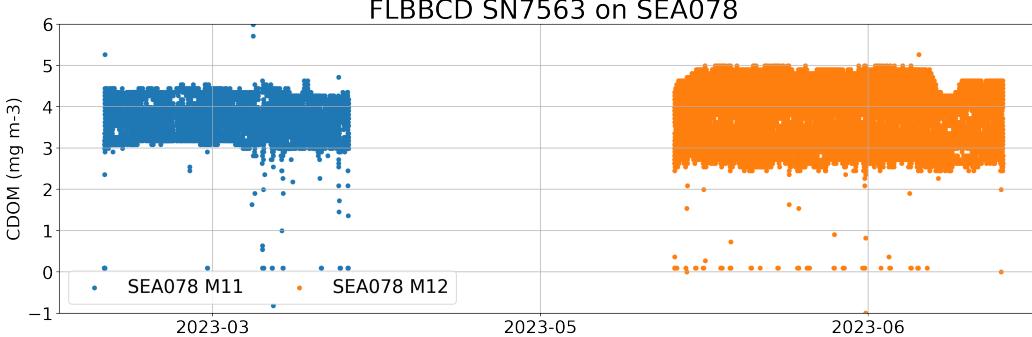
Comment: The protective copper plate was removed before the first deployment. Data never showed a temporal drift. All those missions surveyed anoxic areas.
