Quality Issue #001: RINKO-AROD-FT optodes

1 Introduction

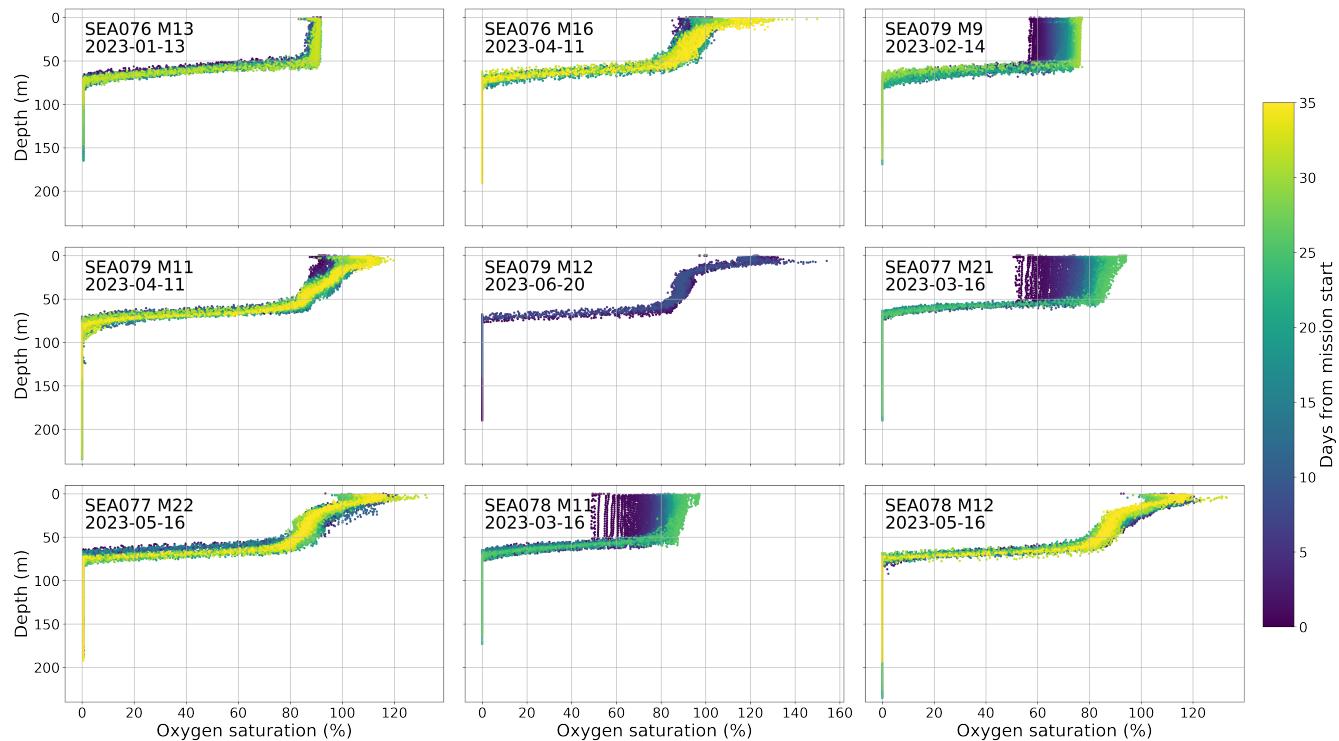
Few example missions from the Gotland Basin are shown below (Figure 1). Oxygen saturation over depth is presented and data is colored by time (in days since deployment). Some missions exhibit an evident temporal drift (SEA079_M9; SEA077_M21; SEA078_M11) with saturation values increasing from around 50% to just below 100% in about 25 days.

Figure 1: Oxygen saturation plotted over depth and colored by time (in days since deployment) for 9 missions in the Gotland Basin. Glider serial and mission number as well as the deployment date are noted on the top left of each subplot.
