Quality Issue #002: CDOM drift

Issue number: 2			
Contact details: chiara.monforte@voiceoftheocean.org; callum.rollo@voiceoftheocean.org			
Version	Date	Comments	Authors
1	2023-07-07	Creation of document	Chiara Monforte and Callum Rollo
2	2023-07-28	Added info on new missions: SEA069_M15; SEA077_M24 and SEA078_M14	Chiara Monforte
3	2023-08-21	Correction of a typo of flag value in the legend table	Chiara Monforte
4	2023-09-21	Added info on new mission: SEA056_M64; SEA079_M14 and SEA076_M19	Chiara Monforte

1 Introduction

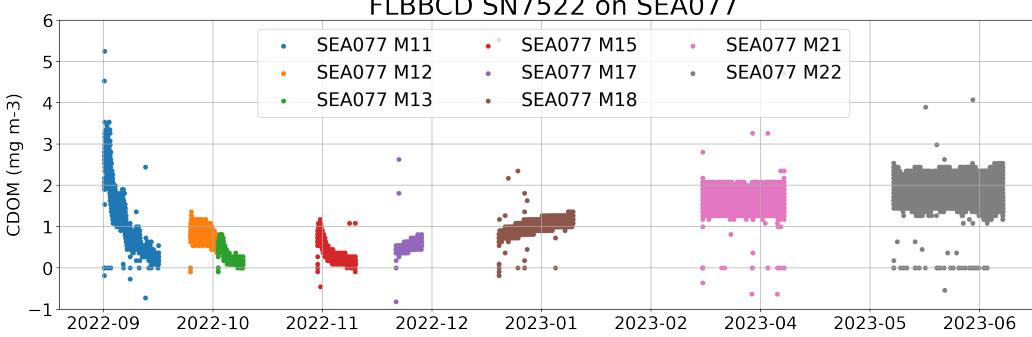
<p>Comment: The first 4 missions (M11-12-13-15) show an evident temporal decrease in CDOM concentration. The protective copper plate on the sensor was removed before the start of mission 17 (in purple in Figure 1). The first two missions after the copper plate is removed (mission 17-18) show a temporal increase instead. Finally, the last two missions (21-22) show no temporal drift. All those missions surveyed anoxic areas.</p>
SEA078	FLBBCD SN7563 on SEA078

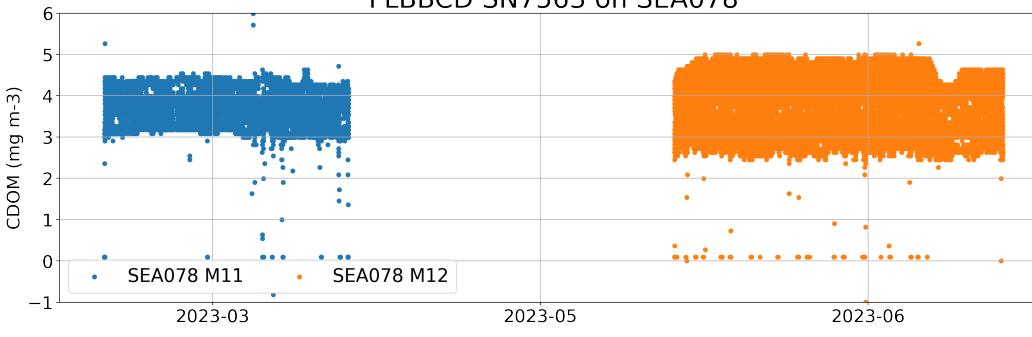
<p>Comment: The protective copper plate was removed before the first deployment. Data never showed a temporal drift. All those missions surveyed anoxic areas.</p>
