Quality Issue #002: CDOM drift

Issue number: 2			
Contact details: chiara.monforte@voiceoftheocean.org; callum.rollo@voiceoftheocean.org			
Version	Date	Comments	Authors
1	2023-07-07	Creation of document	Chiara Monforte and Callum Rollo
2	2023-07-28	Added info on new missions: SEA069_M15; SEA077_M24 and SEA078_M14	Chiara Monforte
3	2023-08-21	Correction of a typo of flag value in the legend table	Chiara Monforte
4	2023-09-21	Added info on new mission: SEA056_M64; SEA079_M14 and SEA076_M19	Chiara Monforte
5	2023-10-06	Added info on new mission: SEA077_M25 and SEA078_M15	Chiara Monforte
6	2023-11-13	Added info on new mission: SEA079_M16	Chiara Monforte
7	2023-11-20	Added info on new mission: SEA066_M52 and SEA076_M21	Chiara Monforte
8	2023-12-07	Added info on new mission: SEA077_M28 and SEA078_M19	Chiara Monforte
9	2024-01-08	Added info on new mission: SEA076_M22 and SEA079_M18	Chiara Monforte
10	2024-01-10	Added info on new mission: SEA077_M29 and . Corrected info on mission SEA066_M52	Chiara Monforte

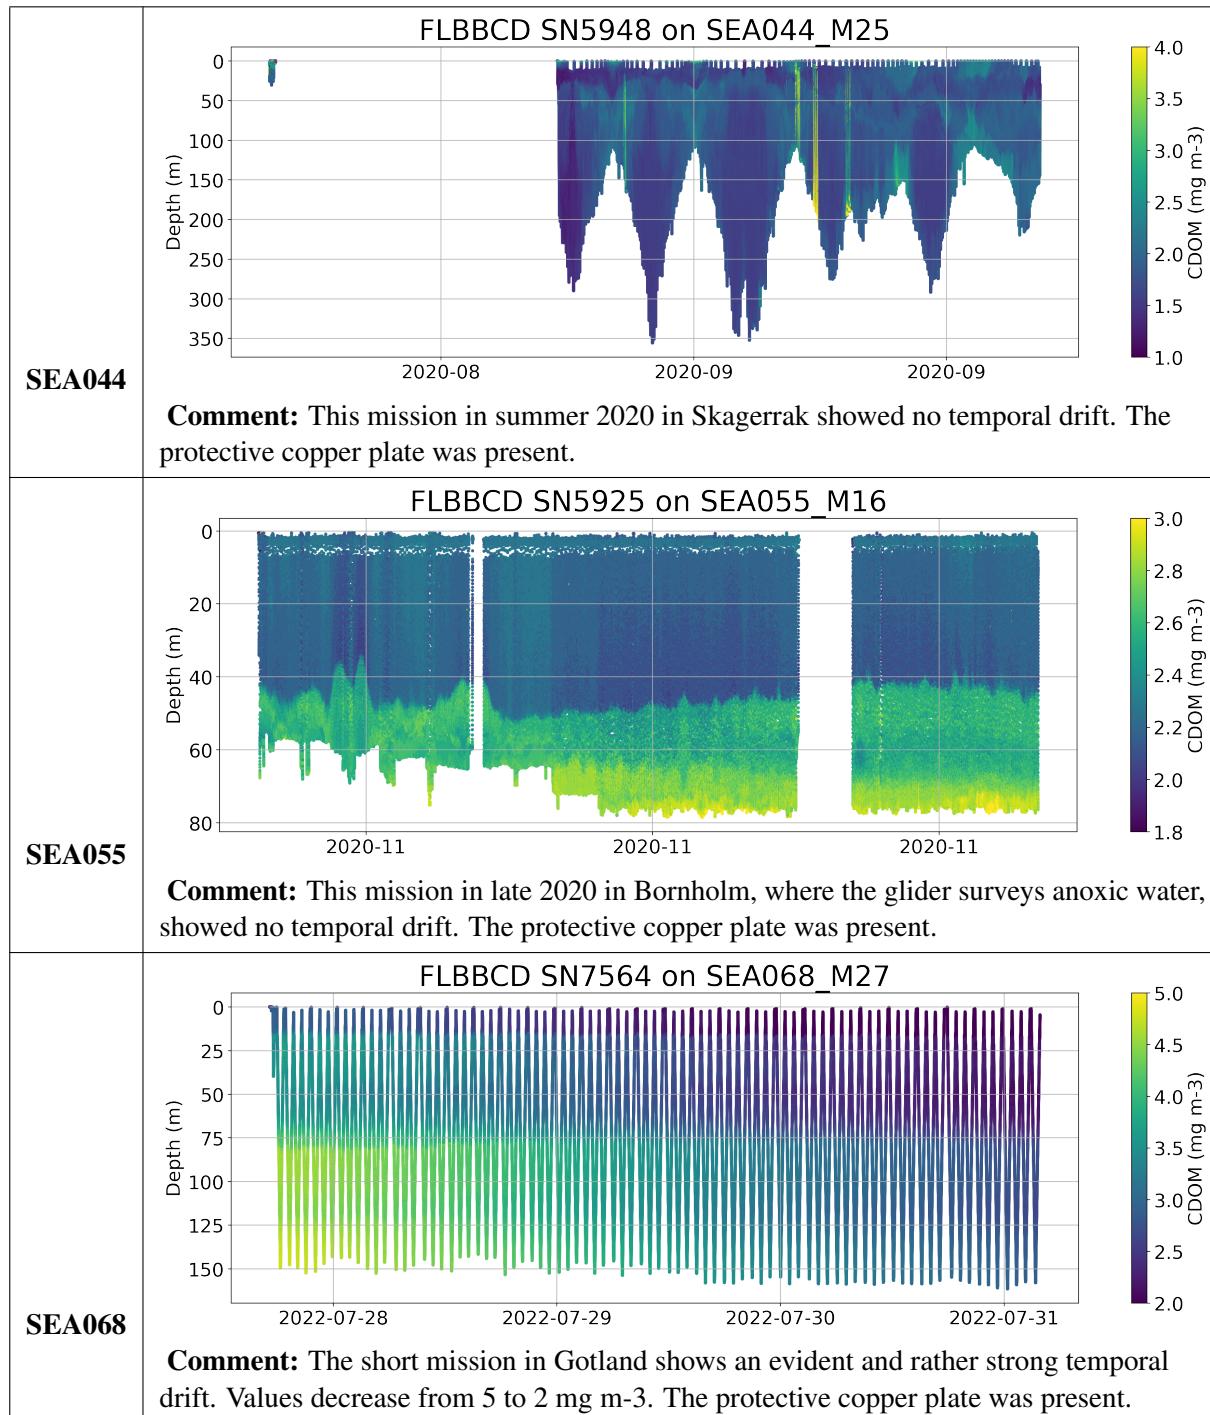
Table 2: CDOM data for each glider to highlight the evolution of the observed issue. (Continued)

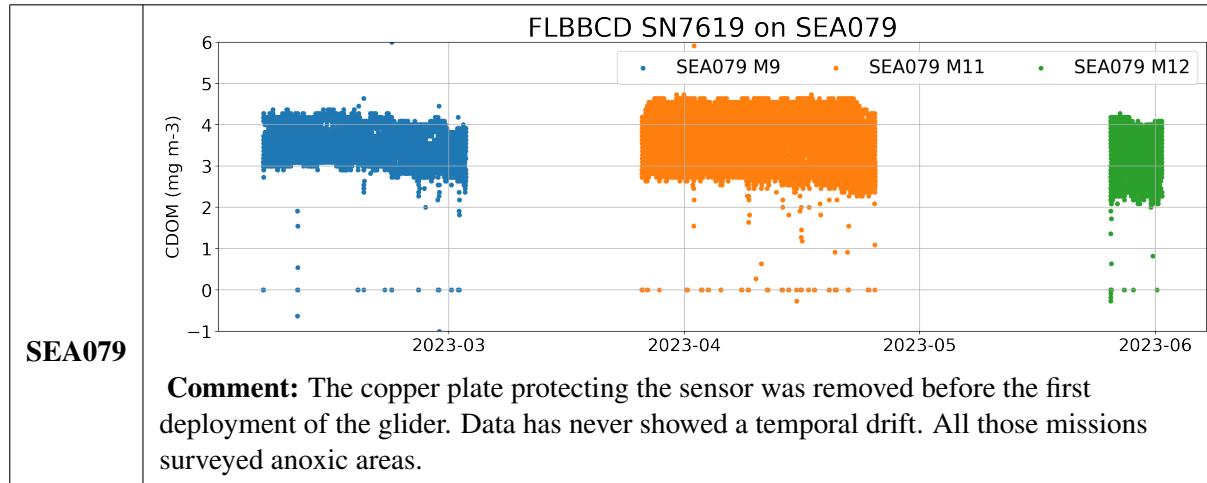
Table 2: CDOM data for each glider to highlight the evolution of the observed issue. (Continued)
