A3 Report

Title of Issue: Battery Contamination

Clogged standing tubes causing contamination of batteries

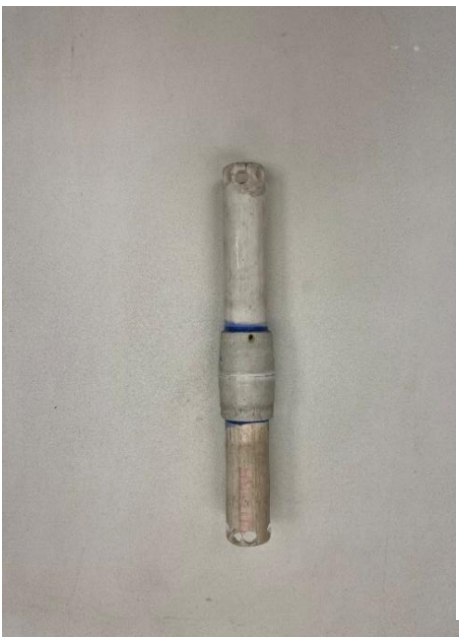
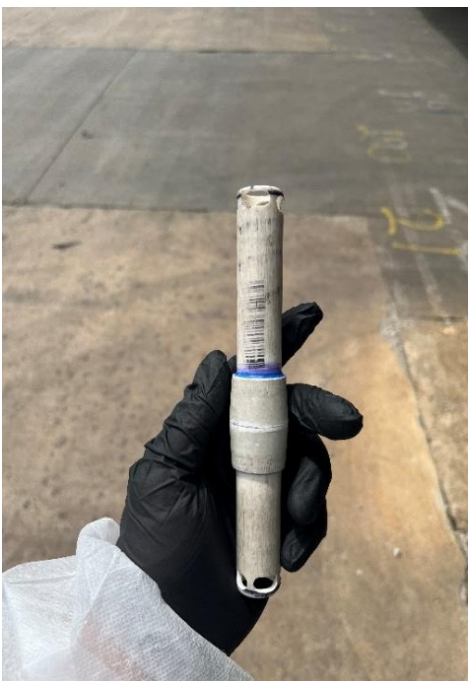
-Earplugs and other debris floating in charging tubs get caught in standing tubes, which leads to clogging and water rises above the batteries, causing contamination and scrap

-Because there is really no way to prevent debris from getting into the tubes, the best course of action is to work on the tubes themselves and develop a countermeasure

| Possible Cause | Why? Because... | Proposed Countermeasure to be implemented |
|---|---|---|
| Batteries contaminated by water flooding the batteries | Why? Objects get clogged in the stand tubes and water can't flow | Unable to keep operators accountable for the debris so the best option is to not allow the stand tubes to be cloggable. Create new stand tube design that allows water flow even if clogged. |
