# DEPARTMENT OF CIVIL AND CONSTRUCTION ENGINEERING MATERIALS AND STRUCTURE TEST

# **FINAL PROJECT**

# Group 03

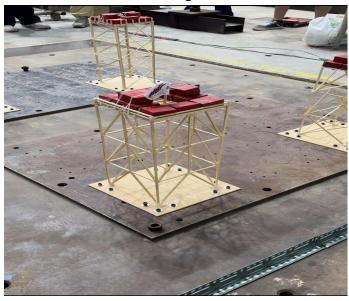
Figure 11.

location of our structure in the shaking table, but the remaining spots were right next to the structure from the other contestants and there was the risk that their bricks could fall into our structure or even their whole structure could collapse and damage our Water Tower. Therefore, the best choice we had at that moment was to place it in the original spot and have two screws a little bit loose.

Once our structure and the structure of the other contestants were all settled into the shaking table, as can be seen from Figure 1, the contest was about to start.

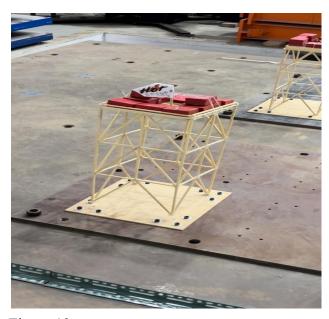
Figure 12.

The intensity of the shaking table was supposed to start at 250 gal and increase until the last structure remained still. But, there was a really strong shake in the table of an intensity much bigger than 250 gal, which lasted around two to three seconds. This said shake was not expected by any of the contestants. Because of this shake is that the columns from our structure detached from the base, as it can be seen from Figure 2.

This affected the performance of our structure when the actual contest started, because our structure was already damaged due to that unexpected shake. This was an error which was later on recognized even by the Professor.

Before the actual contest started, once the columns of our structure were already detached from the base, it was asked by our group to the TA that they give us the chance to fix the problem by gluing our structure back into the base plate. Even though we tried to fix this problem, because of the short time we had to fix it and because we were not given the chance to let the glue dry into the base plate, the performance of our structure was affected later.

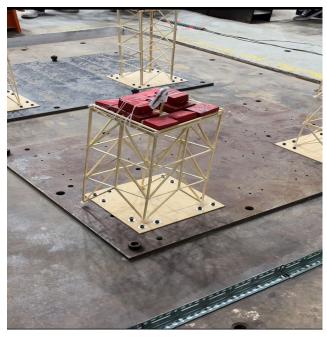
Figure 13.

During the 400 gal intensity, the columns of our structure detached from the base plate but the integrity of our structure was intact, meaning that all of our beams and braces showed no trouble at all, as can be seen from Figure 3.

Because of the detachment of two of our columns from the base plate, our structure could no longer be part of the contest even though it remained with its structural integrity and could have lasted more if that unexpected nig shake did not happen and damaged our structure.
