SUPPLIER QUALITY INSPECTION

Good manufacturing practices inspection report

For-cause supplier quality inspection

| <div>INSPECTED ORGANIZATION</div> <div>BluePeak Biologics, Inc.</div> | <div>SITE</div> <div>Harbor Point Biologics Campus</div> |

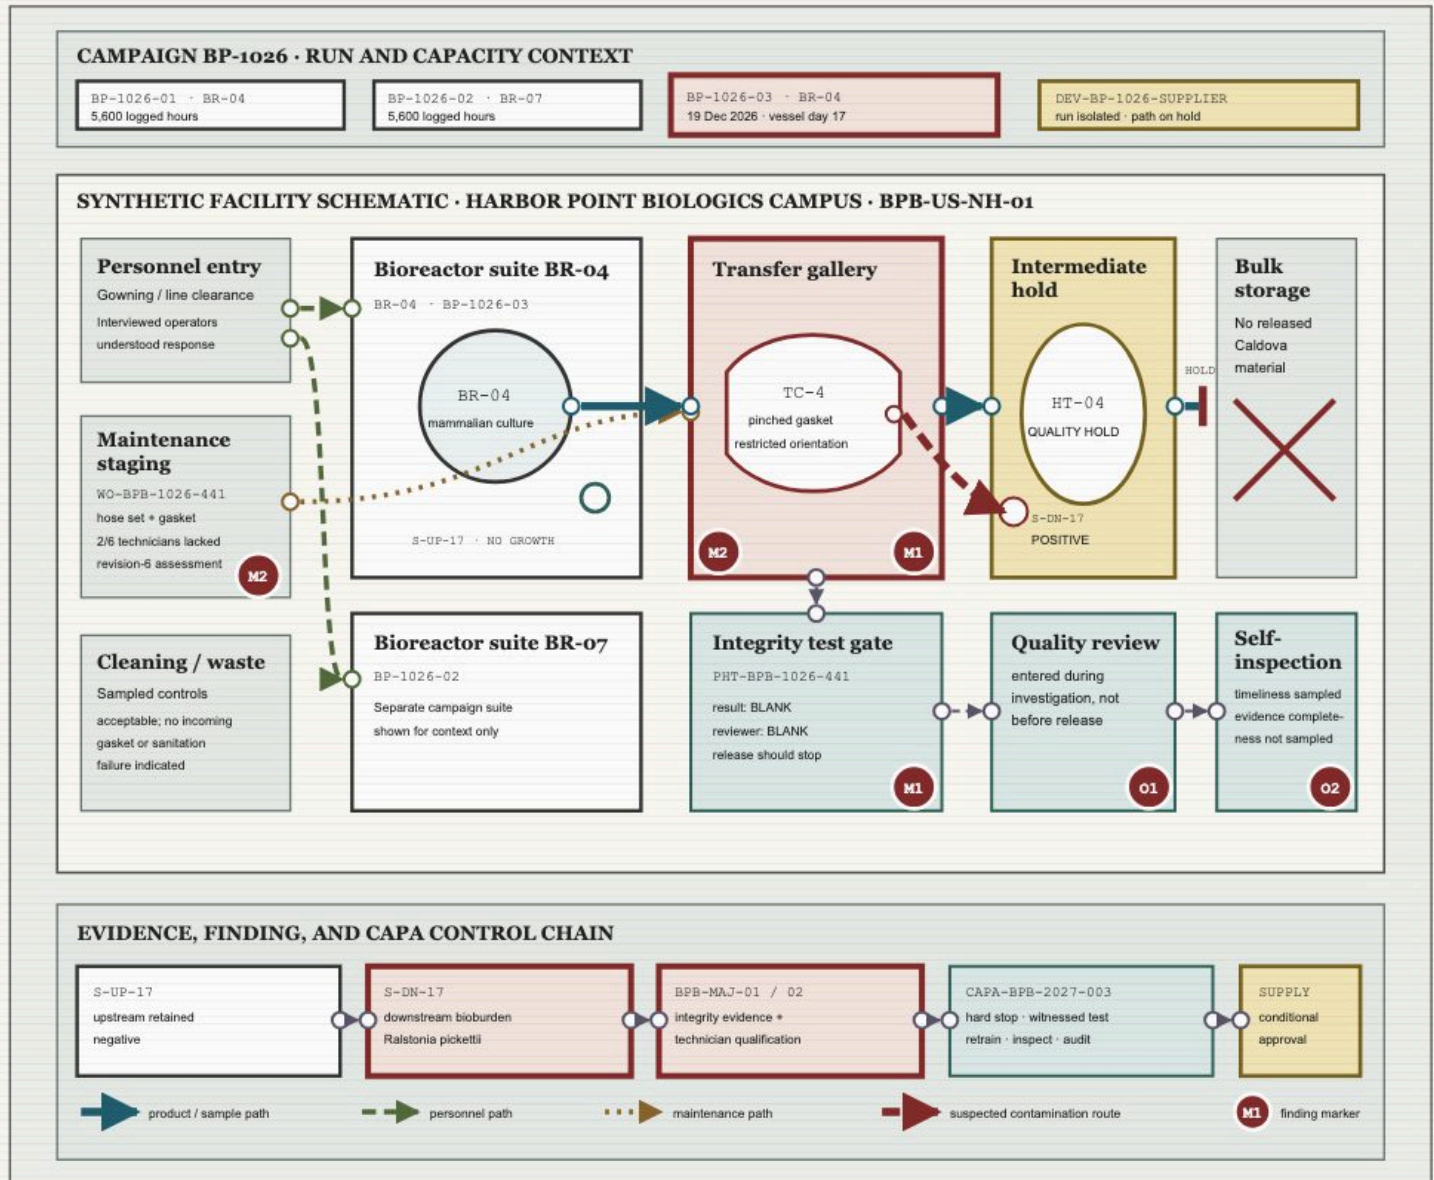
ATTACHMENT A · FIGURE 1

## BR-04 facility, control, and contamination-risk map

**Evidence interpretation.** The negative upstream retained sample, positive downstream sample, and recovered gasket defect support TC-4 as the most probable entry point. The map distinguishes observed process evidence from the synthetic room arrangement.

**Control interpretation.** Missing pressure-hold evidence and late Quality review allowed the maintenance path to bypass a release gate. CAPA adds a hard stop, witnessed testing, practical reassessment, visual verification, and completeness sampling.

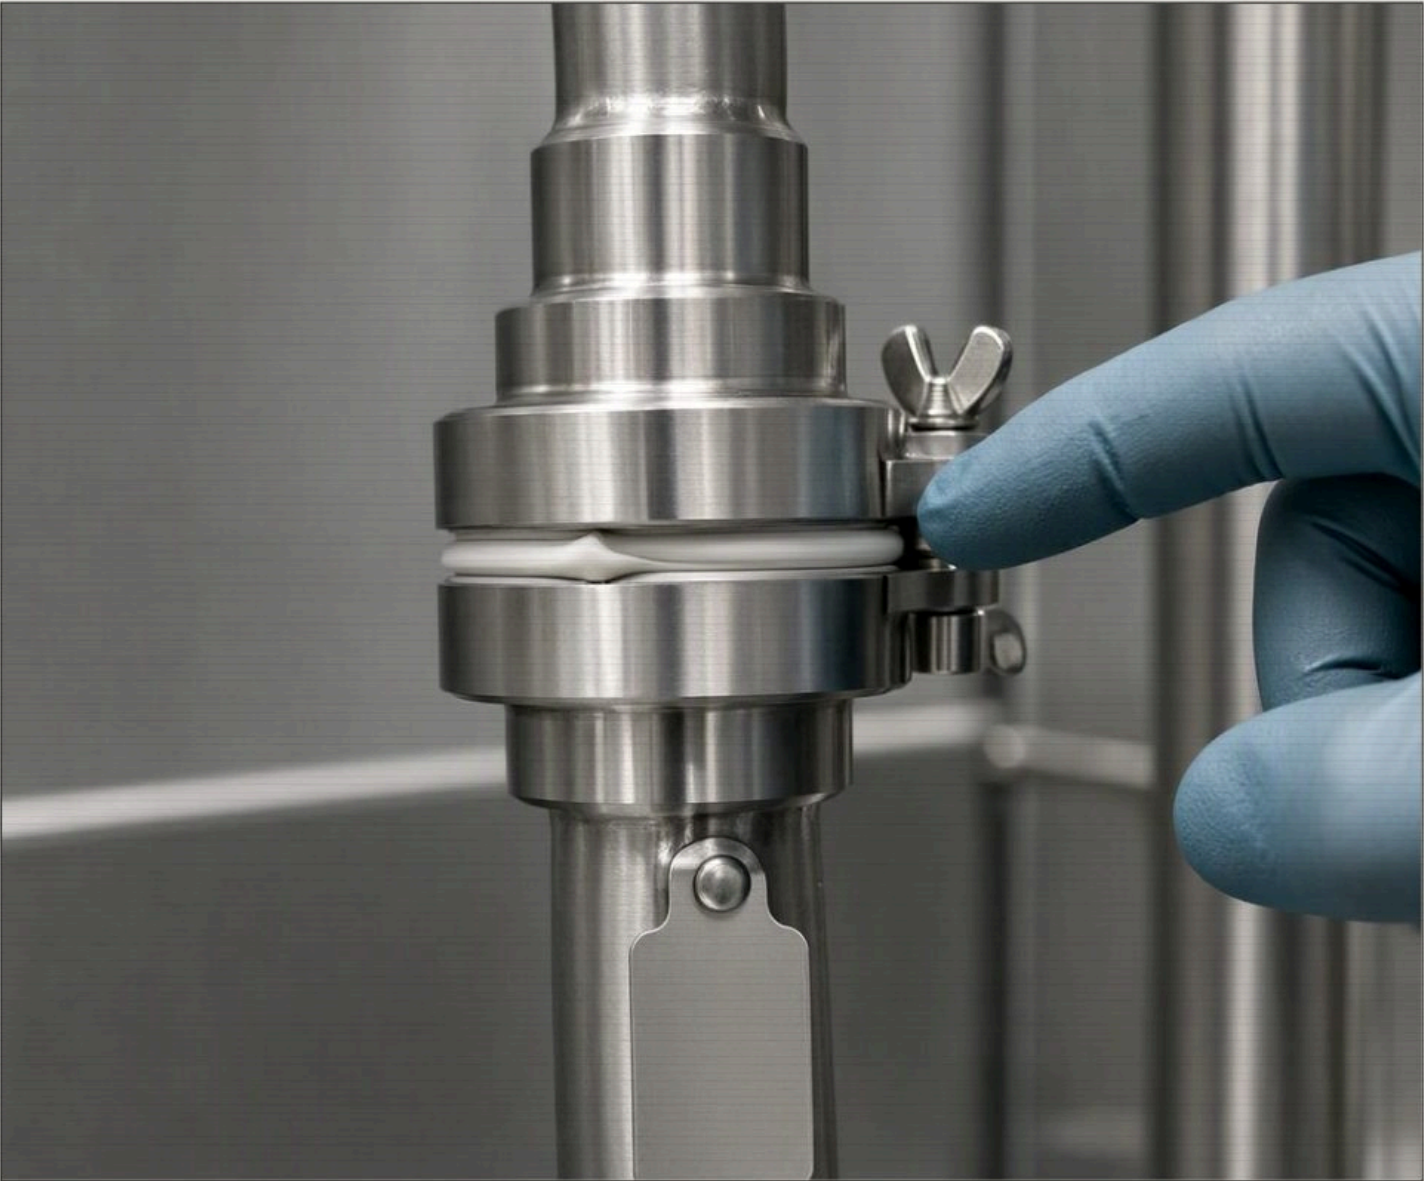
ATTACHMENT B · PHOTOGRAPH 1

## BPB-MAJ-02 · Maintenance qualification did not ensure reliable sanitary-gasket installation

The practical qualification program did not prevent technicians without current revision-6 assessment from independently assembling product-contact connections, and the procedure lacked a compensating visual-verification method for TC-4's restricted orientation.

**Objective evidence:** Training matrix sample; technician interviews; direct observation of TC-4 access; compressed gasket recovered from the connection.

**Potential risk:** Recurring assembly defects may remain undetected until process monitoring identifies contamination.

TC-4 gasket seating condition

**Observed condition.** The image illustrates uneven elastomer exposure around the sanitary joint, consistent with a gasket compressed out of its intended seat. Restricted access at the installed orientation made direct visual confirmation difficult without an inspection aid.

| COMMITTED ACTION | OWNER | DUE | EFFECTIVENESS EVIDENCE |
|---|---|---|---|
| Replace TC-4 gasket and hose set; execute witnessed pressure-hold test before return to service. | Devon Price | 27 Jan 2027 | Approved protocol, raw pressure data, and Quality release |
| Retrain and practically reassess all technicians who assemble sanitary product-contact connections. | Devon Price | 12 Feb 2027 | Direct observation using seeded gasket-position defects |
| Add mirror or borescope confirmation and second-person verification for restricted-orientation connections. | Marcus Lin | 12 Feb 2027 | Three consecutive compliant assemblies at TC-4 |

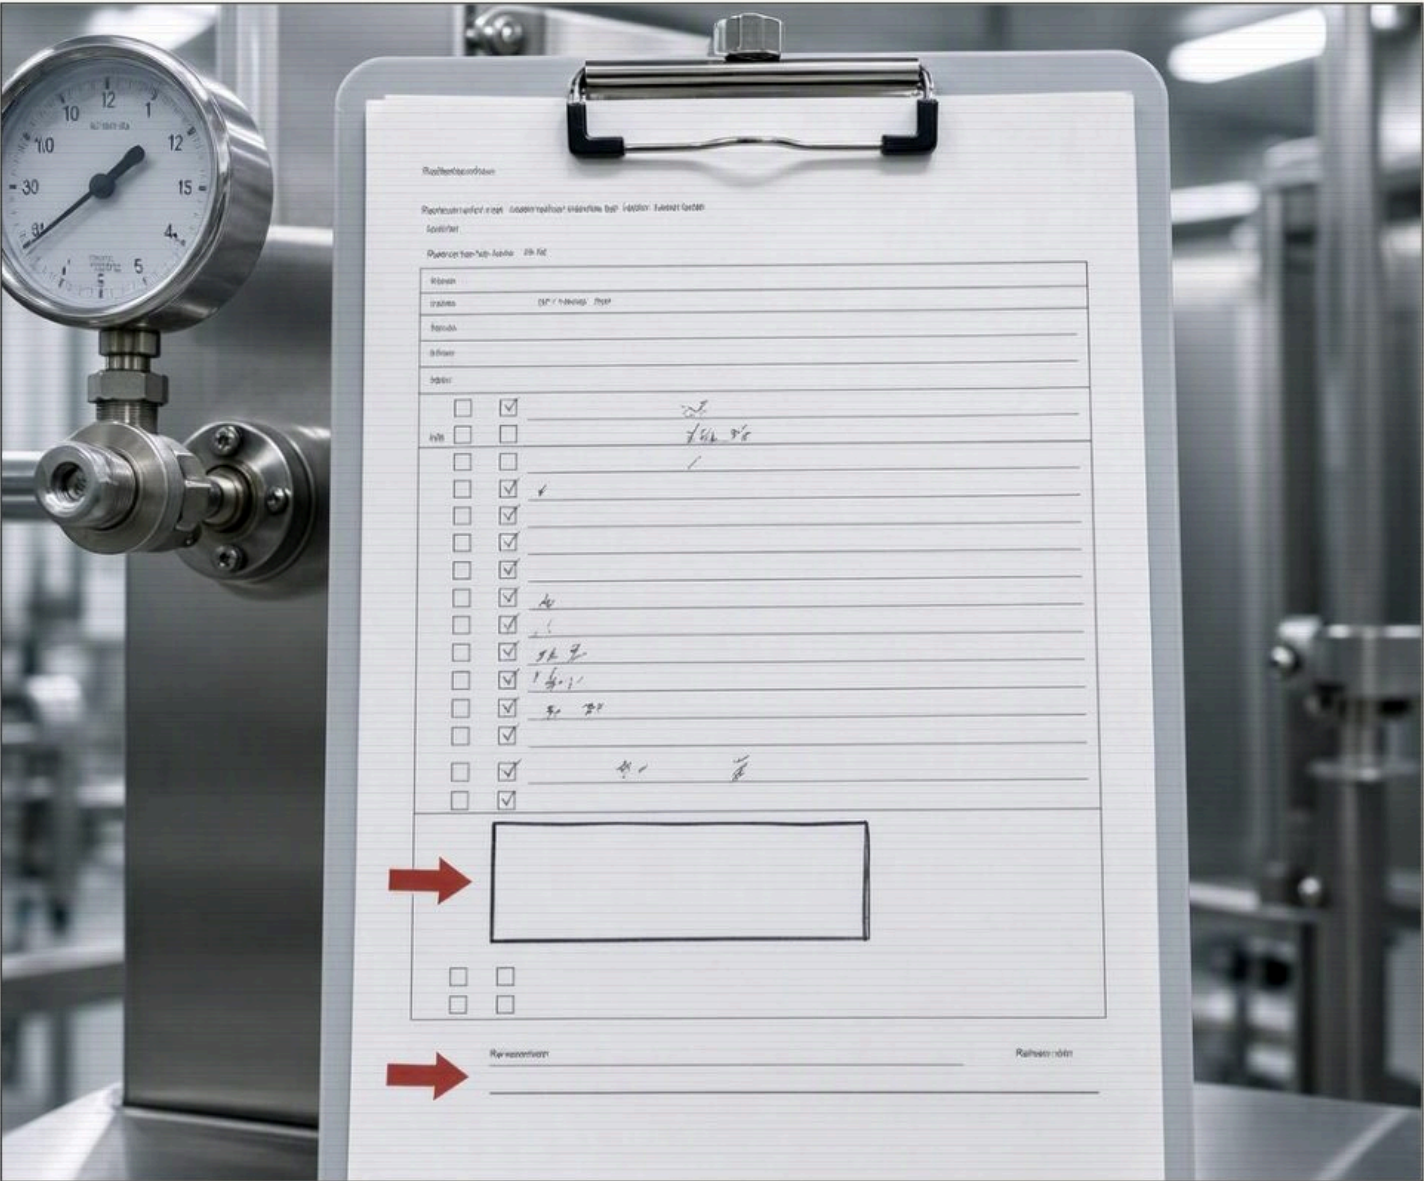
ATTACHMENT C · PHOTOGRAPH 2

## BPB-MAJ-01 · Closed transfer path released without required integrity-test evidence

The site released transfer path TC-4 for manufacturing use after maintenance order WO-BPB-1026-441 although pressure-hold record PHT-BPB-1026-441 contained no result, reviewer confirmation, or objective evidence that the acceptance criterion was met.

**Objective evidence:** Blank pressure-hold result; work-order closure audit trail; run BP-1026-03 equipment-release entry.

**Potential risk:** Loss of closed-system integrity and microbial contamination of in-process product.

Pressure-hold verification station

**Control context.** The checklist appears substantially completed, but the test-result box and reviewer-confirmation line remain empty. The pressure gauge and test connection provide the means to verify closed-path integrity; without recorded results and review evidence, the work order should not have permitted equipment release.

| COMMITTED ACTION | OWNER | DUE | EFFECTIVENESS EVIDENCE |
|---|---|---|---|
| Revise equipment-release workflow so required pressure-hold results and Quality approval are hard-stop fields. | Hannah Wells | 05 Feb 2027 | Challenge test in validated maintenance system using a deliberately incomplete record |
