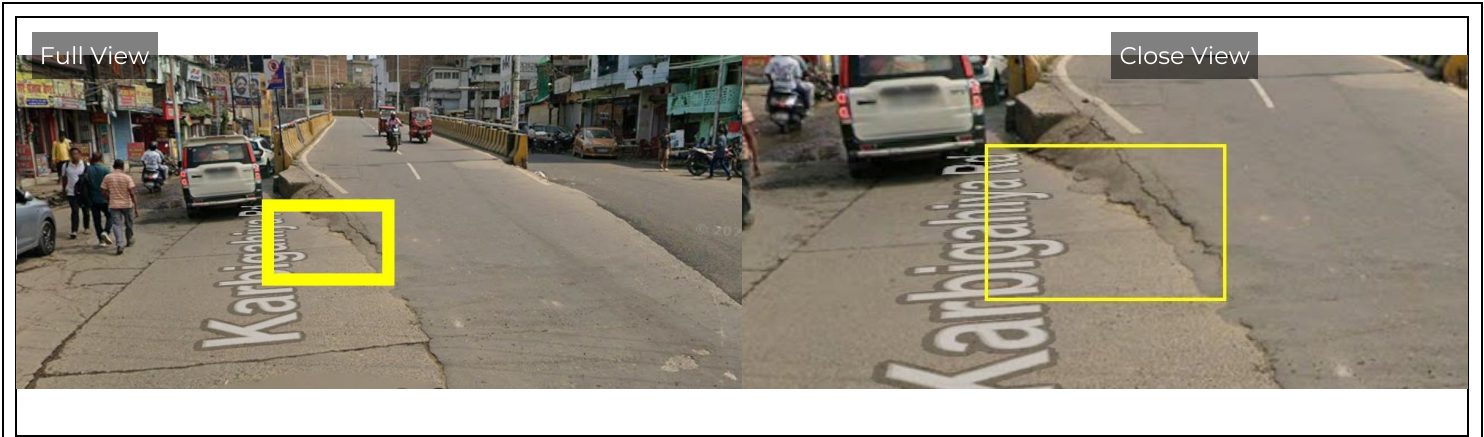
S.no. :1  
Asset Name :Alignment  
Defect Name:Unevenness / Depression

Condition State: IV  
Severity: 0

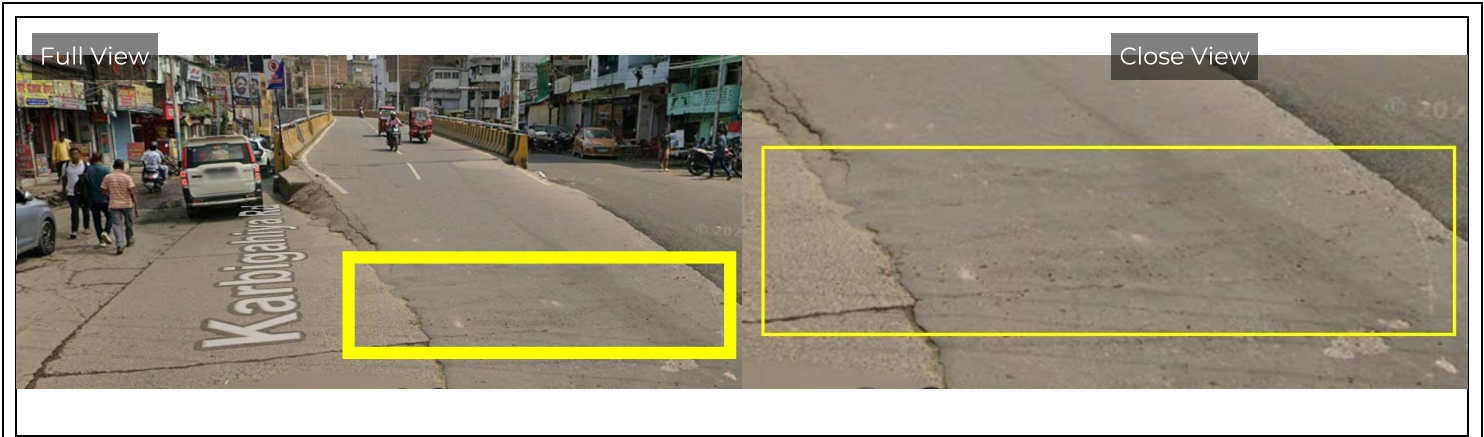
S.no. :2  
Asset Name :Alignment  
Defect Name:Settlement / Bumps / Heave

Condition State: IV  
Severity: 0

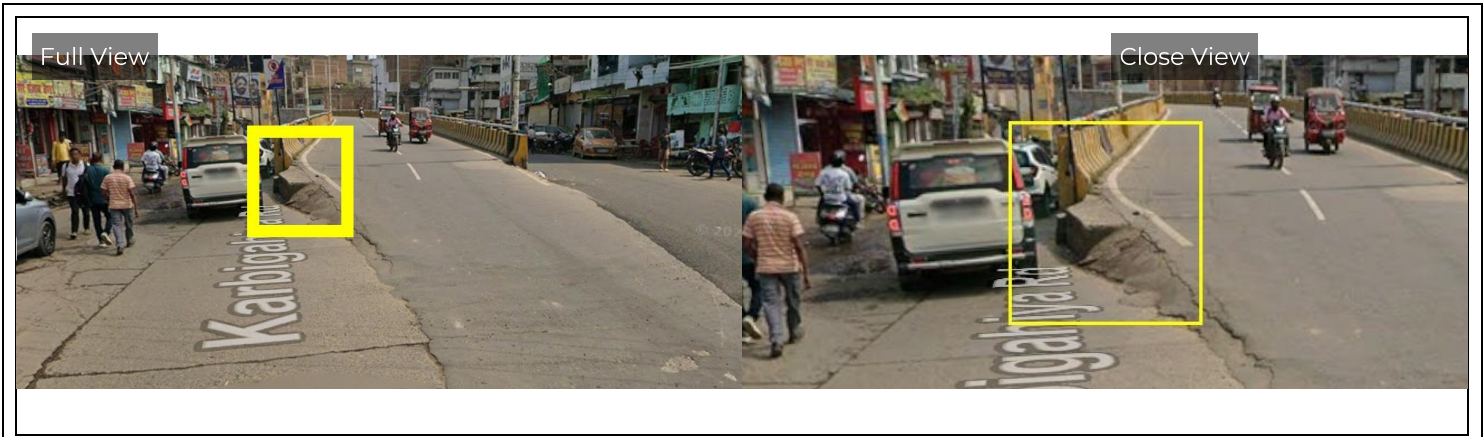
S.no. :3  
Asset Name :Alignment  
Defect Name:Deformation / Deflection / Tilt

Condition State: III  
Severity: 0
