# MR Known Artifacts

On Line Engineer  
GEHC, Buc, France

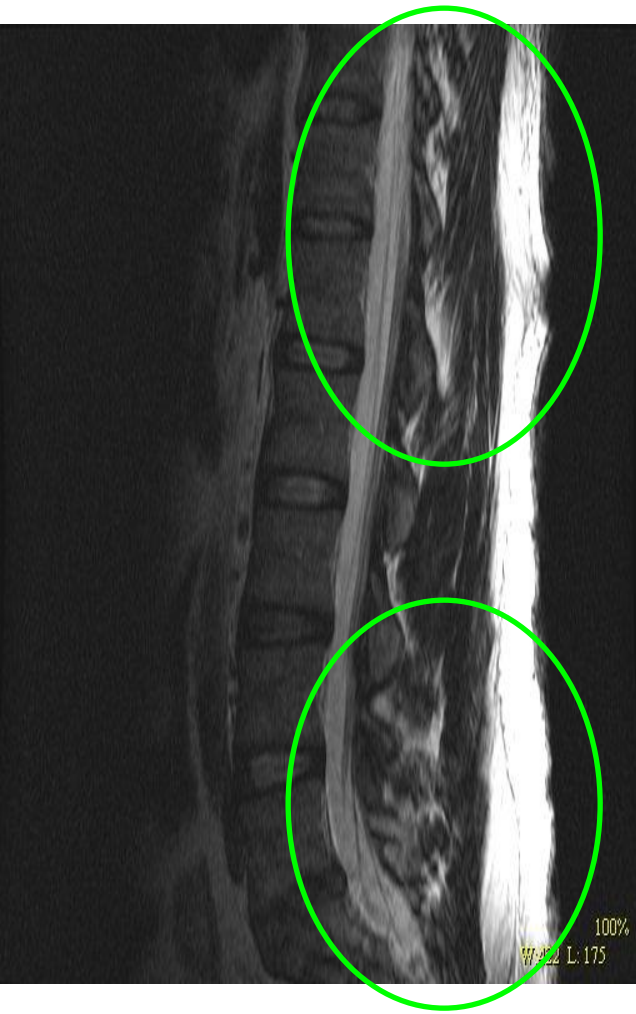
# Maxwell Term Artifacts

Artifact due to running flow compensation while phase and frequency are swapped. Flow compensation is applied on the frequency axis with phase and frequency swapped, flow comp. is applied A-P. Flow comp pulse generates a large Maxwell term down the Z axis (S-I) and causes ghosting, blurring and signal void towards the ends of the field of view. The bigger the field of view the worse the artifact.

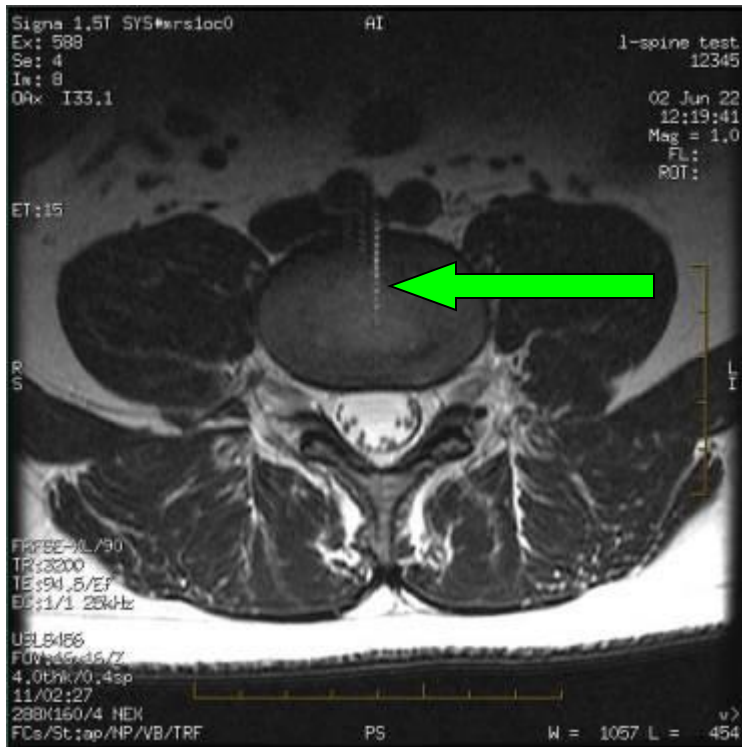
Spatial SAT excites tissue beyond the Zoom coil - The Crusher gradient from the Zoom becomes ineffective.

3-Coil CTL (LS456) in Zoom Mode can receive signal from tissue excited by the wide SAT pulse outside the FOV, and wrap into the phase direction.

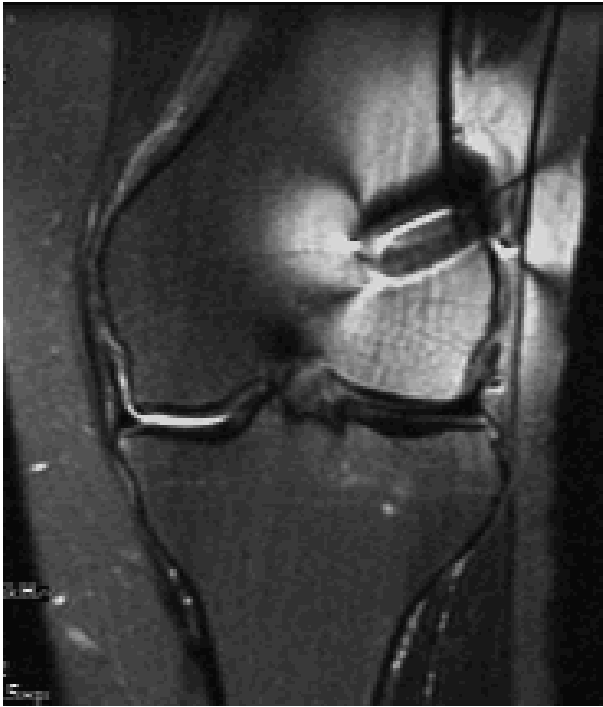
# Metal Effects on Fat Saturation

‘T2 weighted, Fast Spin Echo, Fat Saturated’ image shows how poor Fat Saturation can be in a region of Metallic Prosthesis. Caused by an alteration in the local magnetic field resulting in a change to the *precessional frequencies*, rendering the Chemical Saturation pulses ineffective.

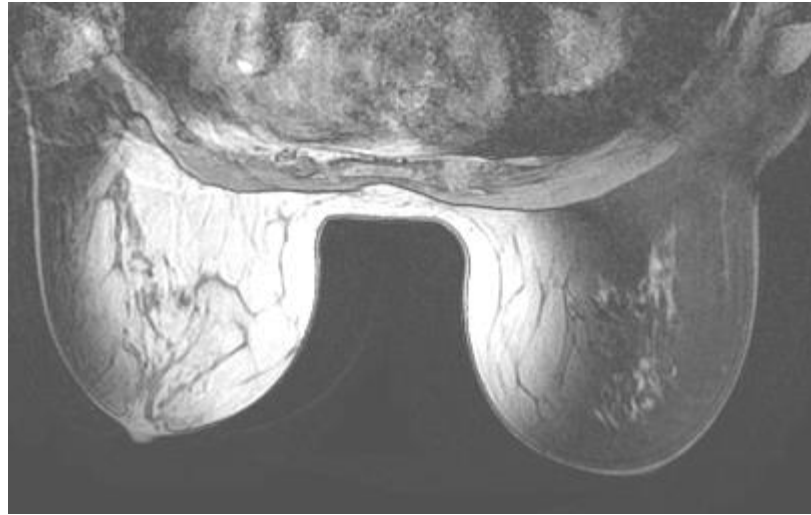
# Pant Zip

Pant zip may cause an artifact distant from the source. Here an example with breast imaging.

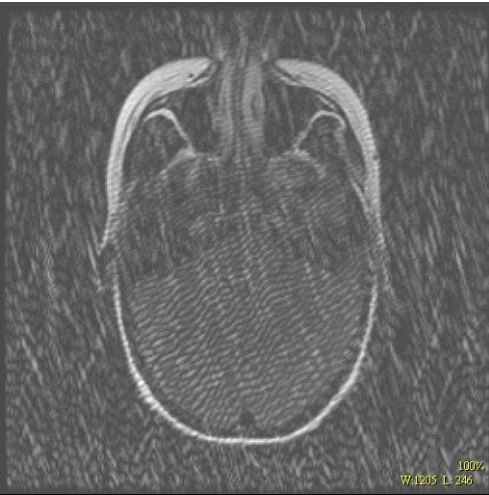
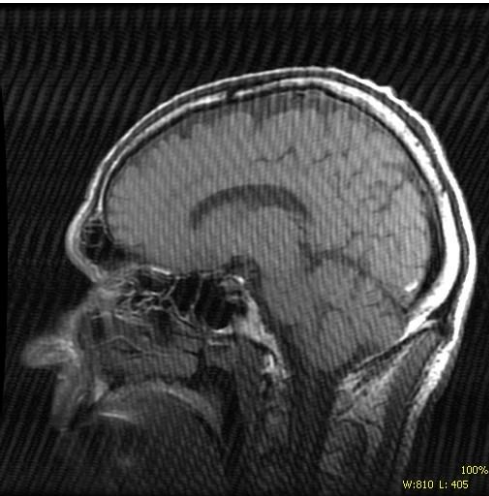
# Coil Related Artifacts

T2 Flair with 8 Ch NVARRAY coil.  
Intermittent but frequent, once a day,  
sometimes vary in appearance  
Only seen with NVARRAY coil.

Coil replacement.

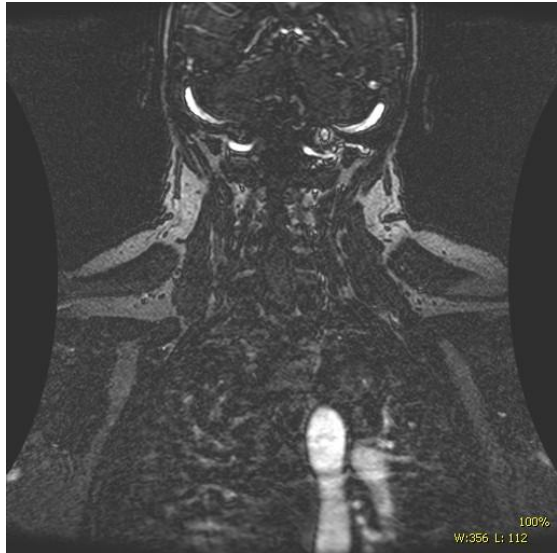
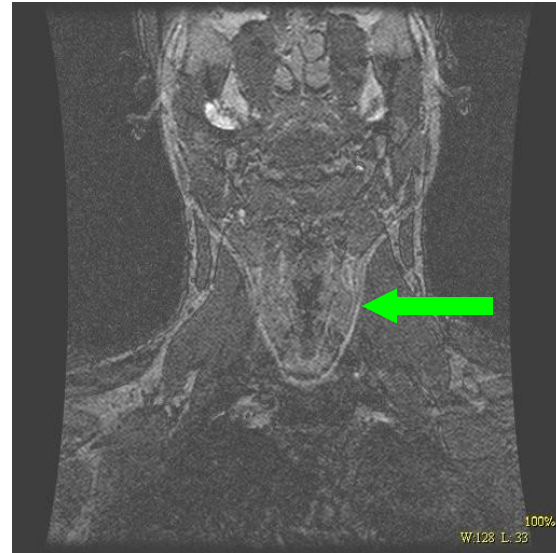
Site has a TwinSpeed, image on the left, no slice wrap.  
And an EchoSpeed, image on the right with slice wrap.  
Same exact protocol used with 2 different patients.

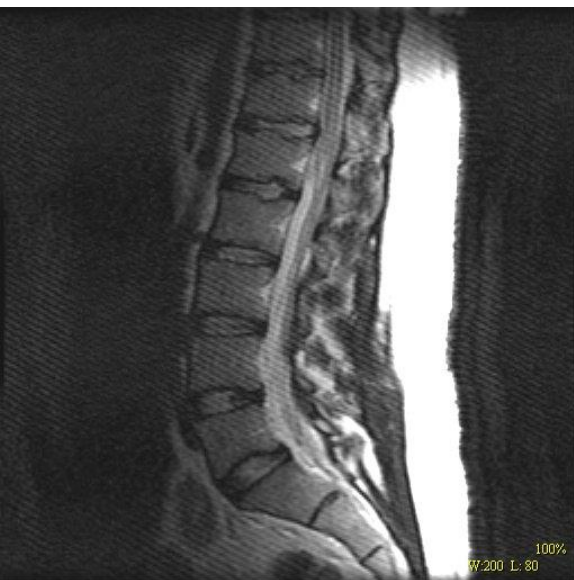
# Corduroy Artifacts

Typical Corduroy artifact.

Find and eliminate the corduroy artifacts source.

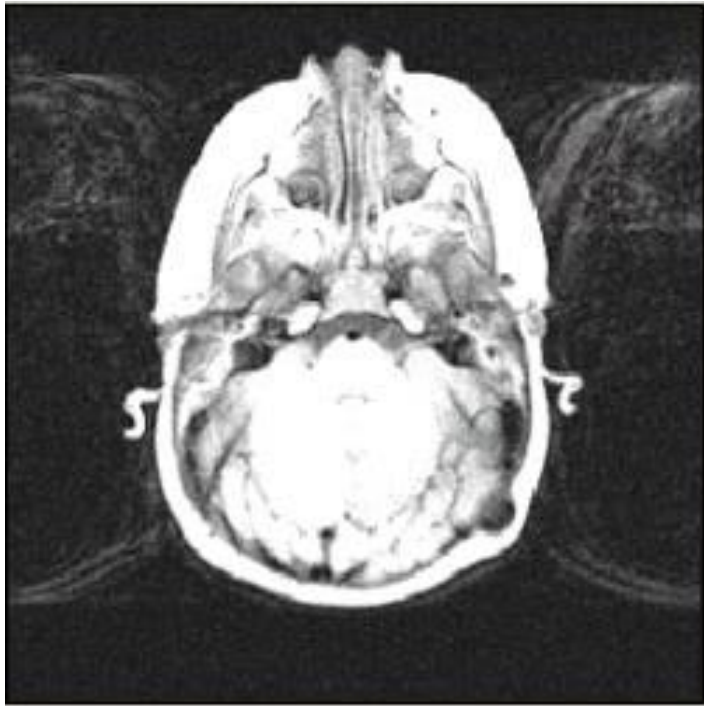
Ghosting Artifacts Due to Respiratory

Ghosting artifacts due to respiratory motion in head images (often seen on sedated patients, who have a deep, regular cycle in their breathing pattern). This is sometimes harder to detect as a motion problem. In this example, note how the ghosts are well defined, suggesting that the disturbance has a regular frequency (cyclical).

The source of cyclical disturbance can be anything that has a regular, repeating rhythm (cold-head, fans, air handlers, rotating machinery, and in some cases people with deep regular breathing).

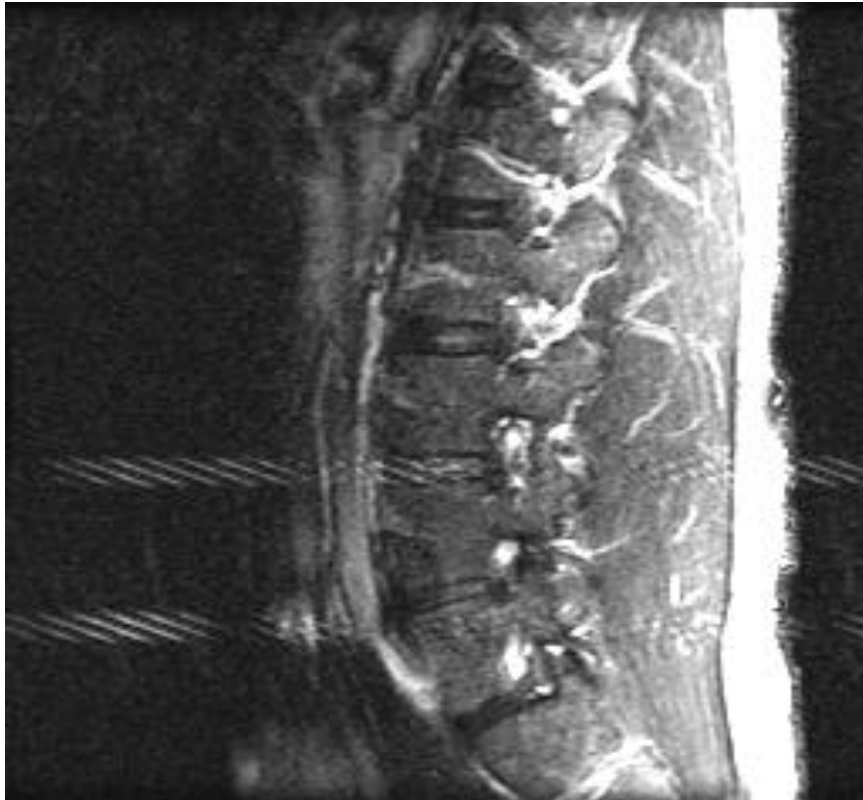
Multiple MR system crosstalk.
