# ATTENTION!

## Attention GE Field Engineer:

## APPENDIX FOR JUMPERS IN 3T94 SYSTEMS [FOR THE 12.X AND E2 SYSTEMS]

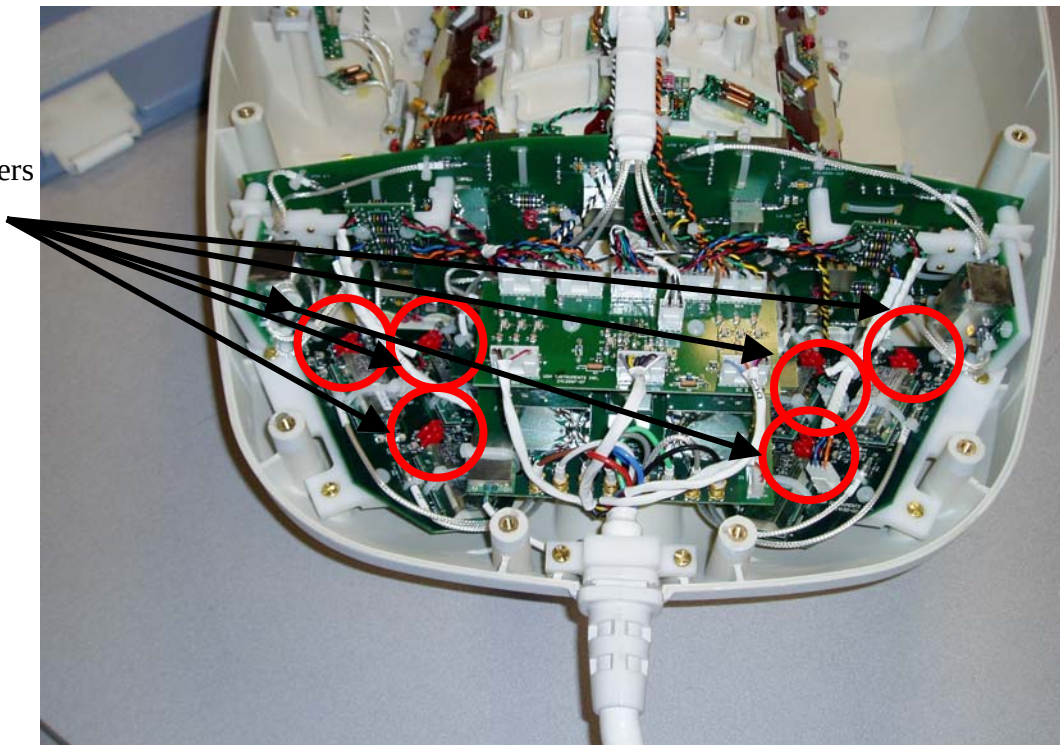
Illustration 2: The 6 jumpers are shown in the circles in the illustration
