## FCT SERVICE NOTE SN05083009a

**Subject:** Fuse holder cap failure is occurring on some H16 MDAS fuse box assemblies, (Fuse Box P/N 2331963).

**Effectivity:** Lightspeed CT Systems with MDAS.

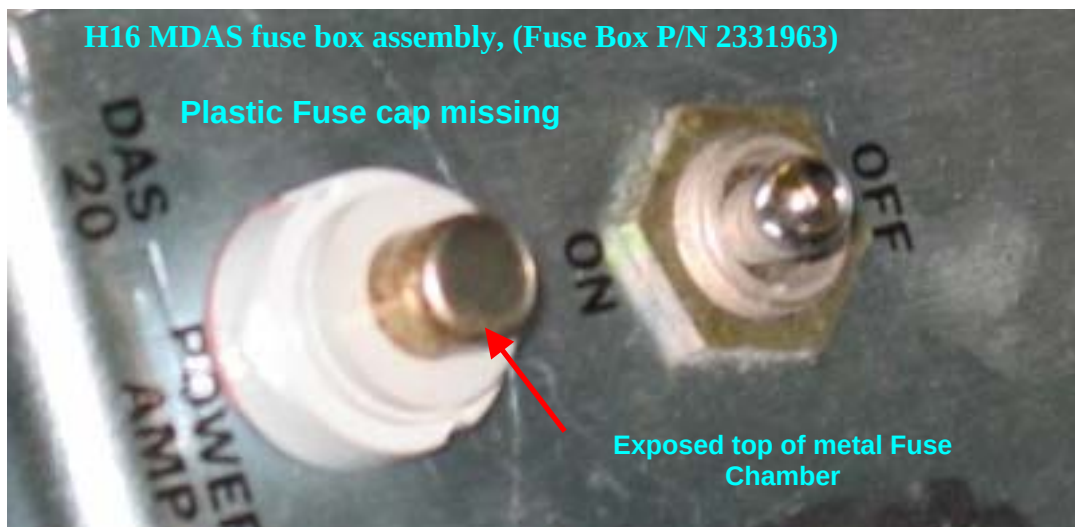
The adhesive holding the plastic cap to the fuse holder may fail. This causes the plastic cap to fall off exposing the top of the fuse chamber. This creates a potential 120V electrical shock hazard to Service personnel due to its proximity to the power switch on the fuse box.

1. Order a new fuse holder, GE P/N 46-170042P26.
2. Order a replacement Fuse, GE P/N 46-170021P81, as this is critical to the corrective action.
3. Remove 120 VAC power from the fuse box assembly.
4. Remove the existing fuse and the defective metal top of fuse chamber.
5. Replace the 20A fuse on the “failed” fuse holder with GE P/N 46-170021P81.

6. Replace the top of the fuse chamber, with the top of the fuse holder from GE P/N 46-170042P26. It is not necessary to replace the entire Fuse holder. Use the cap of the replacement fuse holder to replace the “failed” fuse holder cap.
7. Discard the lower part of the fuse holder, GE P/N 46-170042P26. It is not used in the repair.
