# FCT SERVICE NOTE

## SN05112916a

**Subject:** VCT Systems- DCB may not be seated all the way into chassis

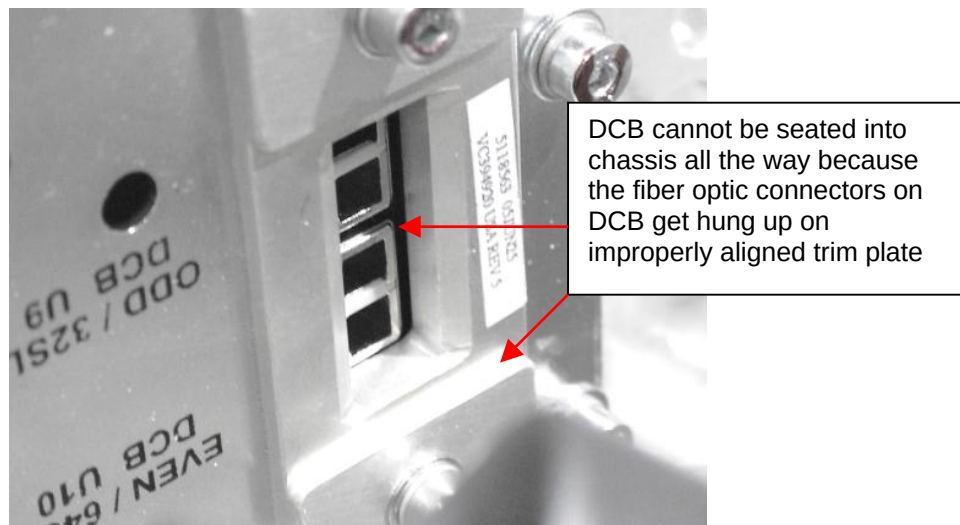
The DCB cannot be seated all the way into the chassis because the fiber optic connectors on the DCB get hung up on an improperly aligned trim plate (5118563).

**Incorrect DCB Configuration**

Remove trim plate before re-seating DCB into chassis. Then install trim plate (leave screws loose) and fiber optic cables to DCB connectors (U9 & U10). Tighten screws on trim plate.

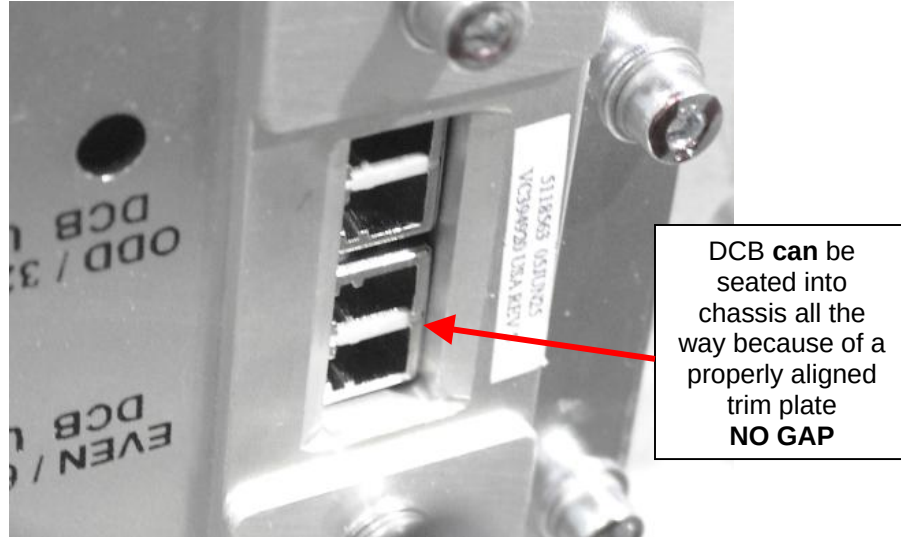
**Correct DCB Installation**

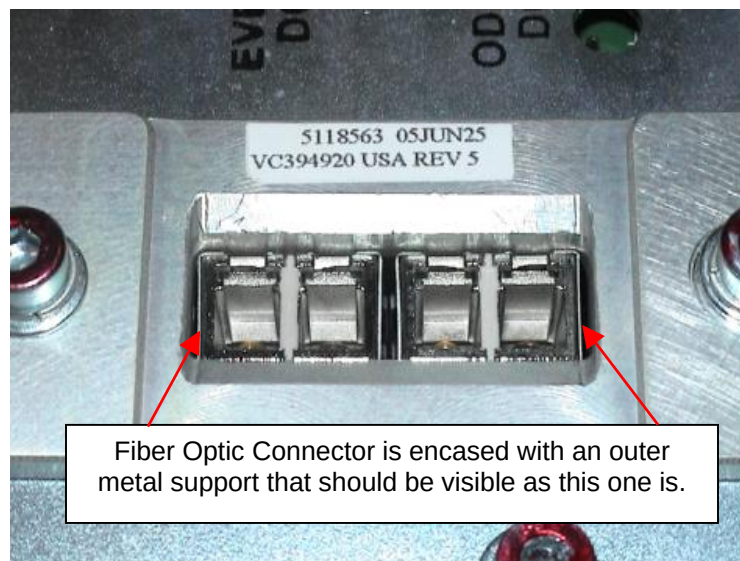
**Correct DCB Installation**
