## FCT SERVICE NOTE SN06102121a

**Date:** Oct.25, 2006  
**Effectivity:** LightSpeed 5.x (HP80, HP100), 7.x (VCT) and RT<sup>16</sup>  
**Subject:** "Off Center Smudge" - Image Artifact

**Details:** Off Center Smudge - Image Artifact

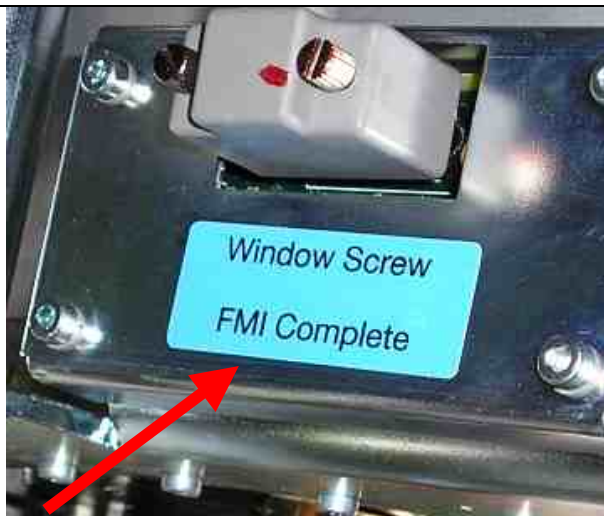
**Figure 5: Window Screw FMI Complete Sticker -Close-up**

**The most recently manufactured tubes include a blue sticker as depicted above indicating the FMI is already complete on that unit.**
