## Power Brush Block 2302508 Barrier Height Issue

MQUE-5BJNRU

HSA, CT/i, LightSpeed QXi

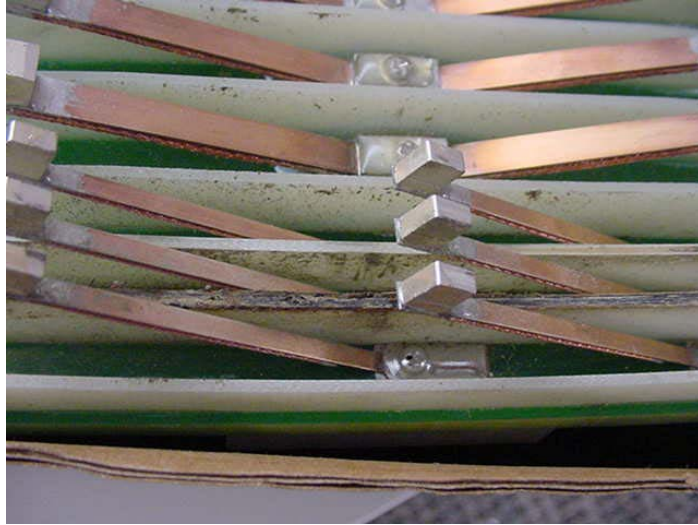
The barriers that are between each of the brushes have been found to be excessively tall in three known cases. They are projecting between .5mm and 1mm higher than specified. This causes the barriers to rub against the slip ring barriers. Please refer to attached images for more details.

Figure 1. Damage Caused by Barrier Height Issue

Only about 3% of the brushes that have been ordered and installed in the last six months have experienced the problem. After installing a new power brush, manually check clearances by rotating the gantry by hand and observing that the barriers on the brush block clear the slip ring barriers by at least .8 mm. Since radial run out can vary from system to system, measuring the brush blocks may not be conclusive in all cases. IF ANY CONTACT OCCURS DURING MANUAL ROTATION, STOP, REMOVE THE BRUSH BLOCK AND ORDER ANOTHER TO REPLACE IT.

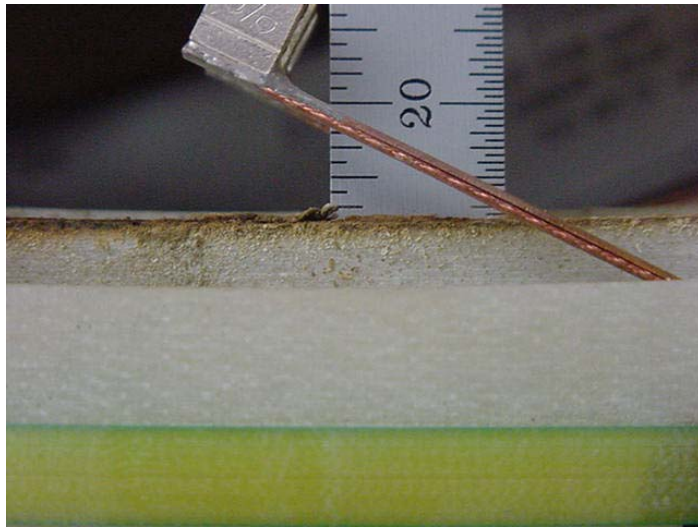
Figure 2. Barrier Height Measurement. Specification is 12 mm +/- .2 mm.
