## Brush Block Guide Pins

MQUE-5E6JEV

LightSpeed Plus, Ultra & 16

## **LightSpeed Plus, Ultra & 16, Brush Block Guide Pins**

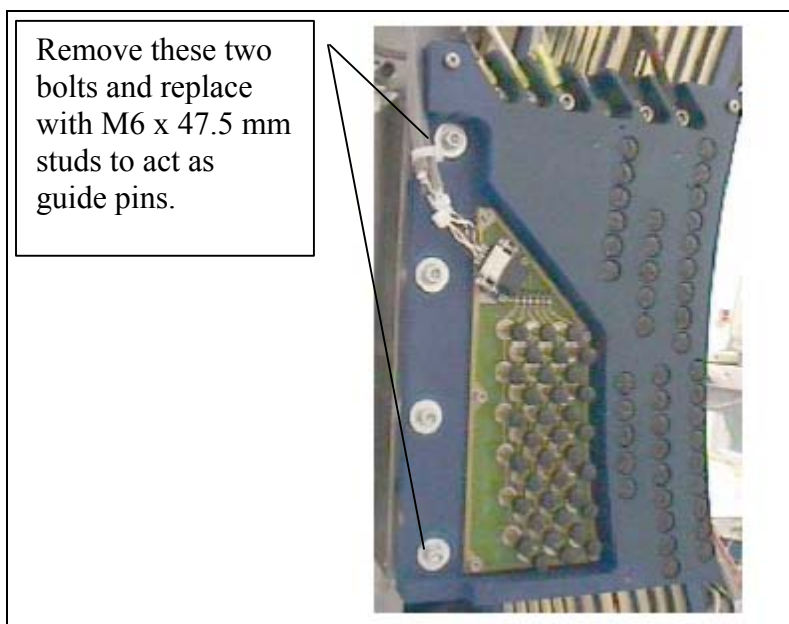
**Figure 2. Brush Block**

The brushes on the slipring brush block are susceptible to breakage if lateral force is applied during assembly back to the gantry.

Remove the top and bottom mounting bolts and insert these threaded rods in their place (see Figure 2). Remove the other two bolts and slide the brush block out using the studs as guides. Perform the necessary cleaning, or removal of the block, and reverse the procedure to re-install the brush block. The guide pins should be removed and the M6 mounting bolts installed in their place upon reinstallation.

**Do not leave the M6 studs on the system.**

Be sure to torque the (4) 6 mm cap screws to 7.9 N-m (70 in-lbs or 6 ft-lbs).
