## TDI HNA Coil Troubleshooting

### 1 TDI HNA Troubleshooting tips

The 3.0T TDI HNA coil is a 21 Element Coil. This coil connects exclusively to the P2 Port.

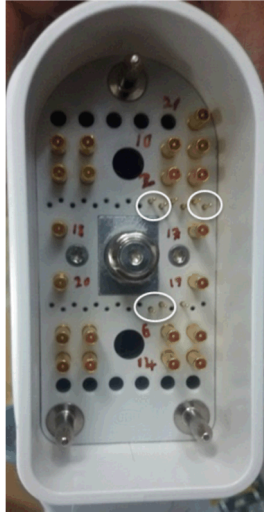
- (i) Intermittent Coil ID detection can be attributed to following 3 components:
- a. P-Port Connector:
    - i. Please check the pins highlighted in the image below. If any damage to any of the 6 pins, please order the Cable FRU assembly and re-test the coil.

- b. Cable Assembly:
    - i. Inspect the Coil cable assembly for any damage to cable, including Nicks and cuts to the cable.
    - ii. If damage present, please order the cable FRU assembly
  - c. Coil ID Board Connector (J54)
    - i. Please reseal the J54 connector of the coil ID Board and re-test the coil.
    - ii. If there is damage to the connector or the intermittency persists, please order the Cable assembly FRU.
- (ii) If the issue continues to persist, in spite of cable replacement, please order the Coil assembly FRU.
