**ADMINISTRATIVE INFORMATION****FMI No: 25351****FMI Title: LightSpeed Pro & RT (100kW 80kW & RT) Program M4 FMI**

FMI Title: LightSpeed Pro & RT (100, 80kW & RT)Program M4 FMI

## ***Purpose***

The purpose of this FMI is to upgrade all 5.X systems with M4 software and to perform the following system quality checks:

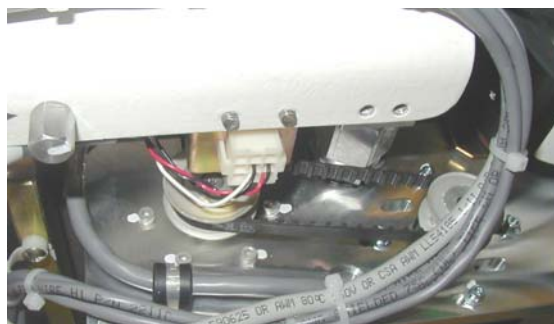
Figure 5 control cable rubbing on belt

- 1) On the cradle drive assembly check that all wires are secured to the frame. Wires should not come in contact with moving parts. See figure 4 & 5 Remove roller debris as needed.
- 2) On the Motor and encoder assembly all control cables should be neatly secured to the cradle frame. See figure 6. All electrical connection should be secure and tight.

- 1) It is possible to have a damaged cable as shown in figure 5. If your cable is damaged you can re-terminate this cable using the pins supplied in the FMI kit. \*

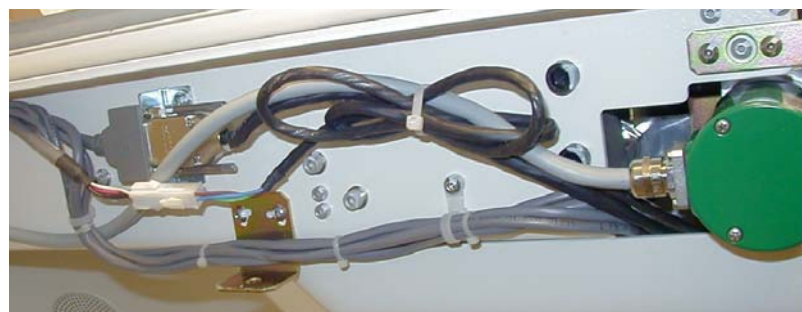
Figure 8 Secure cables as showed
