**ADMINISTRATIVE INFORMATION****FMI No: 25365****FMI Title:** 06MW03.5 SW for CT- LS 1X/2X/3X/4X/5X & HS QX/i with GRE Consoles

The purpose of this FMI is to upgrade system with the new 06MW03.5, software on LightSpeed 1X/2X/3X/4X/5X and HiSpeed QX/i systems with GRE (GOC3 and GOC4) consoles.

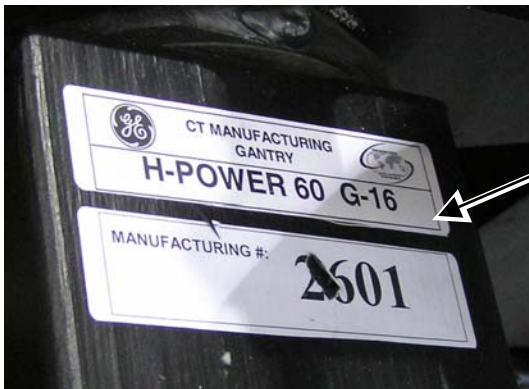
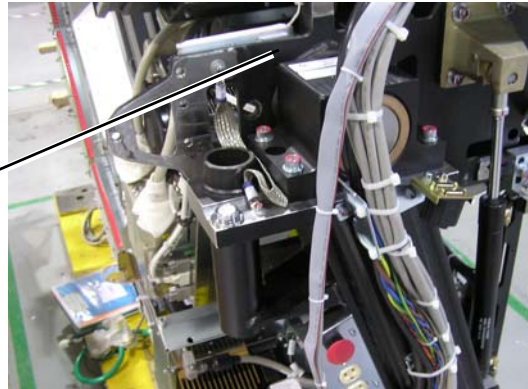
- 3.1 If your system is an HP60 system, Axial Motor Control work **REWORK** may be needed. This modification is needed to fix error “260107214, gantry failed to stop” in certain conditions. To check if your system is an HP60 system:

Check the label on the support leg (see figure below)

Perform Axial Motor Control rework as outlined in the service CD-ROM 5167277-200:

- Open CD-ROM 5167277-200, Xstream FX 1Q '06 Upgrade CD-ROM
- Click on Pre-Install.
- Click on Axial Motor Control Rework.
- Follow the instructions for rework.
