**ADMINISTRATIVE INFORMATION****FMI No: 25389****FMI Title:** 07MW11.10 Software Quality Release for LightSpeed 1X, 2X, 3X, 4X, 5X (not RT16 or Xtra), HiSpeed QX/i, and BrightSpeed 4, 8, and 16 slice (not BrightSpeed Select).

sections **BEFORE performing the load-from-cold** of software release 07MW11.10 provided in this kit.**Unit Tracked:** Multiple Host Console Model Numbers**FMI Instructions Part No.:** 5191771-100, Rev 4**Do NOT leave unsecured on site**

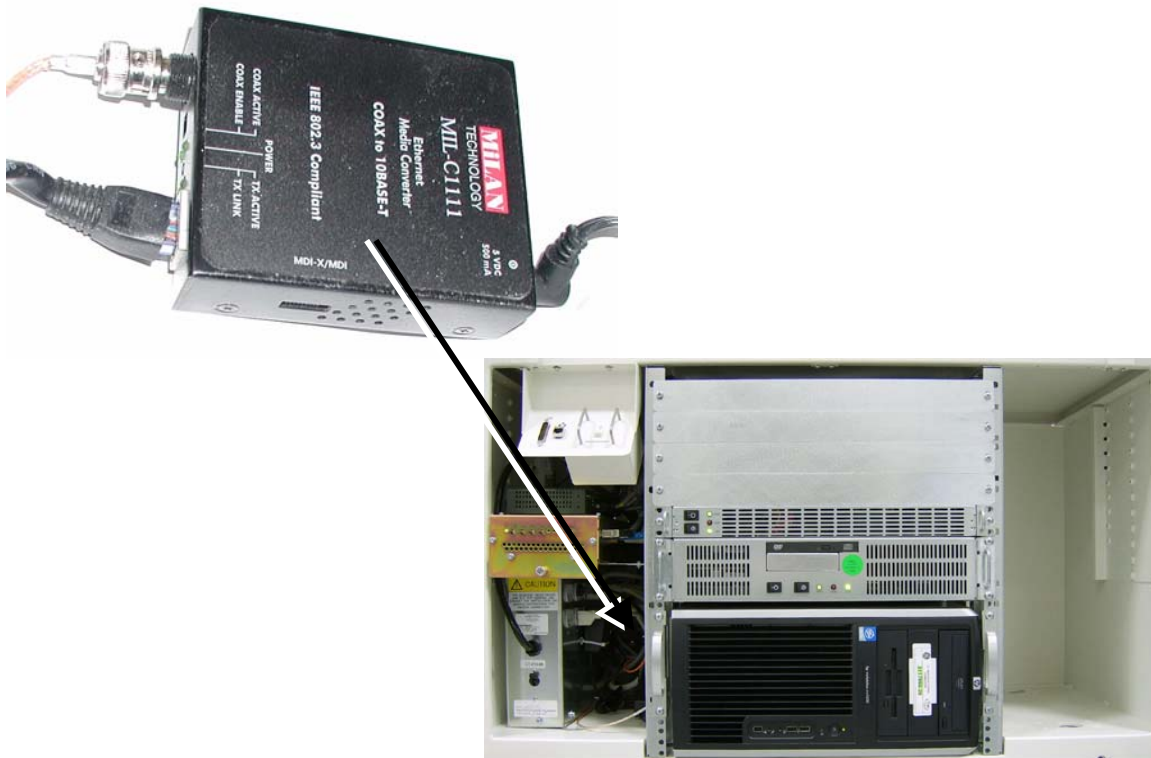
**Illustration 1:** Network Media Converter Location, Affixed to Side of Chassis (Network Media Converter p/n 2377227, Milan model MIL-C1111)

The network media converter, p/n 2377227 (Milan model MIL-C1111), has been suspected of causing communication issues that may cause a scan not to complete correctly.

2. Locate the Network Media Converter; refer to **Illustration 1**.
3. Set / check its DIP-switch settings per **Illustration 2** and ensure no BNC terminator is attached (enable 50 Ohm termination at end of network).
4. Set / check its MDI-X/MDX slide switch setting per **Illustration 3** (enable connecting to workstation / another network converter).

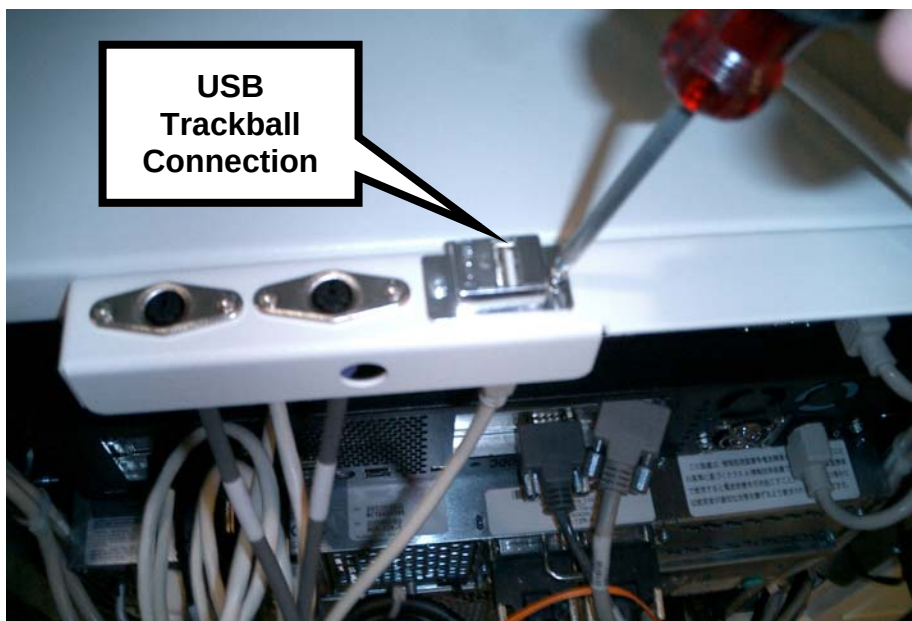
**Illustration 4:** Host Computer Console Bulkhead for Trackball

**NOTE:** For PS/2 cable-based trackballs only, failure to replace the trackball's PS/2-to-USB cable converter may cause the CT host console to "hang" when loading, or after loading, 07MW11.10 software.

If the trackball connection is USB as in **Illustration 4** below, then skip this section and proceed to the next section; do not install the PS/2-to-USB Cable Converter.

If the trackball connection is PS/2, then replace the PS/2-to-USB converter cable perform next two steps.

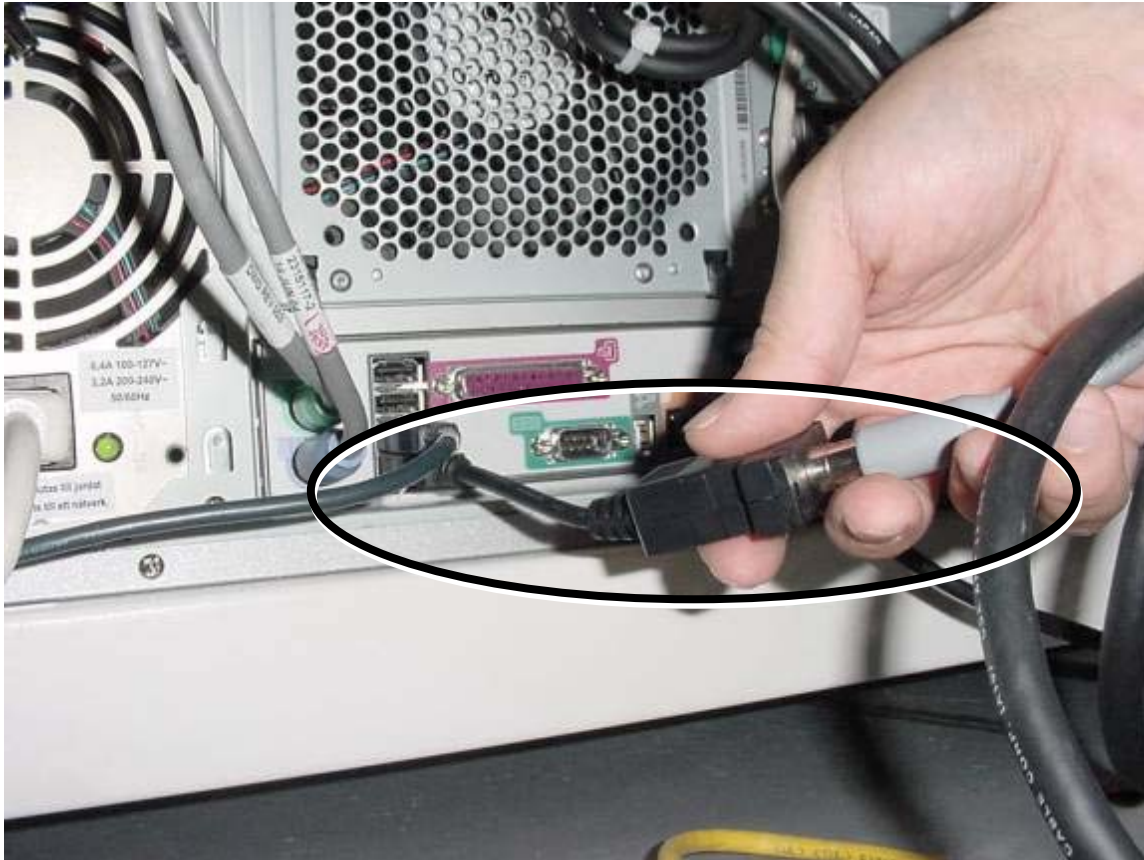
**Illustration 5** HP PC Rear View, PS/2-to-USB Cable Converter

All PS/2 cable-based trackballs must be updated with the PS/2-to-USB cable converter included in this FMI kit, replacing the current black cable converter with this gray-colored version. Replacement is required for the PS/2-based trackball to work with the Linux OS 6.2.9 delivered by software collector 07MW11.10, distributed by this FMI.

- a) Remove the rear cover to the host console to access the rear of the CT host computer console's HP PC.
- b) Replace the PS/2-to-USB cable converter (black) with p/n 5195935, the PS/2-to-USB cable converter (gray) that came in this FMI kit.

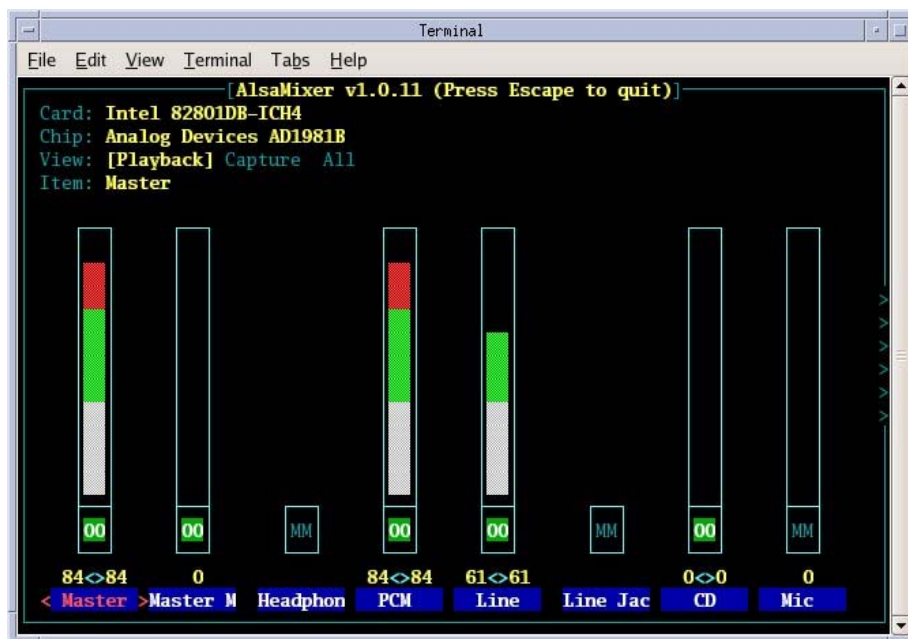
1. If Autovoice volume is too low, select “Autovoice Volume” tool (“audioSetting” tool) from the Tool Chest menu to increase it as needed, and click the “Save,” then “OK” buttons to save to file.
2. If Autovoice feedback issues exist (increasing the volume setting may create feedback), then
  - a. Open a unix shell.
  - b. Type: **alsamixer** [Enter]

- c. Press the right-arrow key → to move cursor selection to the **PCM** slider.
- d. Press the up-arrow key ↑ to increase the **PCM** setting to 100%.
- e. If feedback is heard, press the right-arrow key → to move cursor selection to the **Line** slider.
