**ADMINISTRATIVE INFORMATION****FMI No: 25406****FMI Title:** VCT External Evaluation Sites Inspection and upgrade

The purpose of this FMI is to inspect the original VCT External Evaluation sites listed in the effectivity for proper manufacturing configuration and upgrade where needed.

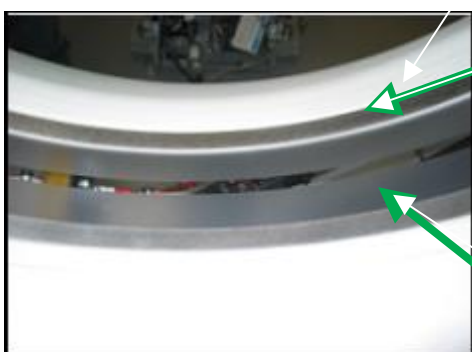
#### Gantry Covers

The correct part numbers are:

Front cover **2397075**

Rear cover **2397078**

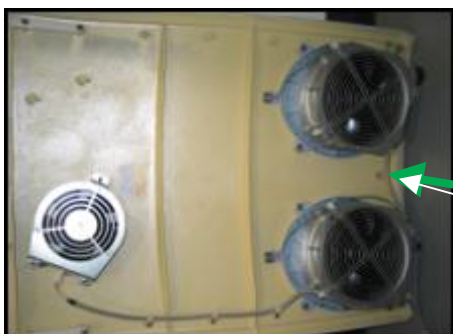
If the system is not getting Mylar Window Errors during fastcal and the scan window doesn't slide back and forth, no action needed.

Scan window part number should be **2401577**. The correct part will have glazed area.

This cable (in the Gantry Top cover) should be a gray or black shielded harness, part number **5130600**. If it is black and red and not shielded, it is the old part number.

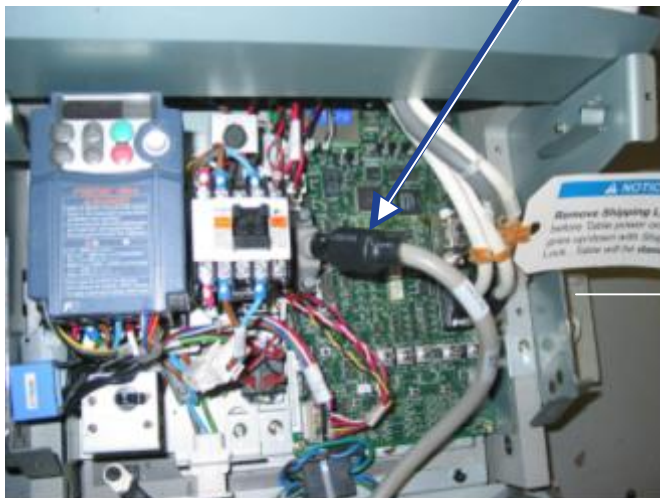
### Table Base

Global table front is shown in picture. There should be a **ferrite bead** on the Global table to gantry harness, **5129522**.

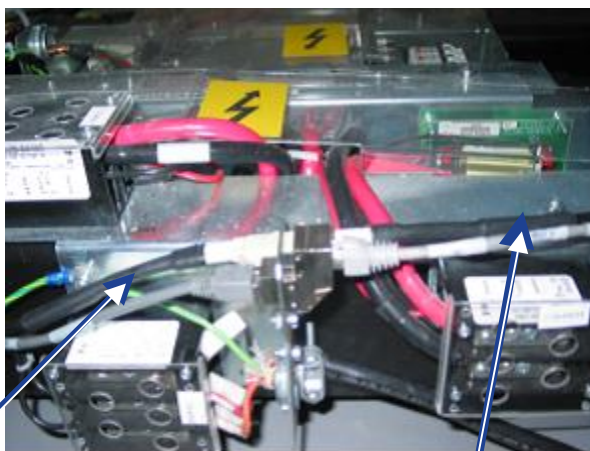
### Gantry Base

Verify that **5125258** – fiber optics with black wrap is installed. Old version will be orange with no wrap. (HVDC power pan rear shown)

Verify that **5125259** – fiber optics with black wrap is installed. Old version will be orange with no wrap.

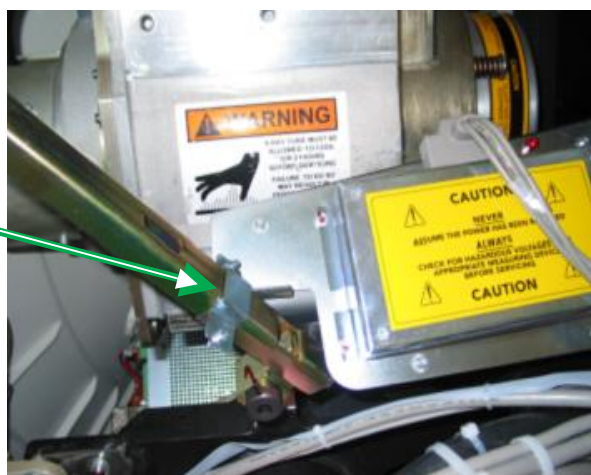
**5126690** KEEPERS – right front  
Verify these Keepers are  
installed on gantry cover support  
base

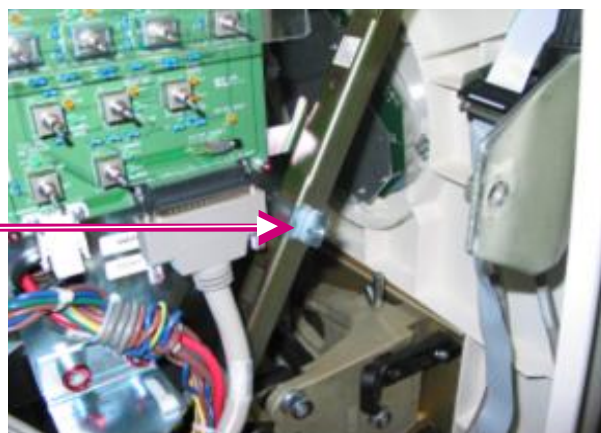
**5126690** KEEPERS – right rear  
Verify these Keepers are  
installed on gantry cover support  
base

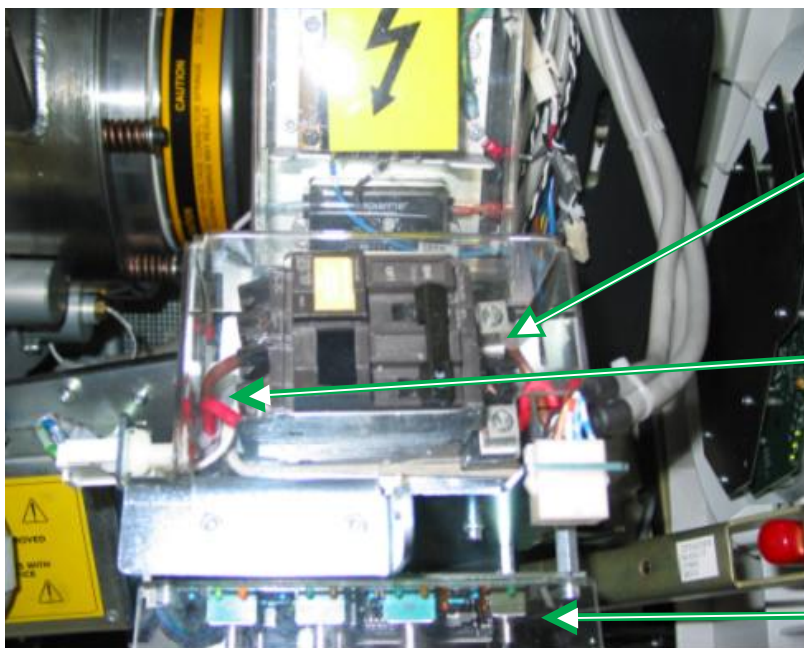
### *Right side – Gantry, looking down*

Verify that harness, **5118424** (Filter to GFI harness) is installed.

Verify that harness **5118296** (GFI to brush-block harness) is installed.

Service board assembly.

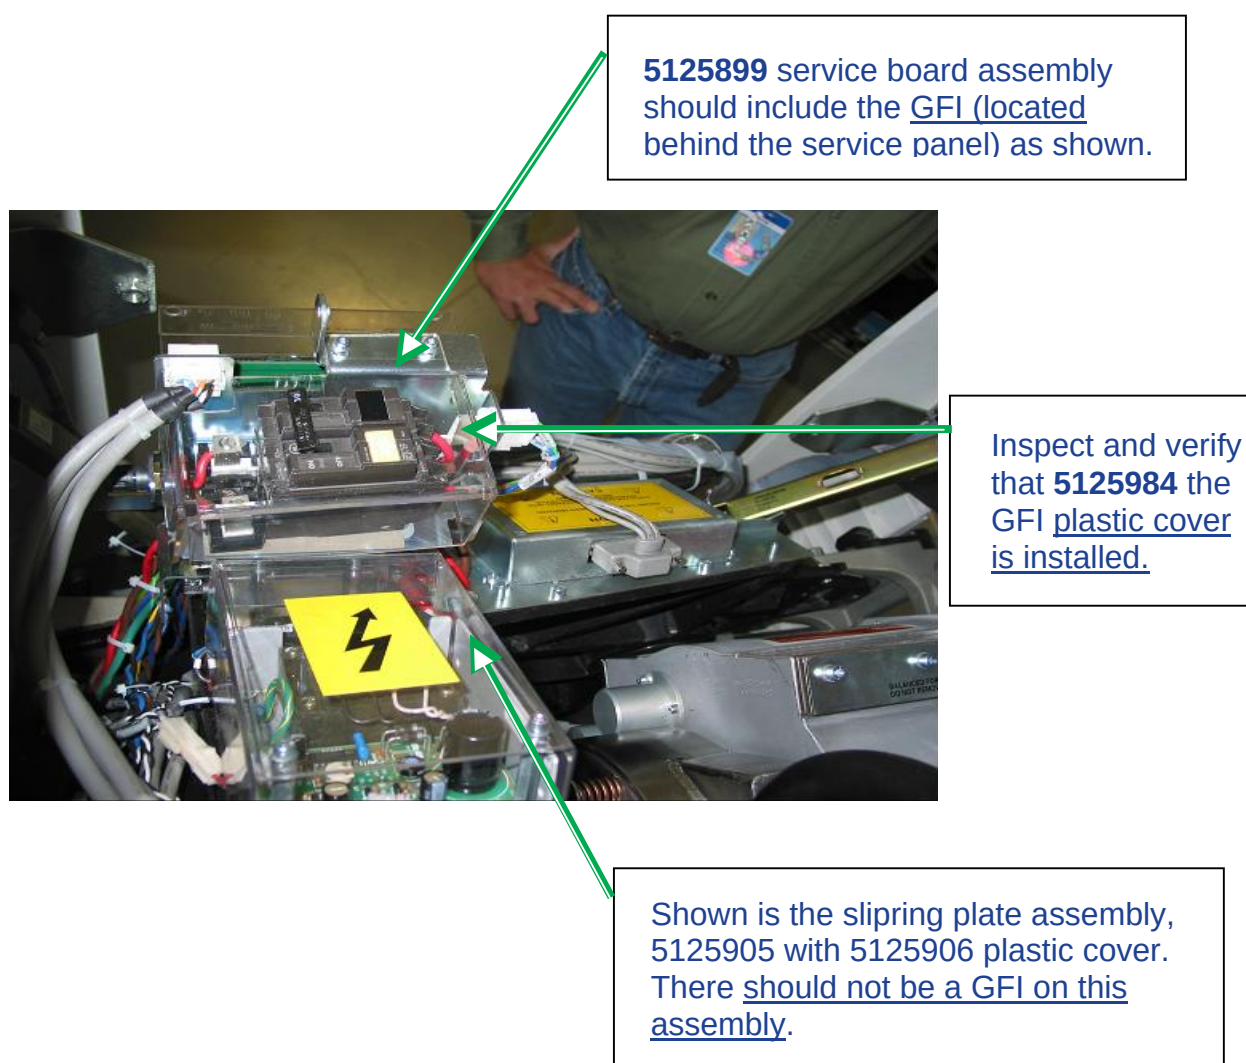
### **Picture from above right rear of gantry, looking out**

GFI was moved from bottom (Slip Ring Plate Assembly) to the top (Service Switch Board Assembly). If moved, the plastic covers will be as shown below. If not, please contact headquarters.

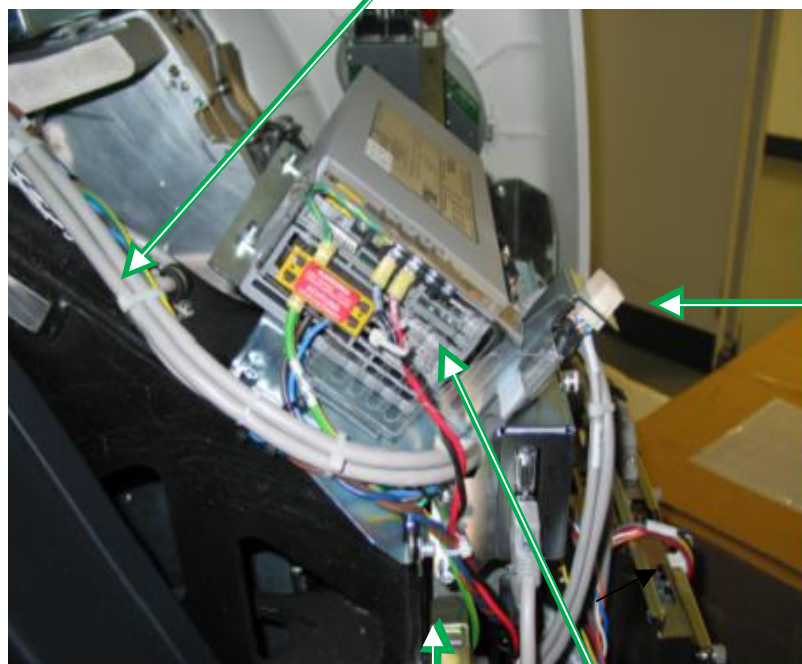
### Left side - Gantry

Verify that **5130598** shielded gray or black harness is installed.

Verify **5128605** bulkhead bracket is installed and holds fan harness in place.

Verify that the Slam latch keeper hook is installed on the power supply assembly. Also verify that **5126690** slam latch keeper is on the slam latch.

Verify **5128606** guard has air vents is installed.

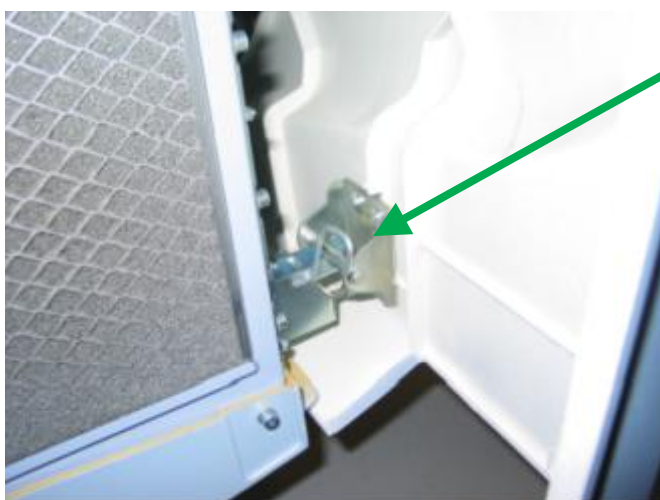
Should have cover latch assembly **5122691** (lower left of gantry near blower box and filter as shown). Front cover shown attached.

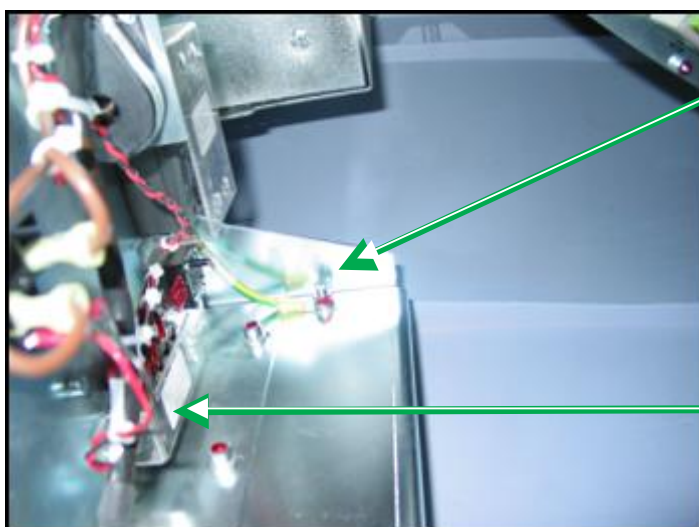
There should be a ground wire attached to the base plate of the stationary side blower box (lower left of gantry).

Terminal strip should have a cover on blower box. Part number is **5119936**.

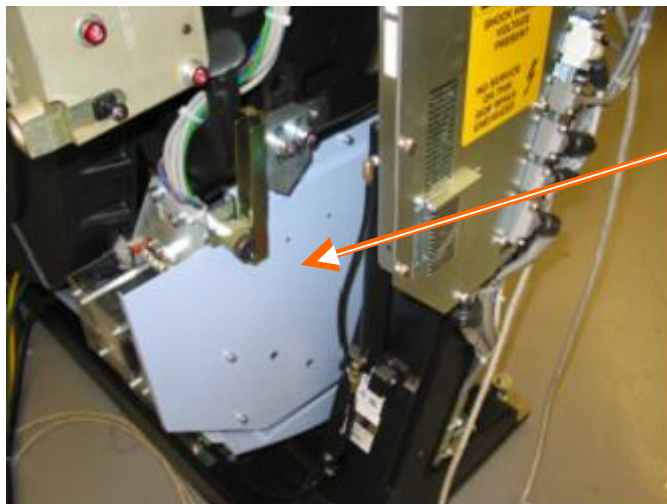
Verify that **5124826** – left side panel is installed.

The side panel should be as shown.

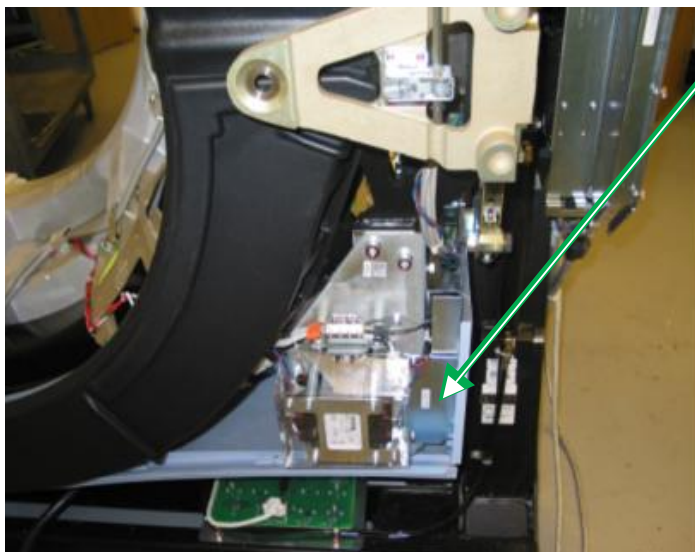
Verify that **5124827** left side panel bracket is installed.

It holds the newer panel 5124826.

(Note: If the system has the side panel, the side panel bracket will be there.)
