ELLIS & WATTS INTERNATIONAL, INC  
4400 GLEN WILLOW LAKE LANE BATAVIA, OH 45103  
(513) 752-9000

10/10/01 SB-009

## **SERVICE BULLETIN**

The following issues pertain to LC20M, LC20M/RAC, LC20M/WC, LC20MT, LC20MT/O, LC18MT/WC, model chillers:

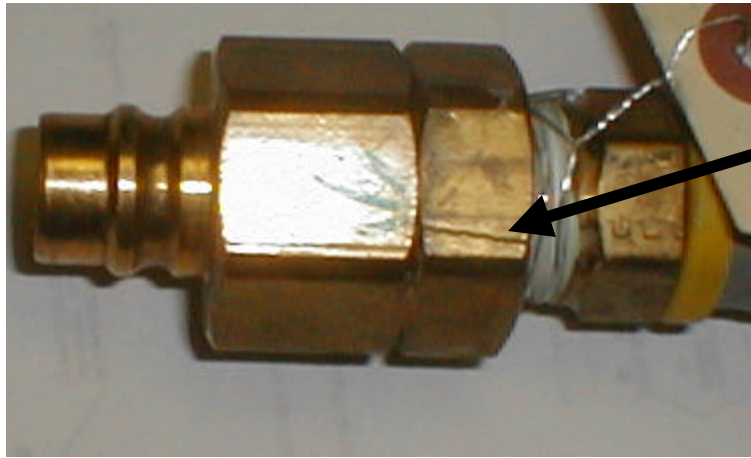
2. It has been brought to our attention that there have been occurrences of cracked Quick Disconnect (QD) fittings (see attached photo). This problem can occur on units with brass QD fittings. We are requesting that all service providers visit each site and inspect all QD fittings for cracks. Please contact E & W Service department with your findings (866-863-7784).

Crack  
location

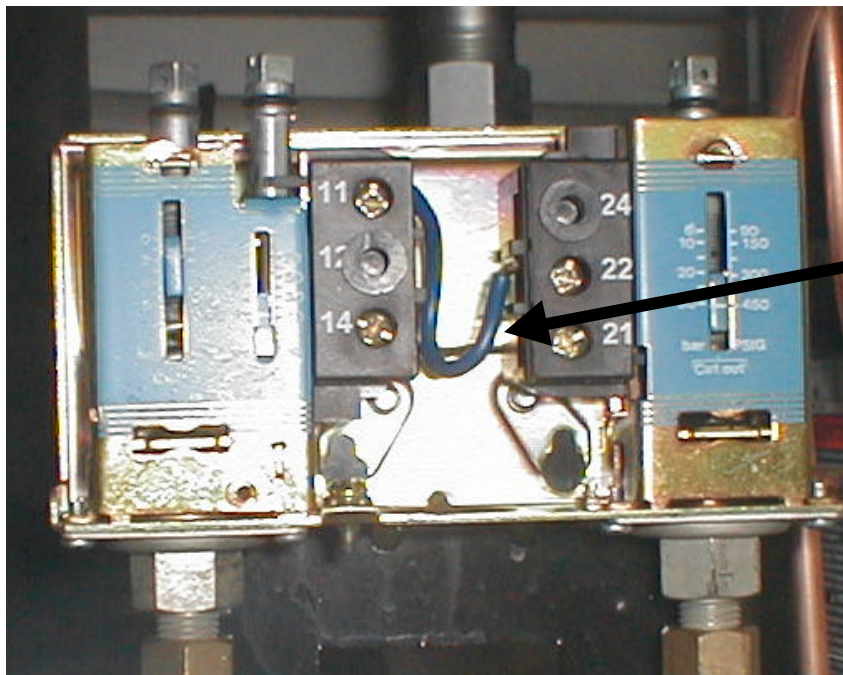
1. During a recent service visit it was discovered that there is a jumper connected between terminals 11 and 22 on the dual pressure control for the refrigeration system (see attached photo). This jumper essentially overrides the safety switches of the control. **Effective immediately** we are requesting that all service providers visit each site **ASAP**, that has any of the above listed models to determine if this control has the identified jumper. If so, the jumper must be removed by cutting it as close to each terminal as possible.

Remove  
jumper

Notes: 1. 24VDC is present on these terminals.  
2. DO NOT attempt to remove the jumper wire by loosening terminal screws without prior permission to shut down the chiller.
