MAGNETOM

# Troubleshooting Guide System

RF System

Avanto  
Espree

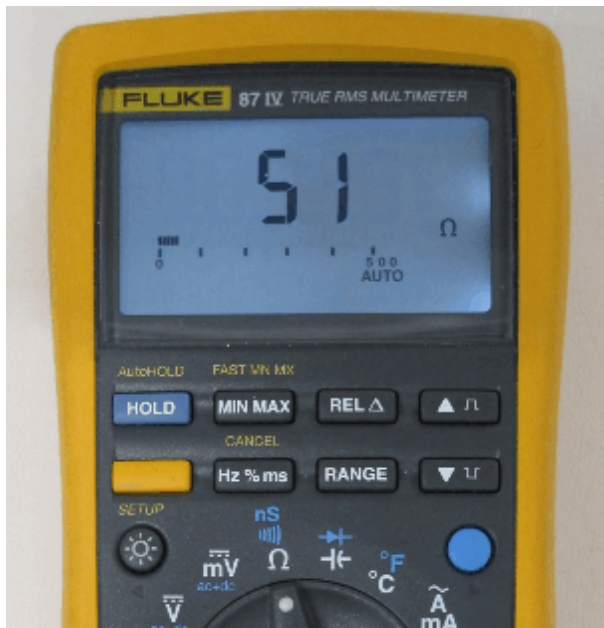
Fig. 29: DVM check 50 ohm

- During table movement, read the value at the DVM
  - » A stable value of approx. 50 ohm should be displayed.
  - » If the value is unstable, or a short or open circuit is measured, the LC-TX cable is broken.
