**ADMINISTRATIVE INFORMATION****FMI No: 25398****FMI Title: VCT 06MW29.7 Patch**

This FMI is **ONLY** applicable to **LightSpeed 7.x VCT** systems running **06MW29.7** software. **DO NOT** perform this FMI on any non-VCT systems running 06MW29.7 software.

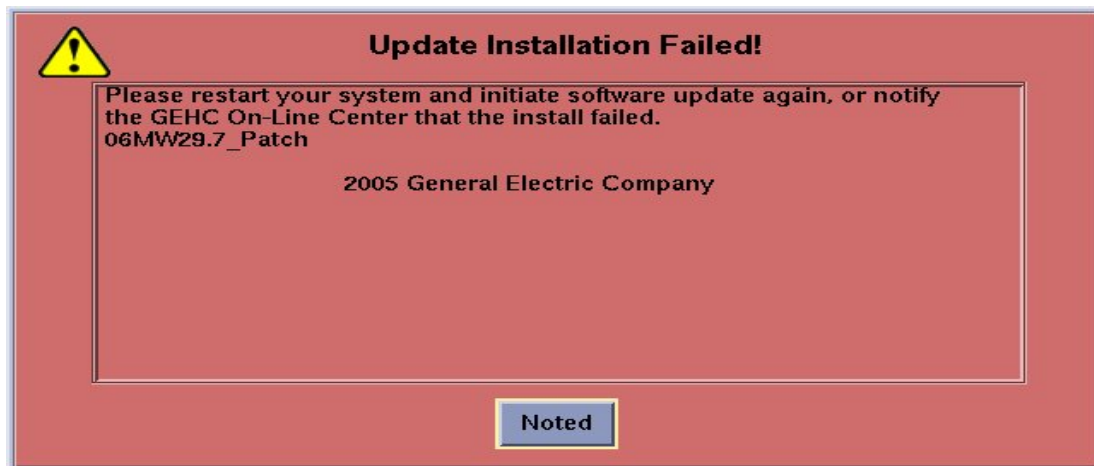
**NOTE:** If the following message box displays the prerequisite software was not installed prior to installation. Please review the ***Verify Prerequisite Patches Installed*** Section.

### Verify Prerequisite Patches Installed
