*GE Medical Systems*

## **Direction 2301701-100 SnapShot Segment Image Quality**

OPERATORS DOCUMENTATION

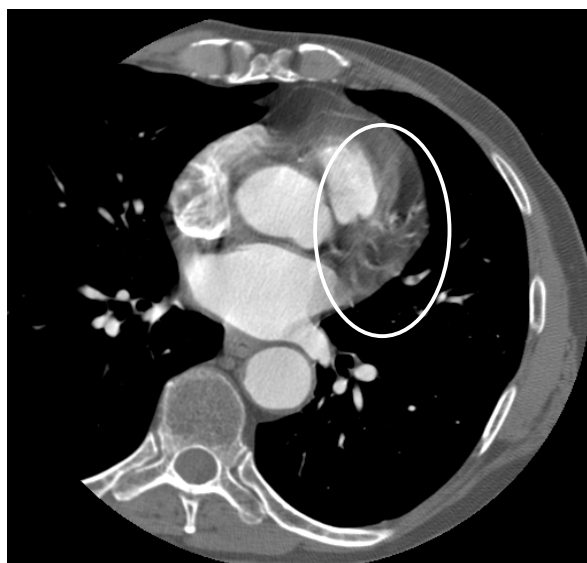
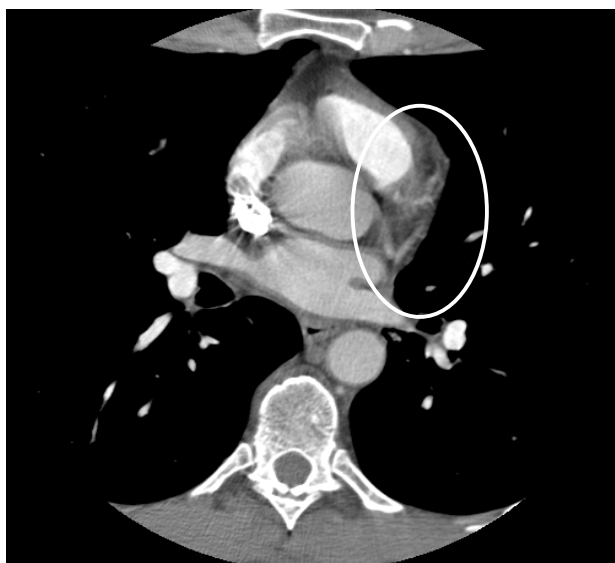
In 2D images the coronary artery can look blurred due to inadequate temporal resolution or patient motion. This is usually caused by scanning a patient with a higher heart rate than is recommended (75bpm or below) or when a patient is breathing during the scan.

**Blurred LCA and LCx**

To avoid blurred arteries, avoid scanning a patient with a heart rate above 75bpm. Care should also be taken to explain the exam to the patient and inform them of the length of the breath hold. If the breath hold is too long, inform the patient to slowly release their breath at the end of the exam.

If a patient has been scanned with a heart rate below 75bpm and the images are still blurry try to produce the images at a different phase location. Sometimes this will reduce the blurring in the vessels. The right coronary artery is especially prone to this artifact.

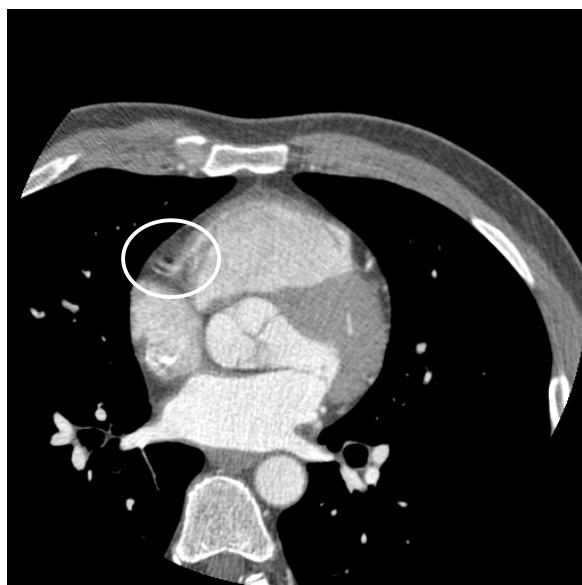
**Blurred/Whispy RCA**

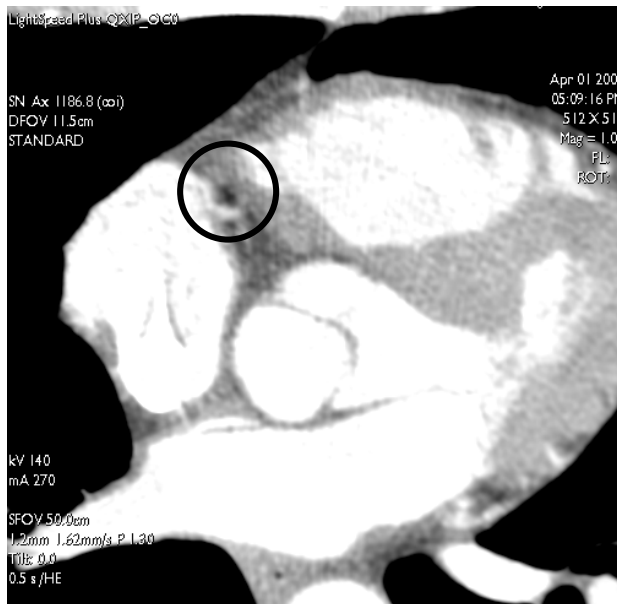
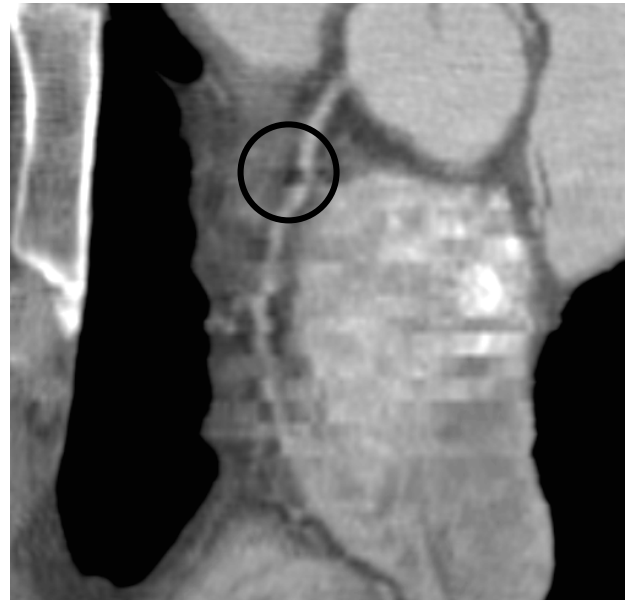
In some 2D images of the coronary artery the right coronary artery may disappear or a black circular artifact may appear where the RCA normally lies. The black circular artifact may also appear in the 3D images. This is due to insufficient temporal resolution, which in turn will not freeze the motion of the RCA.

The RCA is the most difficult artery to image due to the motion of the artery in the diastolic phase. It is thought that the artery is best seen in end systolic phase, so if the right coronary artery is missing in some of the images or this circular artifact appears, the user can try and reconstruct the images in another phase.

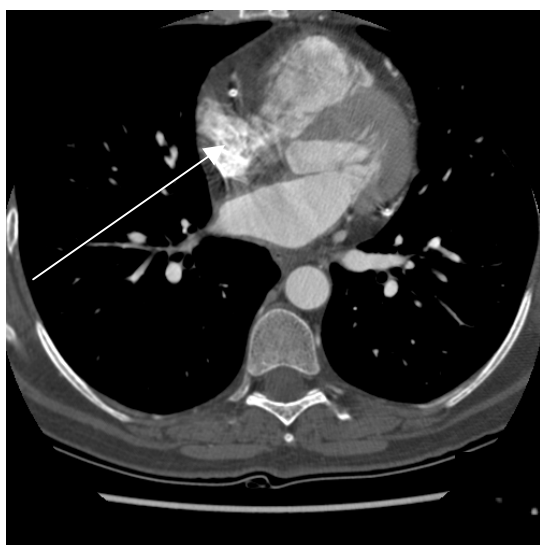
In 2D images of the heart the user may notice streaking artifact in the area of the Superior Vena Cava, this is due to the large amount of contrast flowing through the superior vena cava.

In the 3D images of the heart the user will notice banding artifacts in the sagittal and coronal images. This is due to CT number shifts or noise pattern differences between horizontal bands/regions on the images. Each band corresponds to a set of axial images generated from one cardiac cycle. The following may be causes for banding artifacts:

- Contrast non-uniformity - for contrast enhanced tissue who's CT number varies with time, CT number differences between heart cycles will be accentuated by gated reconstruction.
- SVC and metal streaks – streaking due to high contrast in the SVC can affect the CT numbers of surrounding tissue, when viewed as reformat the user may see gray scale shifting from band to band
- Noise patterns – for larger patients noise patterns in the axial images may be more apparent in reformatted images from band to band.

The SVC artifact can be reduced by scanning inferior to superior, but there is a risk that the patient may not be able to hold their breath during the complete scan, which in-turn will cause motion artifacts in the proximal coronary arteries.

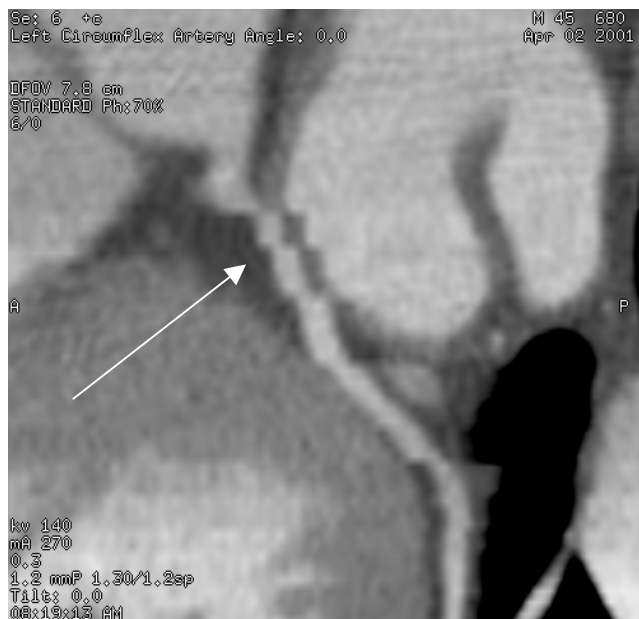
In the 2D images of the heart the user will notice an apparent “beating” of the heart as they scroll through a series of the cardiac axial images. When the user pages through the images they will notice the artery/cardiac structures moving from side to side or up and down.

In the 3D images the heart will display horizontal shifting in the coronal/sagittal images where the heart could not be frozen at the same position or phase location from heart cycle to heart cycle. This artifact is most prominent in the mid section of the heart and is visible at the edge of the left ventricle.

Phase misregistration may be caused by inadequate temporal resolution, which in turn does not freeze the motion of the heart in patients with high heart rates. It is recommend scanning patients with heart rates below 75bpm. Phase misregistration may also be caused by the ventricle contracting differently from cycle to cycle (image to image) causing the artery or location of the ventricle to change from one image to another causing misregistration.

**LCX with Misregistration**

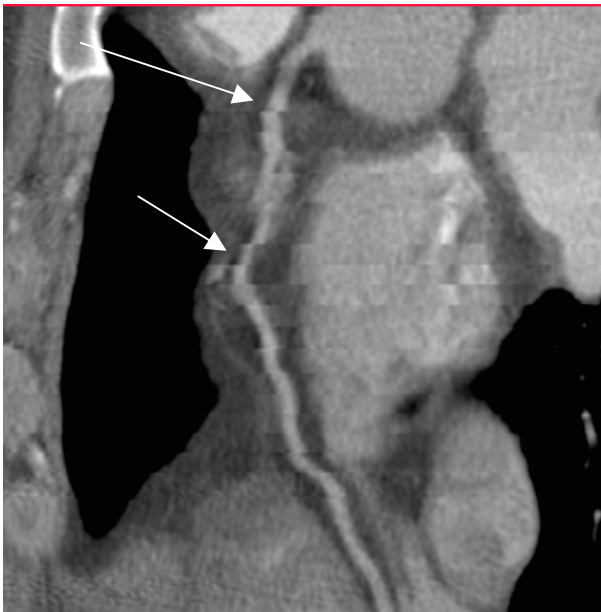
When using the Vessel Analysis software the user may create an image and notice the vessel has misregistration artifacts. This artifact may be corrected by producing an image in another phase and then running vessel analysis again. As you can see from the case below, the first RCA artery was produced with a 70% phase location and throughout the data set the artery has misregistration artifacts. When the user changes the phase location to 80% most of the artifacts disappeared.

**Misregistration 70% R to R Interval**

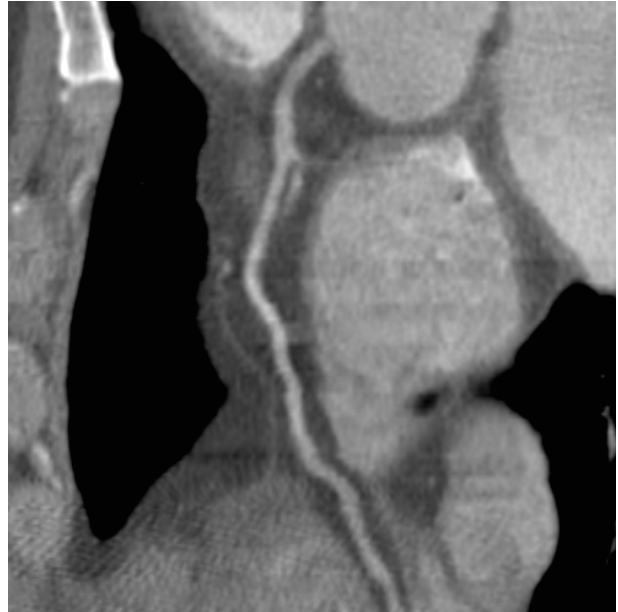
**Improvement with 80% of R to R Interval**
