***GE Medical Systems***

**Direction 5115418-100 Revision 4  
Addendum – LS2002M5**

**LightSpeed 2.X, 3.X, 4.X**

**Application Tips and Work-Arounds**

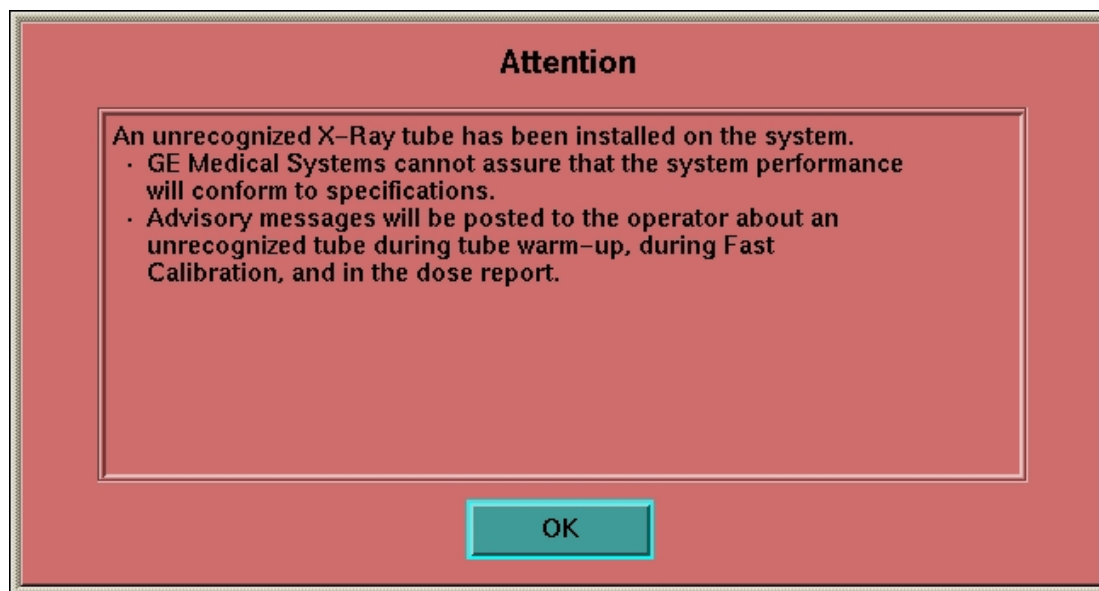
If a Non-GE-Supplied tube is found, the following warning dialog box will be posted at system start-up.

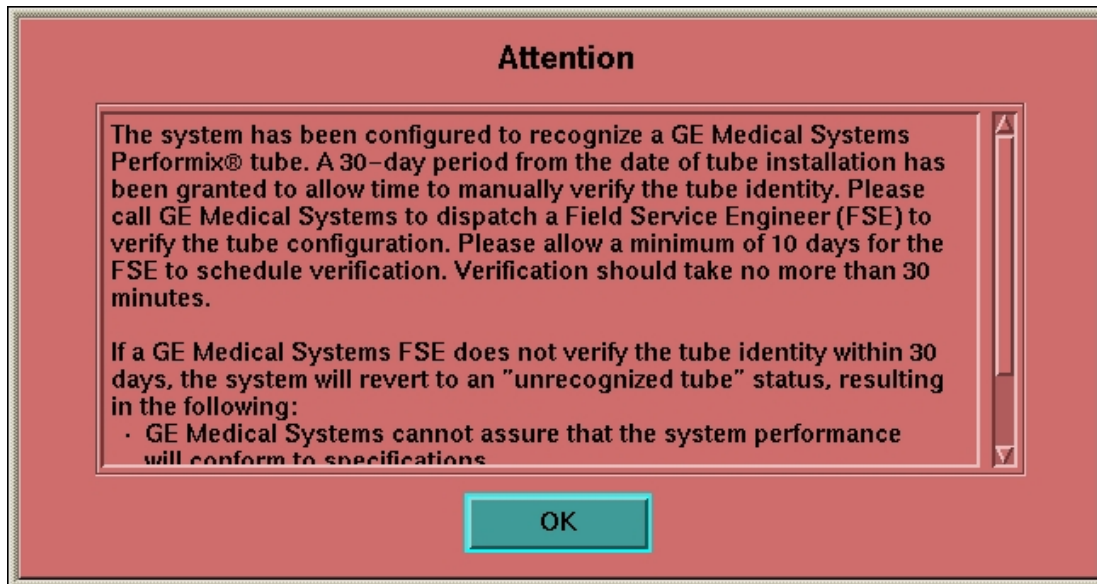
If the installed x-ray tube is a GE-Supplied tube and the field service engineer did not have all the appropriate information to complete verification, a message will be displayed indicating verification needs to be completed.

If the GE-Supplied tube is installed by either an in-house or 3<sup>rd</sup> party service provider, the same message will be displayed and customer will need to call to have a GE Service Representative dispatched to verify the identity of the tube. The following message will be displayed for 30 days or until the field service engineer is able to complete tube installation verification within the 30-day window.

If the verification is not completed within the 30-day window, software will revert to unrecognized tube state. In that state, advisory messages for an unrecognized x-ray tube will be seen during Start-Up, Tube Warm Up, FastCal and on the Dose Report screen save image. The user will need to acknowledge the messages before he or she can scan.

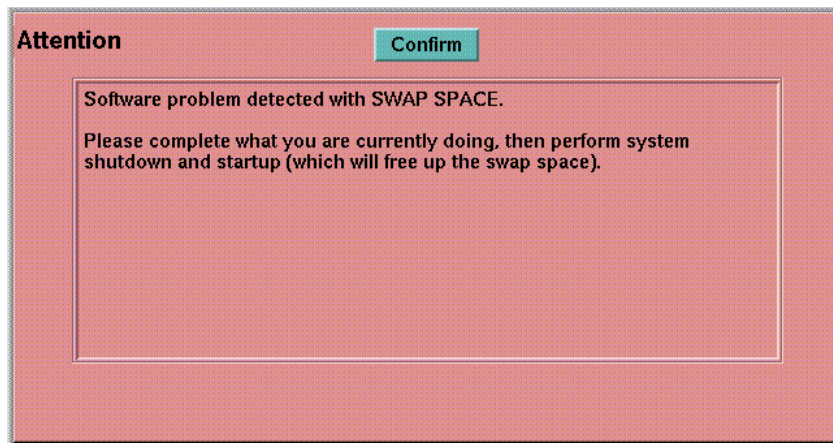
**Swap Space** – If the amount of swap space available is detected to be a low level preventing system from functioning properly, a pop-up message will be displayed to instruct the user to close out actions and reboot the system to recover swap space and system functionality.

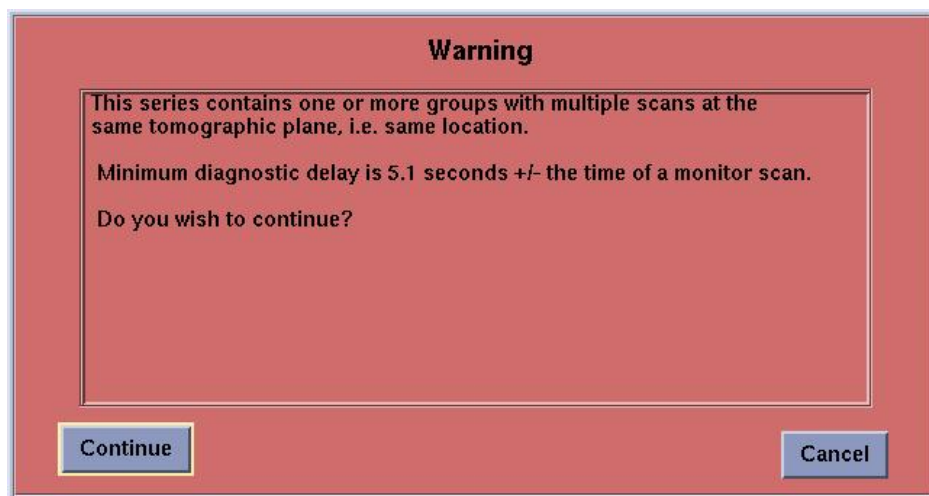
1. Issues with SmartPrep failing to start were addressed.
2. Communication issues between ScanRx and Display processes were improved to make SmartPrep more reliable.
3. Issues with the SmartPrep diagnostic delay not as expected have been addressed. The diagnostic delay is adjusted at [Confirm] to take into account any table movement that is needed to move from the location for the Monitor scan to the start location for the Scan phase. If the diagnostic delay is going to be longer than what is specified in the SmartPrep menu, the SmartPrep Warning dialog box will display the actual diagnostic delay time to transition from Monitor Phase to Scan Phase.
