## FCT SERVICE NOTE SN06022713a

**Effectivity:** **LightSpeed VCT 64, 32 Slice and H-power Brush Block Alignment**

**Subject:** Poor Slip Ring Brush Block Alignment 5.x and 7.x Systems

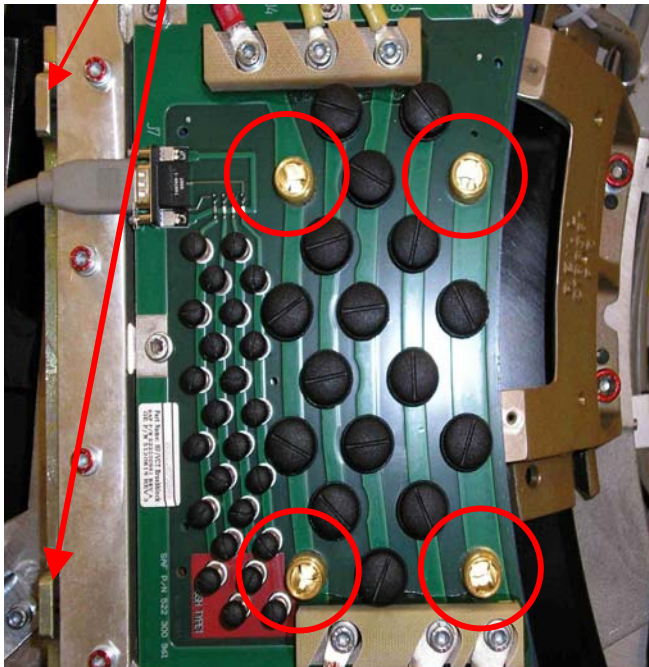
Adjustment setscrew

**Issue:** VCT and H-power Slip Ring Brush Block Misalignment is a leading cause of communication problems across the Slip Ring.

**Cause:** Brush Block to Slip Ring **Alignment is critical to ensure problem free operation.** VCT and H-power systems have Faster Rotation Speeds. The Faster Rotation speeds of 0.4 and 0.35 seconds have magnified the importance of proper Slip Ring Brush Block Alignment.

**Resolution:** Align the Brush Block assembly to the Slip Rings. See The Service Manual for the Brush Block Adjustment procedure, look under replacement procedures section. Perform this Brush Block alignment check on your next PM or when ever Slip Ring communication problem occur.

1. Carefully push brush block against the position adjustment set screws in the mounting bracket.
2. Remove (4) Power brushes (all four corners).
3. Use a flashlight to verify Brush Block position, adjust the brushes so they ride in the center of their tracks via the Adjustment Screws. Adjust the brush block setscrews if necessary to center the brush over the ring.
