## **FCT SERVICE NOTE SN06051511a**

**Date: May 11, 2006**

**Effectivity: CT systems using the Performix Pro VCT 100 X-Ray tube (Hercules - D3194T).**

**Subject: Performix Pro 100 KW X-Ray Tube Coolant Hose Routing**

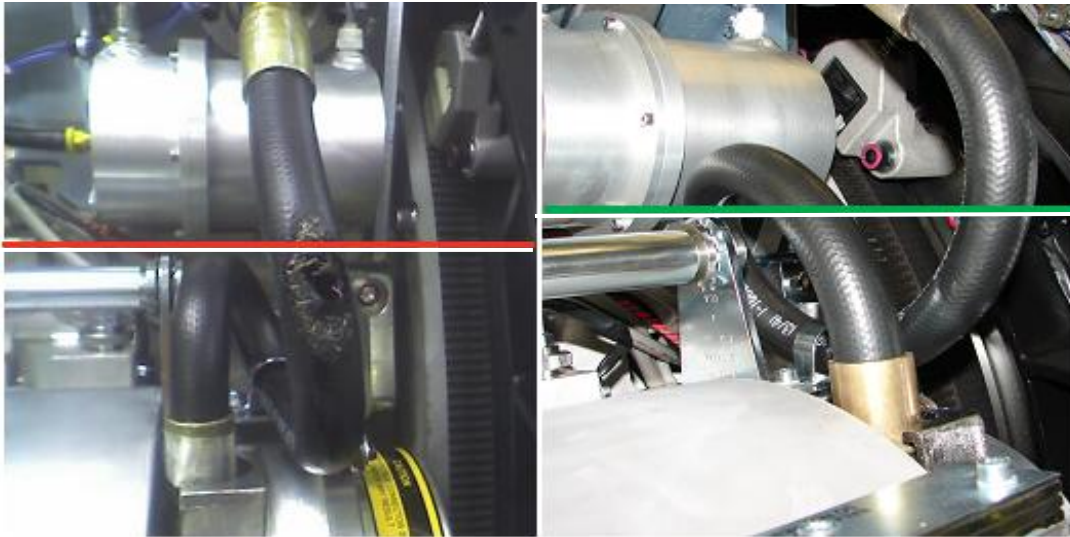
**Issue: Improper x-ray tube coolant hose routing could allow the oil coolant hose to contact the Gantry frame resulting in a loss of coolant oil and/or other Gantry damage.** The purpose of the looped coolant hose on the cathode side is to allow flexibility when trying to reach the heat exchanger quick-disconnect during a tube change. If the black coolant hose is pulled into a coil that is too small, portions of the hose will contact the stationary portions of the Gantry during rotation. This contact could result in damage to the hose and possibly leak oil throughout the Gantry.

The attached pictures show a failed hose with a tight loop, and an example of a properly looped hose.

**Side view:** Improper (left) and proper (right) loop

**Resolution: The position of the loop in the coolant hose on the cathode end of tube must be maintained.** The short-term solution is to have the field engineers make sure the looped hose extends above the lift bracket. A permanent poke-yoke solution will be released later. The Tube replacement procedure will be updated to make everyone aware of this potential issue in the future and the Service classes will be updated to inform FE's of the potential issue as well. If the hose loop is too tight, the hose should be adjusted to make the loop extend past the lift bracket (see pictures below).

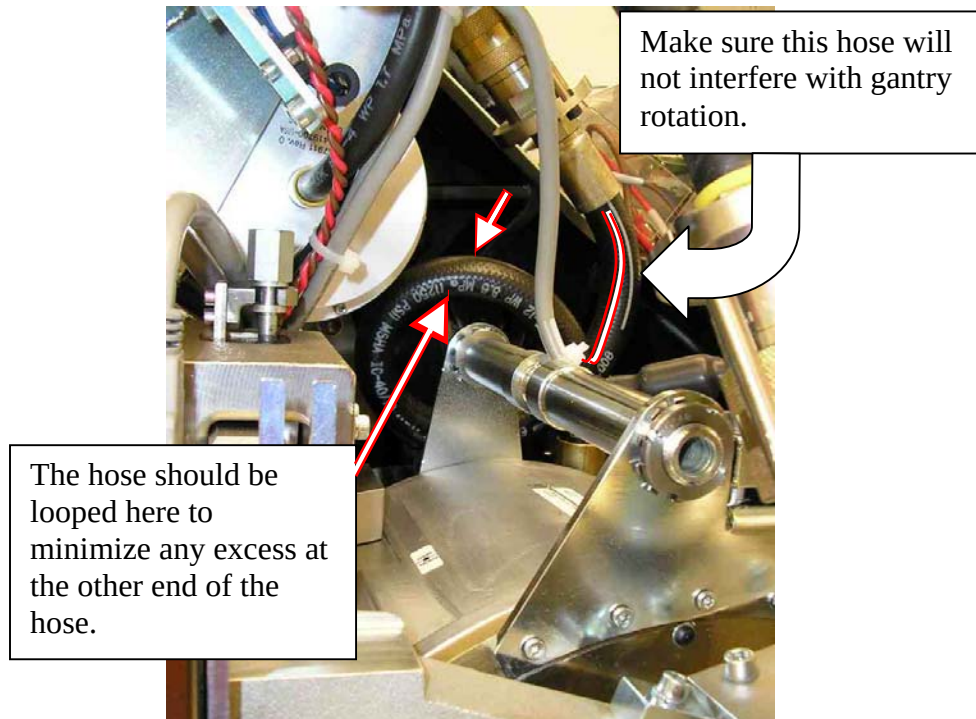
**Front view:** Proper Loop above Lift Bar the hose loop should extend above the Lift bar.
