## FCT SERVICE NOTE SN06101714b

**Subject:** VCT Detector Module Open Pixel Faults

**Effectivity:** VCT VDAS32 and 64 systems and HDAS systems

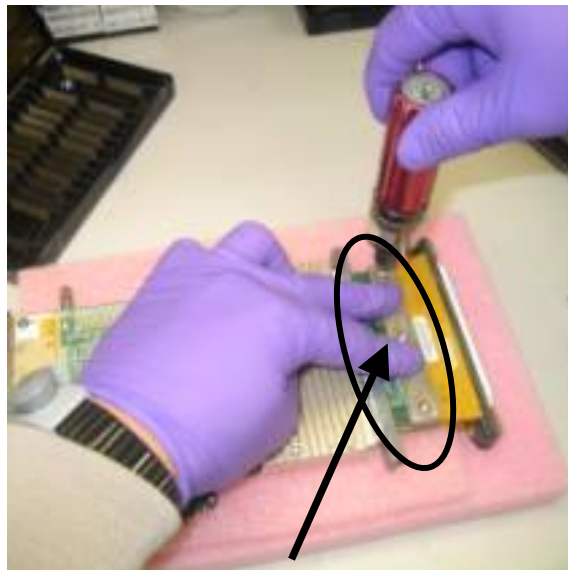
Almost all incidents of "OPEN" pixel faults have been found to be flex clamp screw torque issues. The screws for the flex clamp on digital modules can become loose over time. Shorted pixel faults are not caused by this issue. Using this procedure to re-torque the flex connection screws for Open Pixel faults can save the expense of a new module in most cases.

Figure 1: Flex connection screws (3)

- Pull the module out per replacement procedure.
- Torque the 3 flex connection screws to 4 lb-in (0.5 N-m or 4.6 kg-cm) starting with the center screw.
- Put the Module back in and Plenum on per standard service instructions.
- Run maratio's test from DASTools to see if problem has been resolved.

If this does not fix the issue, then replace the module.
