**MI&CT ESERVICE NOTE  
SN07062210a**

**Date:** June 22, 2007

**Subject:** Performix X-Ray Tube harness (2151264) may have loose wire crimps.

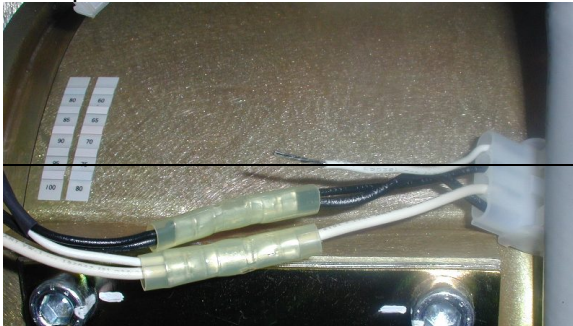
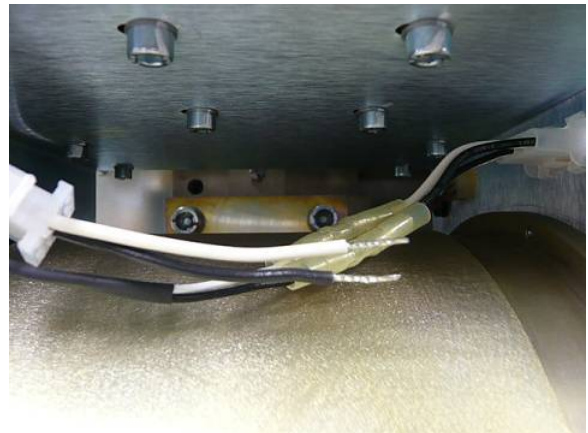
There is a possibility that units listed in the effectivity above fail to produce x-rays due to a wiring failure in the harness 2151264. It is possible that the unit reaches the maximum allowed temperature and activates the protection circuit if the cooling system (oil pump and fans) is not energized properly. It is also possible, even though not reported to date, that the loose wires cause a short to the surrounding metal surfaces and cause the protection fuse to open in the CT gantry base.

Examples of the Harness defect

1. All units in the effectivity list above manufactured after June 18, 2007 have the harness 2151264 inspected for loose wires (pull test at supplier) and are ready for installation and use without inspection.
2. Inspect all units on hand, in effectivity list above, prior to installation.

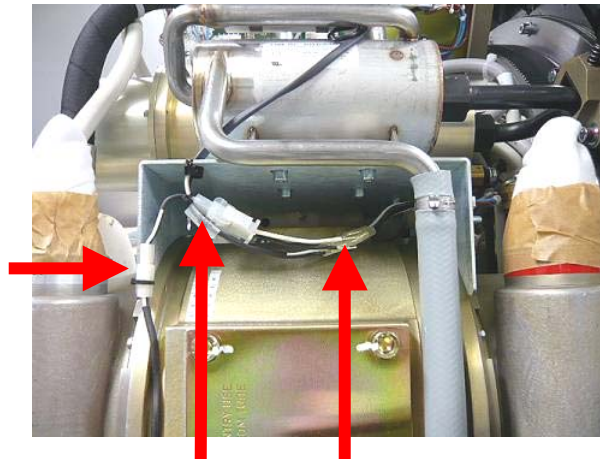
**Note:** There is no need to pull-test the wires going to the 3 connectors shown below
