# Trouble Shooting – Gradient Supervision

## Currently seen problems – differential pressure related problems

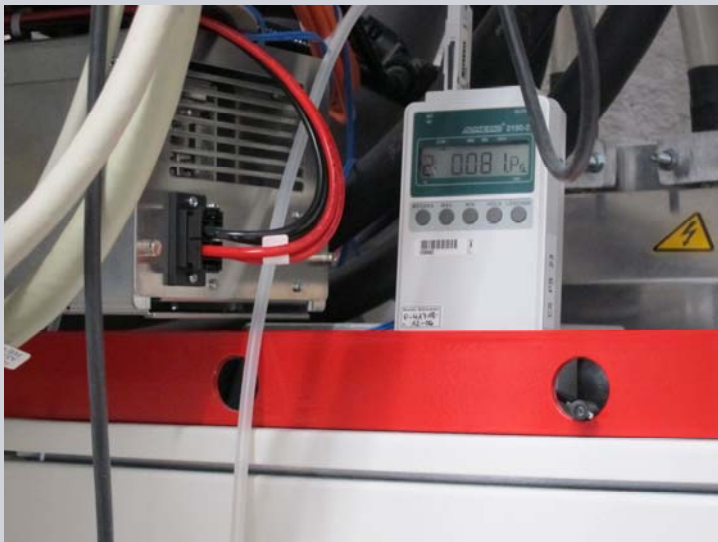
1. Excessive differential pressure between RF-cabin and equipment-room ( $>80$  Pa). This should be below 40 Pa. This kind of problem can be typically verified by:
  - RF door closed (VLM normalised and status „OK“)
  - RF door open (VLM status „FAULT“)

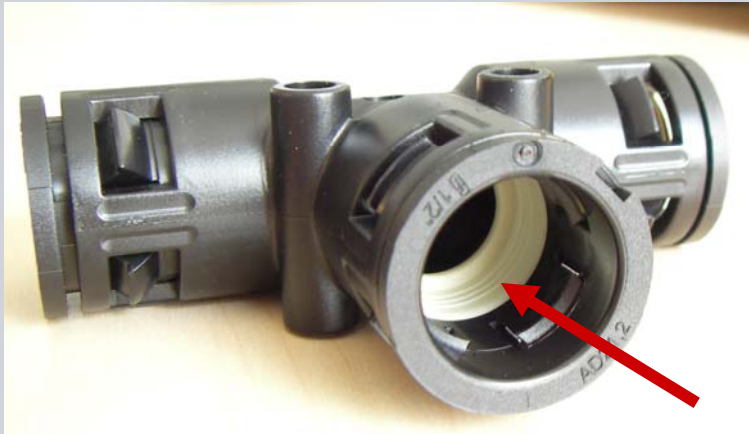
4. Missing sealing in joint elements.  
In case of a FAULT condition, check the joint elements (T-pieces) for proper sealing. There must be a white rubber seal as shown on the left in each joint. A missing seal results easily in an air flow difference of 1.4 ltrs./min. (~7%).

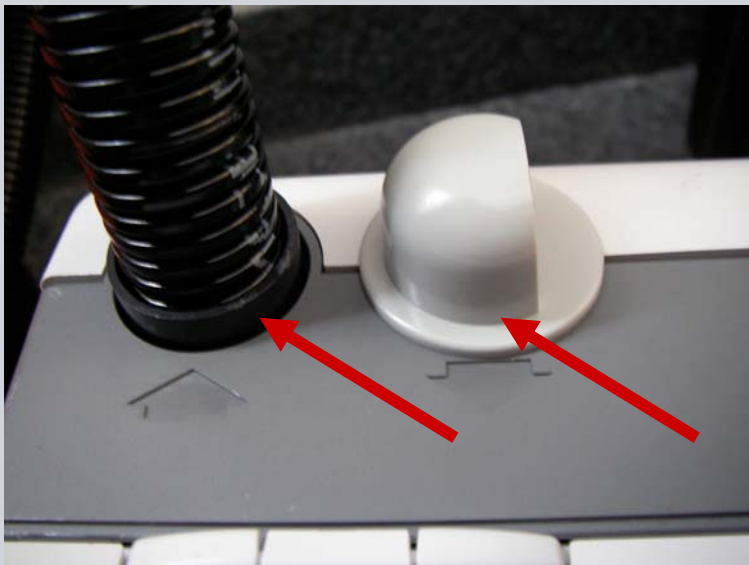
5. The black bushing must always be used when a hose is being connected to the inlet or outlet of the VLM. If missing, the flow will increase dramatically for 9 ltrs./min. (~43%). When the grey outlet cover is being removed, the flow increases for 0.4 ltrs./min. (~2%)

If needed, the black bushing at the VLM-in/outlet can be also ordered as a spare part: 10683929.
