**ADMINISTRATIVE INFORMATION****FMI No: 25390****FMI Title:** Performix Pro VCT 100 (Hercules) Tube Window Screw Replacement

**Unit Tracked:** Refer to Effectivity list on page 2.**FMI Instructions Part No.:** 5193259-100, Rev 2**Do NOT leave unsecured on site**

## ***Purpose***

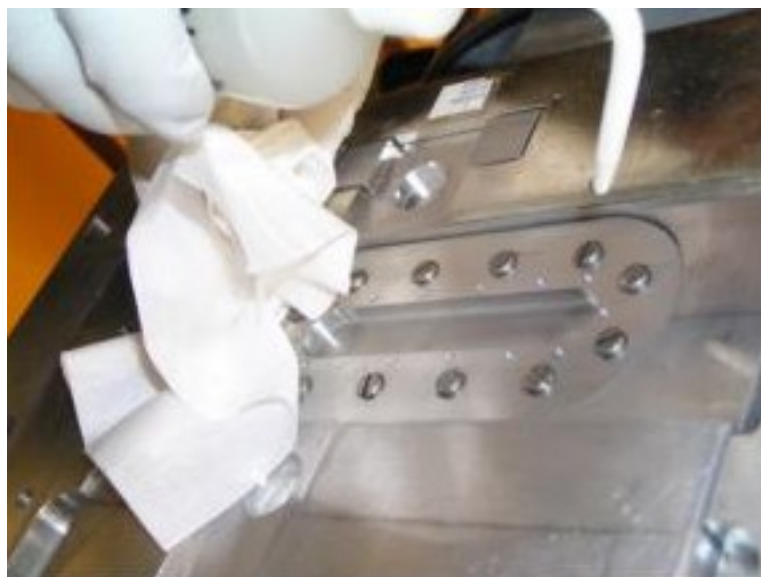
11. Inspect the aluminum casing window for traces of oil. Using clean wipes and alcohol, clean any traces of oil at the window and around the screws.
