**ADMINISTRATIVE INFORMATION****FMI No: 25407****FMI Title: Service Pack 2.0 for Software Versions 07MW18.4,  
07MW11.10, and 07BW08.4**

**Unit Tracked:** Multiple Host Console Model Numbers**FMI Instructions Part No.:** 5264685-1EN, Rev 2**Do NOT leave unsecured on site**

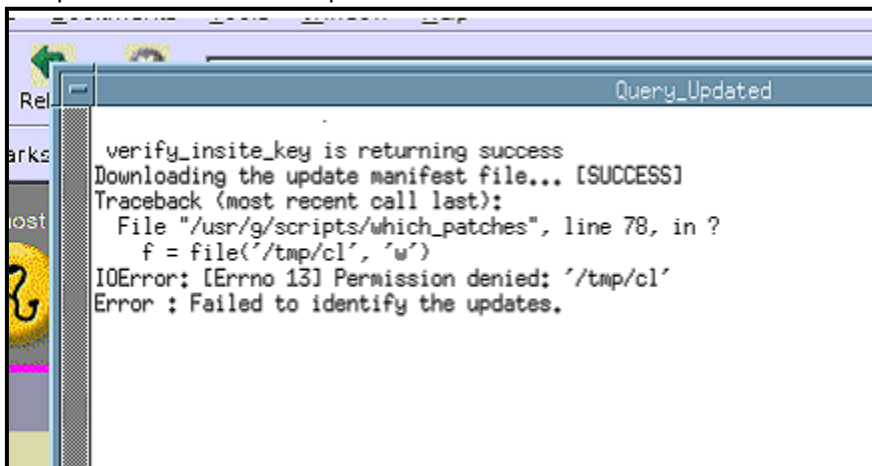
13. If after selecting **[Query Updates]**, you get an error message similar to the one below, proceed to the next steps to resolve it. NOTE: this error will be fixed with Service Pack 2.

14. You will need to change ownership of the following files:

**/tmp/cl**
