# **FCT SERVICE NOTE**

## **SN05080916a**

Power cable (2363839-2) for slip ring transmitter may not have (Fair-rite) ferrite bead positioned or secured properly.

HP60, HP100 & RT systems manufactured in Waukesha from approximately January 2005 to present.

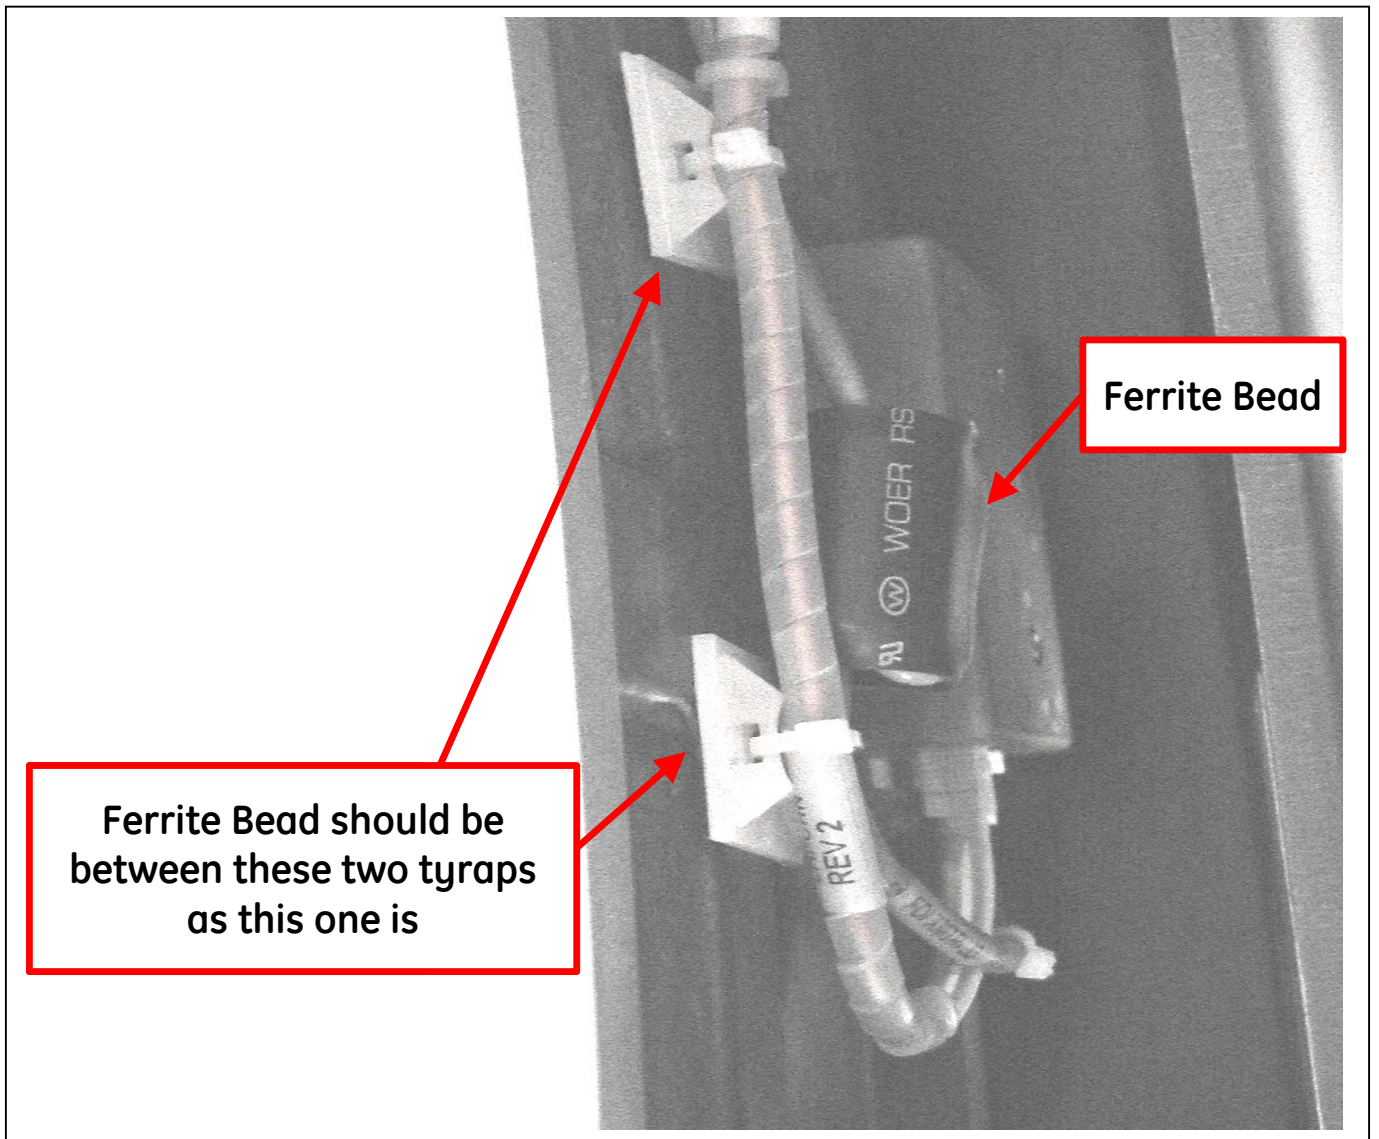
The ferrite bead moves around when it is not secured properly. The cable becomes disconnected and cable damage may occur.

The transmitter is located on the slip ring and directly below it are 2 ty-wrap pads.

The ferrite bead should be ty- wrapped between these pads.

Inspect ferrite bead position. Remove right gantry side cover. Turn off axial drive & HV enable switch. Rotate gantry so that the center das chassis is approximately at the 1 o'clock position. You now should be able to see the transmitter though the opening in the upper slip ring cover. The opening in the cover is by the receiver.
