# FCT SERVICE NOTE

## SN05110411a

**Subject:** VCT POR Dial Indicator mounting bracket & Local FE Support actions.

**Effectivity:** VCT 32/64 slice systems

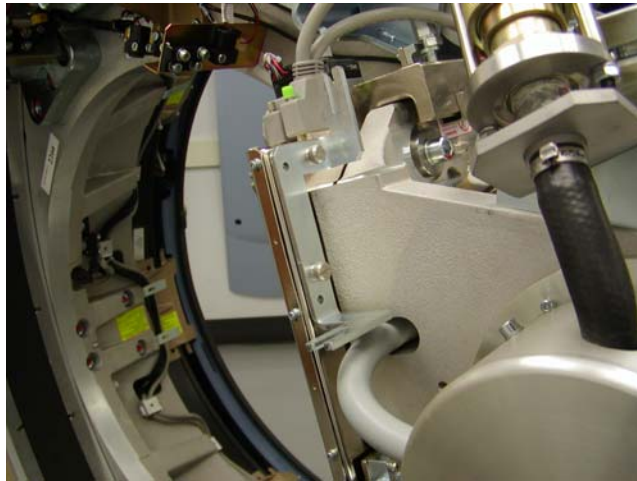
**Figure 1 POR Bracket Location**

The POR mounting bracket has been found to vibrate loose and fall off during system operation. This has resulted in damage to the Detector Mylar window in one confirmed case. As with any loose object, other unspecified damage can also occur. Currently this part is not a FRU. Engineering is working to change this to a FRU Yes. Part # 5126933

Upon system installation, PM, or any service call requiring Gantry cover removal, inspect this bracket to see if it is loose. It is recommended that this bracket be removed and stored in the provided Service cabinet until needed.
