## FCT SERVICE NOTE

### 06120807a

**Subject:** VCT Detector Cable Interference to Stationary Part

**Effectivity:** VCT (7.x systems) with 2006 Style Plenum  
(This includes 64-slice Sherlock detector, 64-slice HALO detector, and 32-slice detector.)

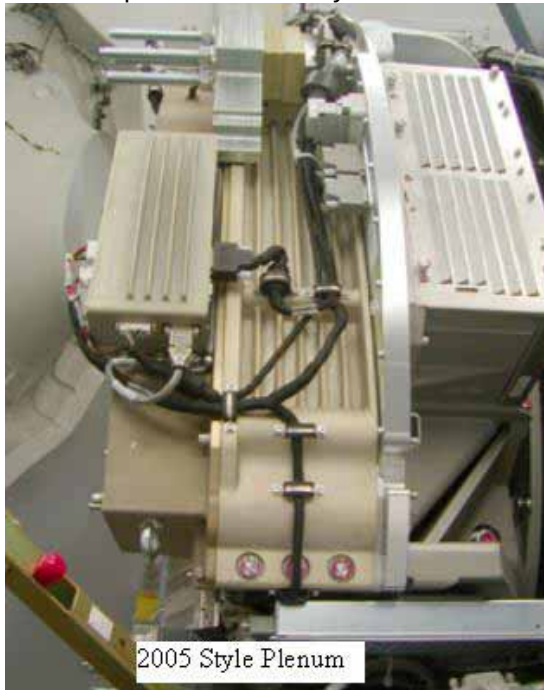
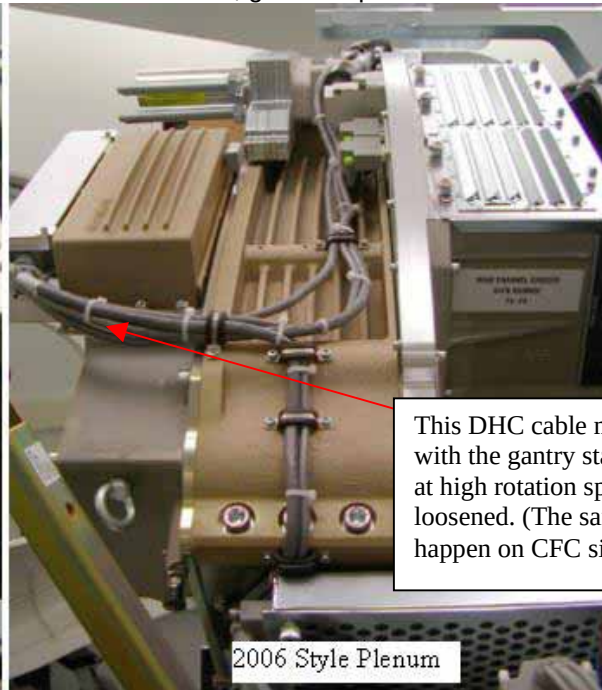
It was found at a few systems in manufacturing and field that the detector DHC and CFC cables contacted the stationary part of the gantry during the rotation, making some tapping noise. The cause of the problem is inappropriate clamping of the cables on the 2006 style plenum. This problem does not exist on the 2005 style plenum.

This DHC cable may contact with the gantry stationary part at high rotation speed if loosened. (The same could happen on CFC side.)

- 1) Remove gantry right side cover.
- 2) Disable Axial Drive and HVDC from the service switch panel.
- 3) Rotate the gantry to see the detector plenum.
  - ☐ If plenum is old 2005 style (5117776) shown below, go to step 6, no change required.
  - ☐ If plenum is 2006 style 5158921 or 5169298 shown below, got to step 4.
