## MI&CT ESERVICE NOTE

### SN07012213a

**Subject:** Slipring Brush Disconnects

**Effectivity:** HP-60, -80, -100 systems, RT, VCT

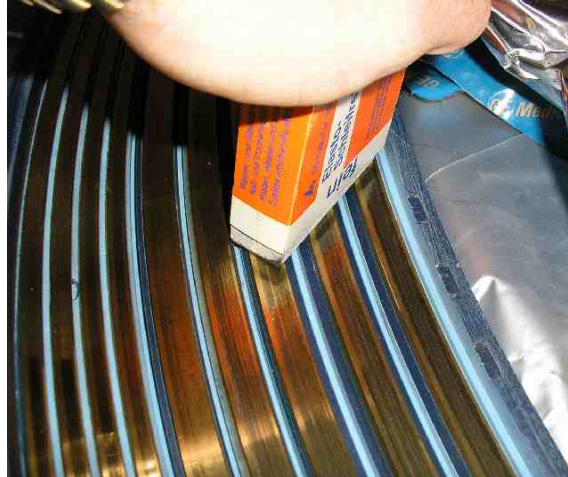
#### ILLUSTRATION 6 – CLEANING WITH THE ERASER

The ring color should return to a shiny new brass color (Illustration 6).
