## 1 – DESCRIPTION

Troubleshooting EPI ghosting problems is often very challenging, given that EPI has so many mechanisms that contribute to ghosting. This checklist is designed to provide a structured approach to correcting EPI ghosting problems in EXCITE (10.0) systems (do not use this document to troubleshoot LX (8.X, 9.X) systems). Here is how to check what revision software (compare the grayed number) your system has loaded:

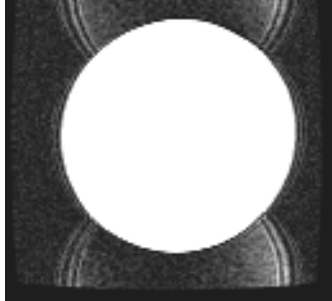
| <p><b>3.1 “Edge” ghosting</b> – normally seen with ramp-sampled EPI prescriptions</p> <p><u>Check (Section 4):</u> 6, 8, 10</p> | <p>Figure 3.1</p> |

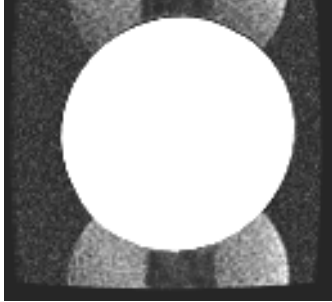
| <p><b>3.3 “Linear” EPI ghosting</b> – similar to a B0 ghosting in appearance with the addition of a vertical signal void. Linear EPI ghosting is caused by a residual delay between even &amp; odd echoes. Increased linear ghosting normally indicates a gradient problem.</p> <p><u>Check (Section 4):</u> 3, 4-1, 4-2, 6, 7, 8, 9</p> | <p>Figure 3.3</p> |
