# MR - 1.5T Signa® HDx & 3.0T Signa® HDx Release Notes and Errata

1.5T Signa® HDx & 3.0T Signa® HDx  
Operator Manual, English  
5159410-100  
Revision 2  
© 2006 General Electric Company  
All rights reserved.

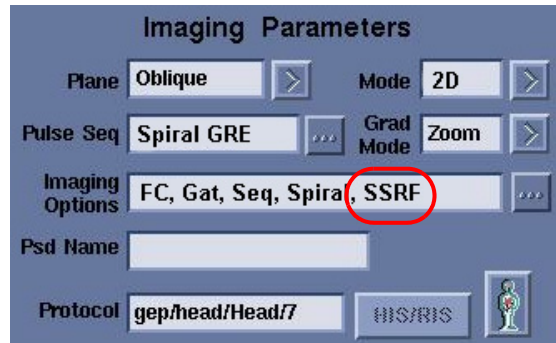
**What Happens:** You are prescribing a Spiral scan. If you delete the SSRF option from the Imaging Option field on the Imaging Parameters area of the scan desktop rather than from deselecting it on the Imaging Parameters pop-up window, then the prescription user interface greys out (becomes invalid).

**Work Around:** Do not delete SSRF from the Imaging Options text field.

Only delete an Imaging Option by deselecting the radio button from the Imaging Parameters pop-up window.

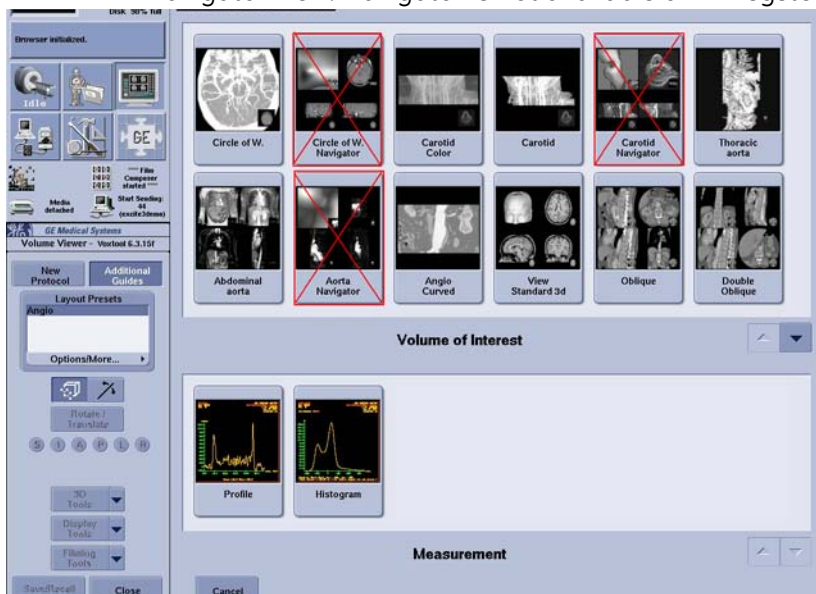
**What Happens:** In IVI, there are Navigator protocols on the Additional Guides window. You can select these protocols and the Navigator wizard appears in the lower left viewport, but you cannot create a navigator view. Navigator is not available on MR systems.

**Work Around:** None. Navigator is available on AW systems.
