Air Transat Flight 236

Flight Info

Air Transat - Airbus A330

23-24/08/2001

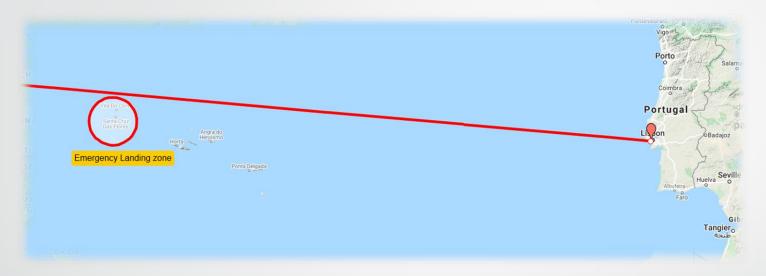
Overall Situation

Landing speed: 200 knots (370 km/h)

Landing run: 2.3 km

Runaway length: 3 km

No victims

2 people seriously injured
