Advance TechnoForge Ltd.

8D Report

Customer: Precision Hydraulics Private Limited

Part Name: 4002674 - Head

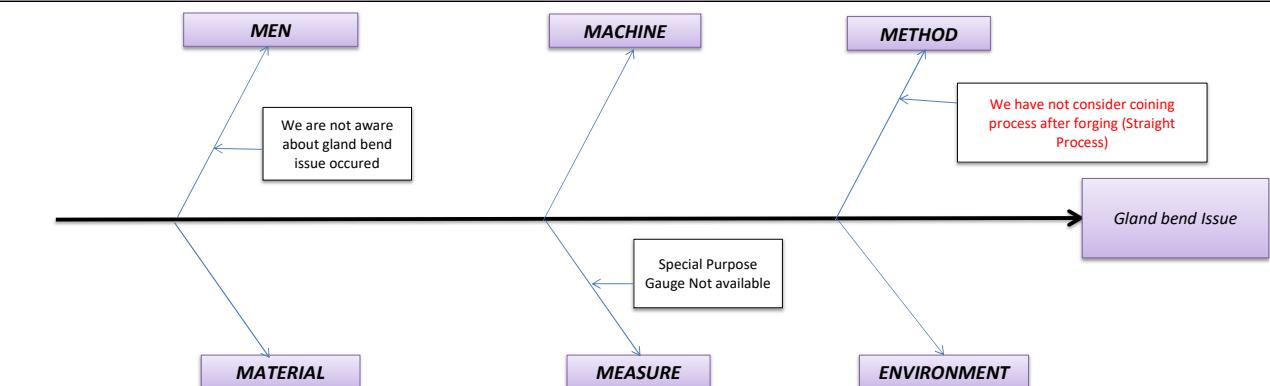
4.) Fish Bone Analysis:

Gland Bend Issue

1.) Why was the non conformity made?	2.) Why Was the non conformity not detected?
Why? We have not consider coining process after forging (Straight Process)	Why? Why? 100% Inspection not carried out at Final inspection stage
Why? We are not aware about gland bend issue occurred	Why? Why? Special Purpose Gauge Not available
Why?

1. We have not consider coining process after forging (Straight Process) 2. We are not aware about gland bend issue occurred 3. Special Purpose Gauge Not available	Responsibility	Responsibility
	Mr. Bipin	Mr. Vikaram
	Department	Department
	Production	QC

- 1 We have started the coining process for eliminate Bend issue in which have available Forging stock at our end.
- 2 Quality Alert to be displayed at work station
- 2 100% Parts should be checked before dispatch

Action:	Responsibility	Target Date
1.) We have add & started the coining process for eliminate Bend issue.	Mr. Bipin	already started
2.) We will introduce the Special Purpose Gauge.	Mr. Vikaram	30-04-2025
3.) Quality alert to be displayed at work station & Awareness about complaint to be given to respective persons.	Sagar Visapara	already Implemented
