# TECHNICAL BULLETIN

Bull. N°: 0008

MINI, METRO, MONTEGO, 200, 400, 100

SEAT SQUAB 'CREEP BACK' - RECLINER NUT

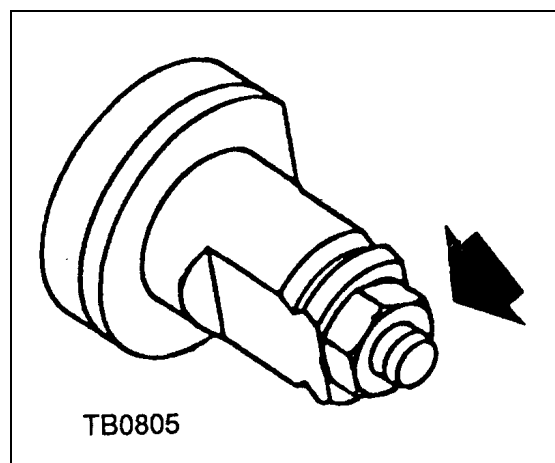
Seat squab suffers regression or creep back and requires frequent adjustment.

Torque relaxation of recliner mechanism nut.

Remove recliner hand wheel to expose the die casting and M4 nut (see illustration.

Hold die casting with an 8mm spanner across the flats and tighten the M4 nut a quarter of a turn (one and a half flats). check operation of recliner, if OK apply Loctite 924 or 638 to end of nut / thread. Refit hand wheel.
