# TECHNICAL BULLETIN

*Bull. N°:* **0009**

**E.C.U. FAILURE - WATER INGRESS**

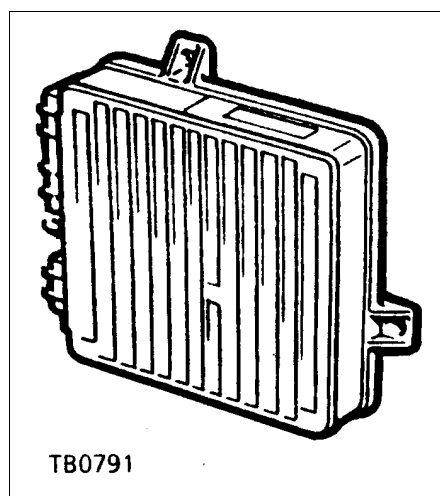
**E.C.U. failure, either permanent or for a short period of time.**

**Water ingress into E.C.U. due to various power wash operations.**

**The E.C.U. is designed to be splash proof only, therefore it is possible under an extreme power wash situation to force water into the E.C.U. via the casing or drain holes.**

**Inform all relevant service staff of this possibility and ensure adequate protection for the E.C.U. is provided if a power wash is used in the engine compartment.**
