# TECHNICAL BULLETIN

*MODEL/DERIVATIVE:*  
**MINI**

*Bull. N°:* **0004**  
*CDS. ref:* **R5898bu**  
*Issue:* **1**  
*Date:* **25.05.94**

*PROBLEM:*  
**ENGINE SHUNT - WEAK STEADY BAR BUSHES**

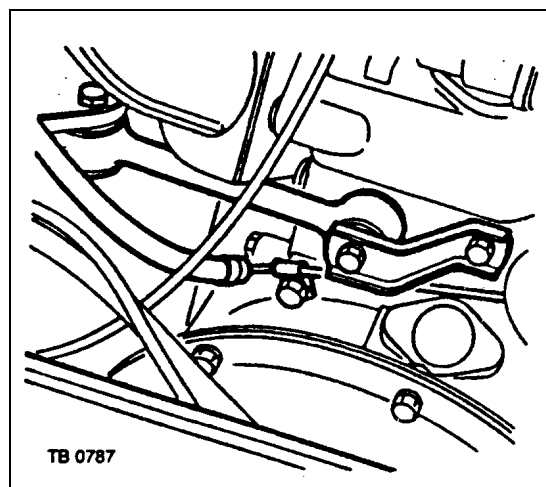
Engine shunt / kick, at light throttle. This condition may appear from approximately 6000 miles (9600 Kilometres) onwards.

*CAUSE:*  
**Upper engine steady bar bushes providing insufficient damping**

*ACTION:*  
**Replace existing bushes with heavy duty bushes.**

*PARTS INFORMATION:*  
**KKF100390 - Bush Engine Steady (heavy duty) - 4 off**
